Report No. WI-2003-14
30th June 2003

The Watershed Institute

Hydrology and Water Quality Of the Carmel and Salinas Lagoons Monterey Bay, California 2002/2003

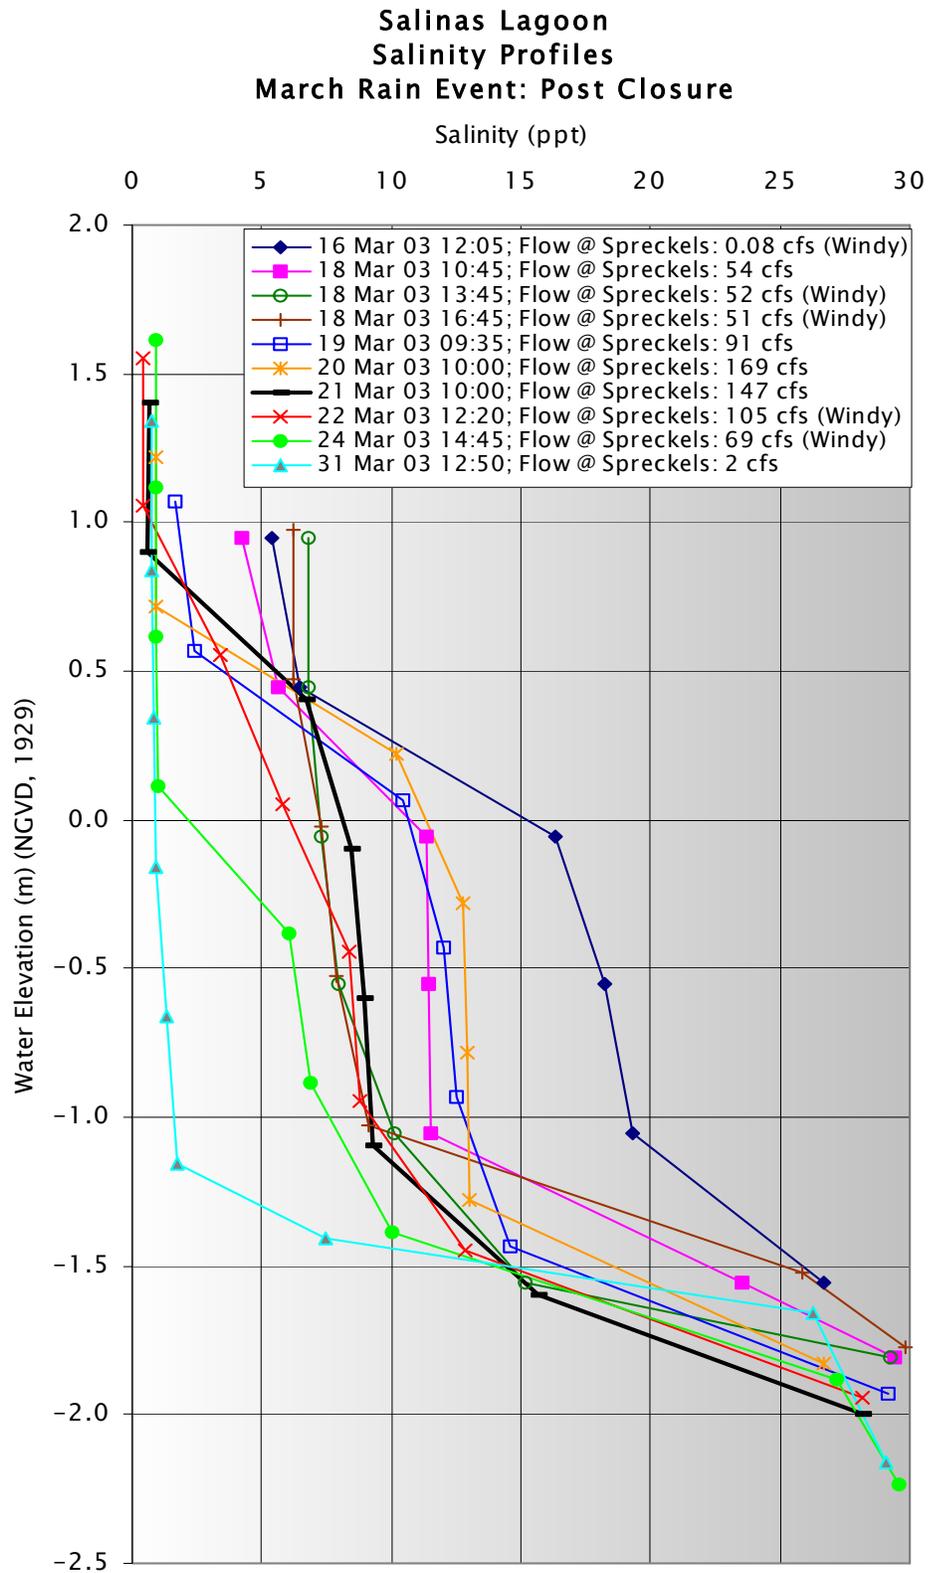
Figure 5.18 Salinity profiles collected during the rising hydrograph following the mid March rain event.

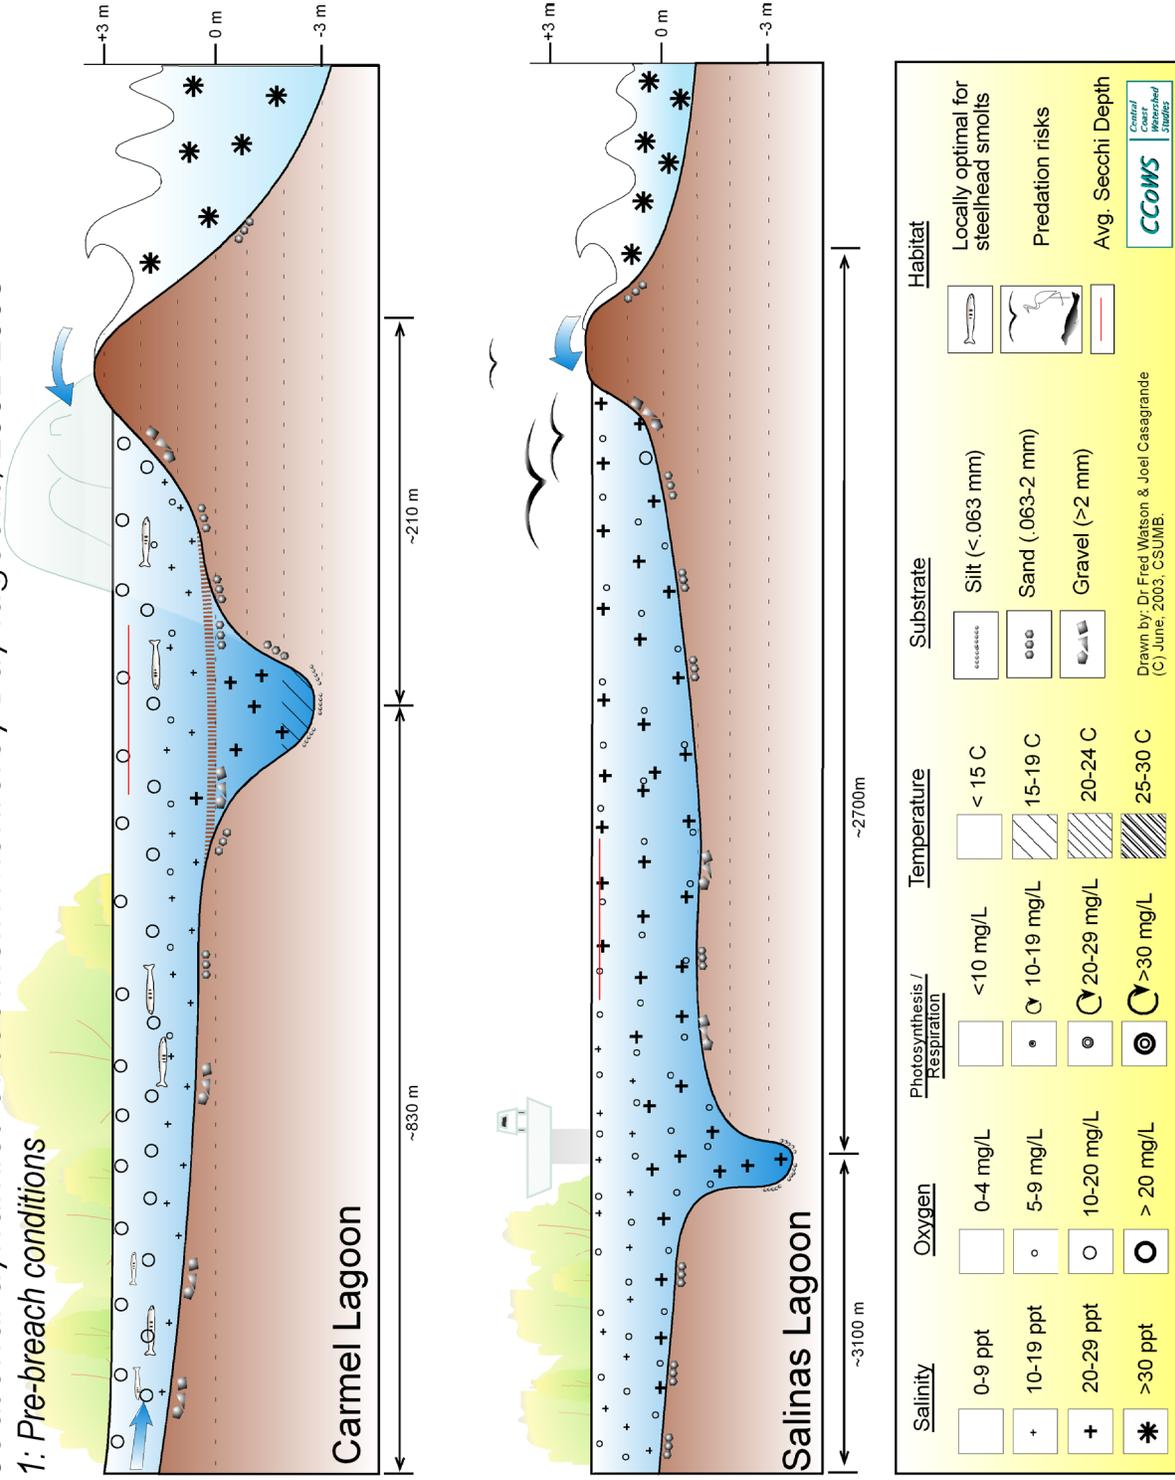
Seasonal dynamics of southern Monterey Bay lagoons, 2002-2003
 1: Pre-breach conditions

Figure 6.1 Pre-breach conditions of the Carmel and Salinas Lagoons, 2002–2003. Note that secchi depth was only measured in certain areas of the lagoons.

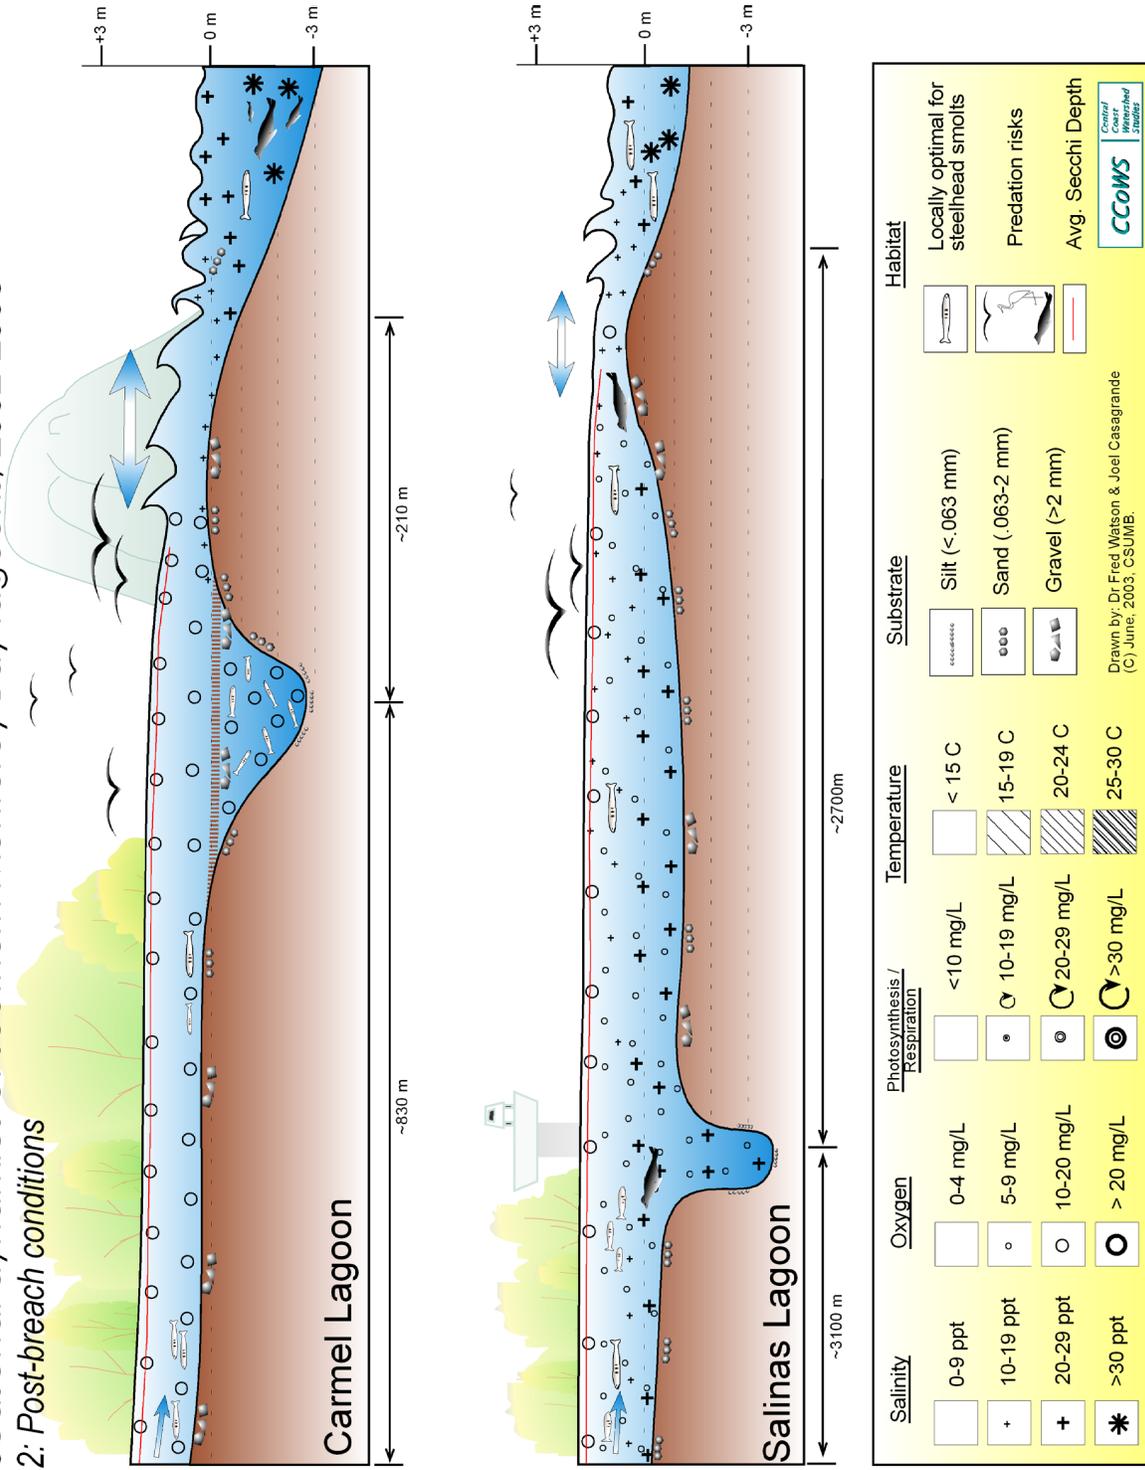
Seasonal dynamics of southern Monterey Bay lagoons, 2002-2003
 2: Post-breach conditions

Figure 6.2 Post breach conditions of the Carmel and Salinas Lagoons, 2002-2003.

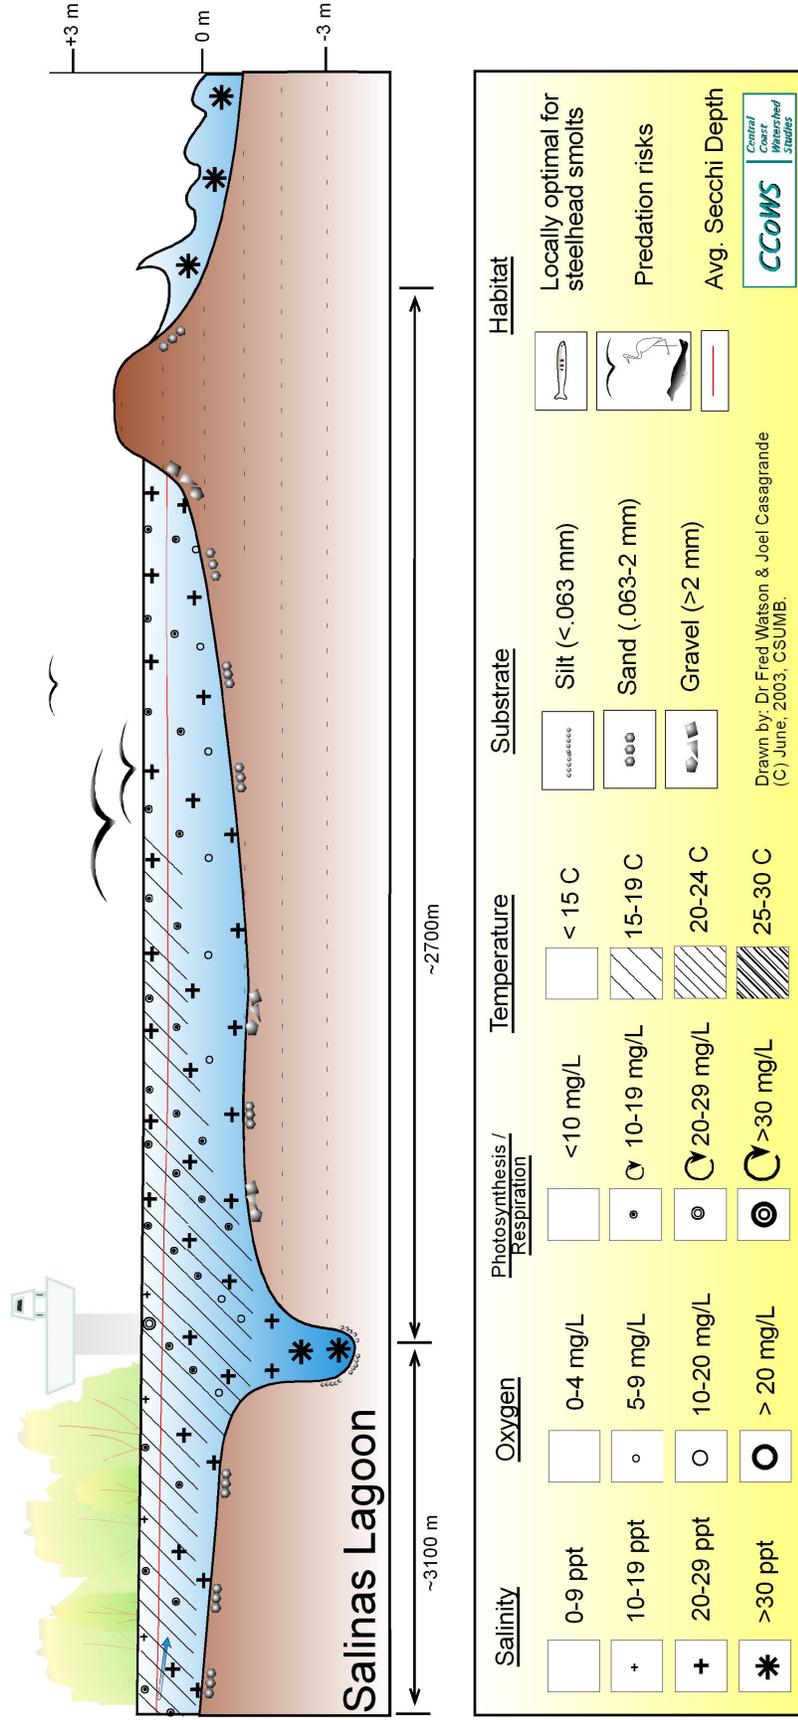
Figure 6.3 Post closure conditions for the Salinas Lagoon, 2002–2003. As of June 23rd, the Carmel Lagoon had not closed; therefore a post-closure schematic was not constructed for the Carmel Lagoon.

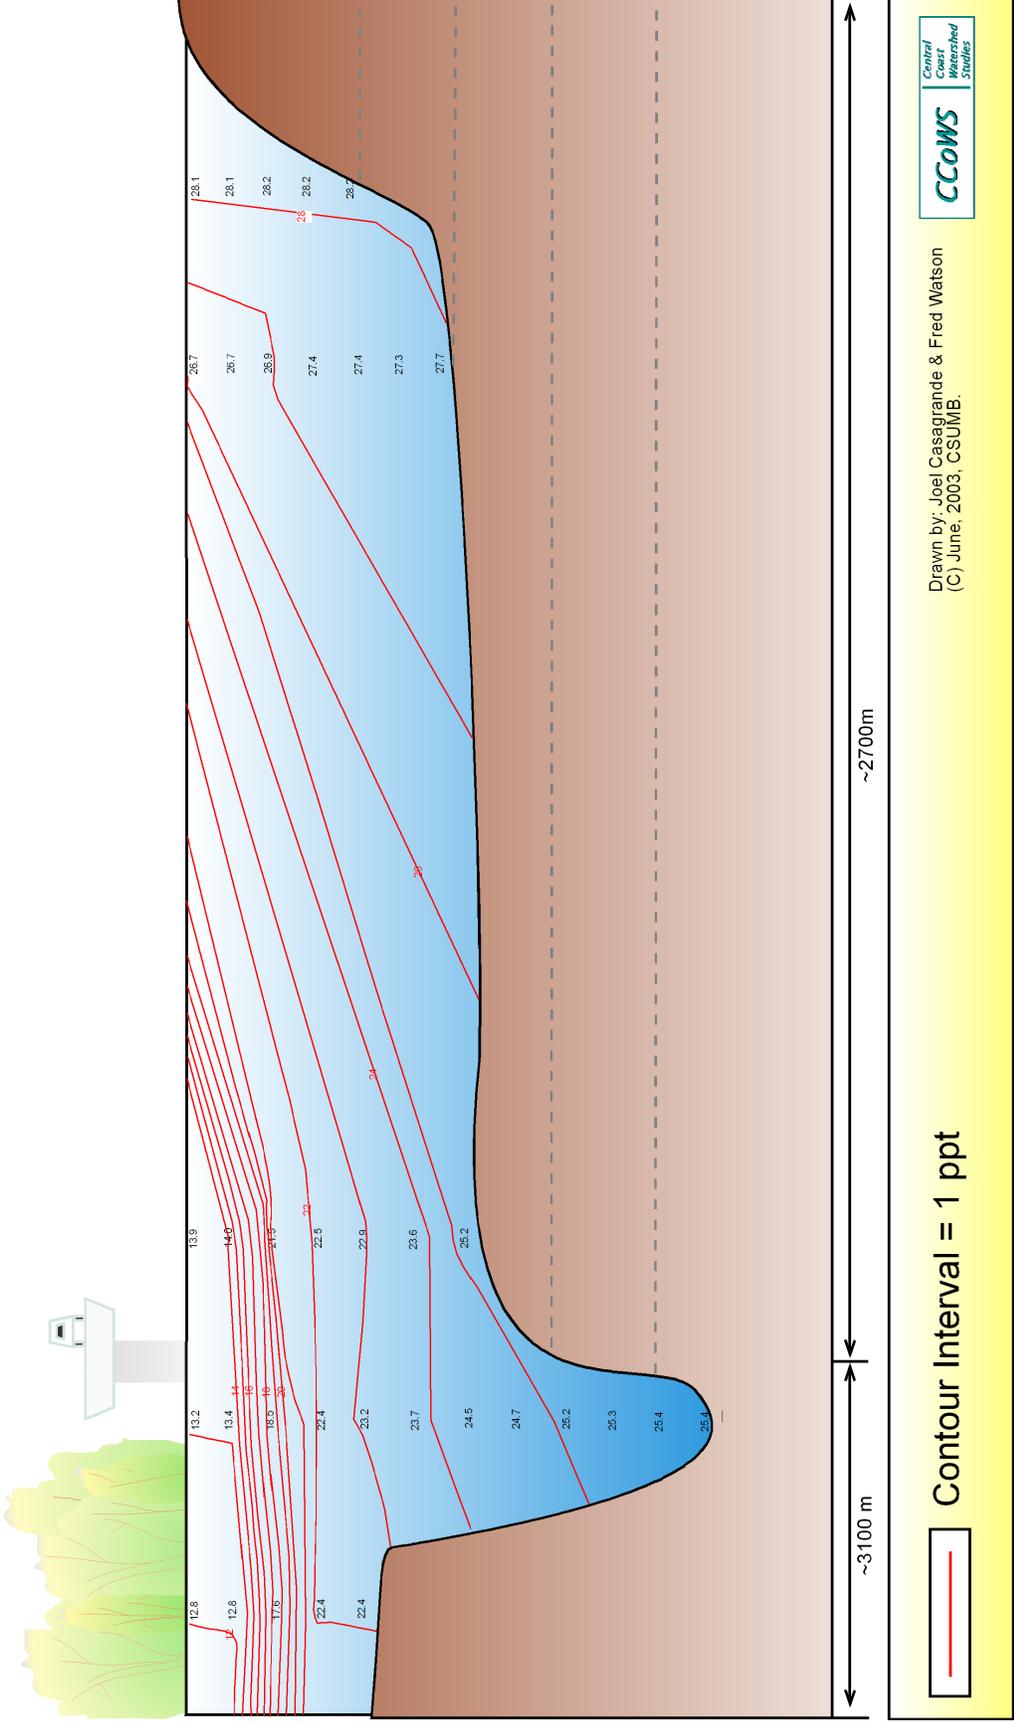
Figure 9.1 Longitudinal salinity gradient in the Salinas River Lagoon prior to breaching.

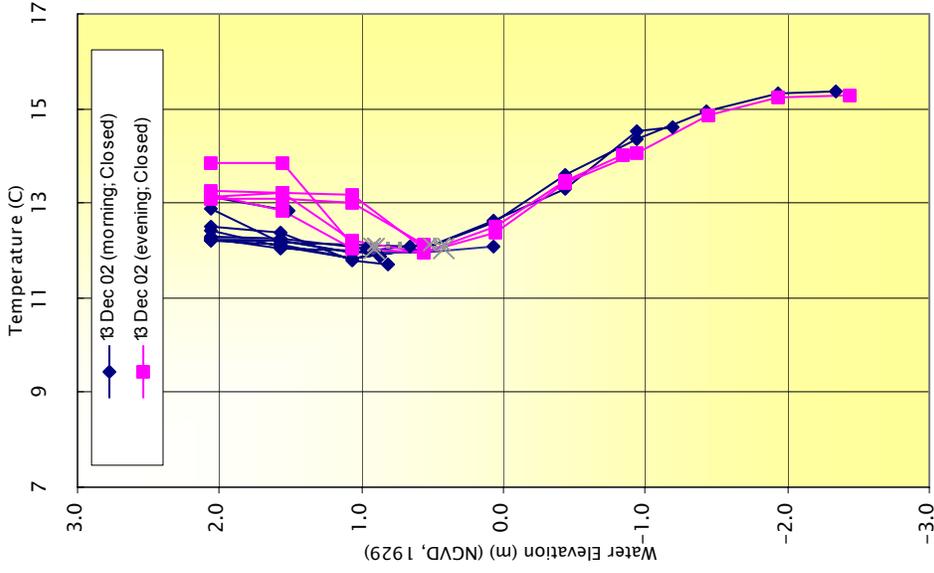
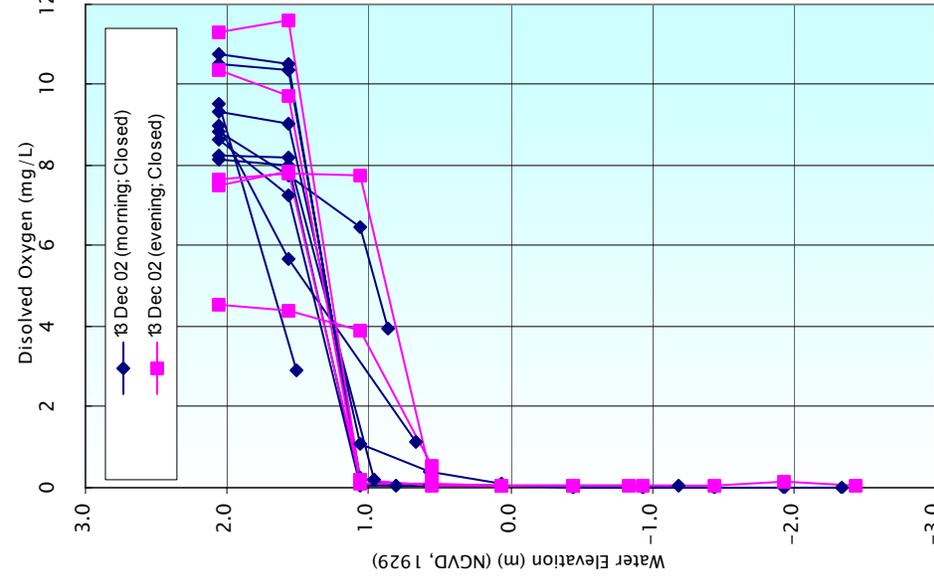
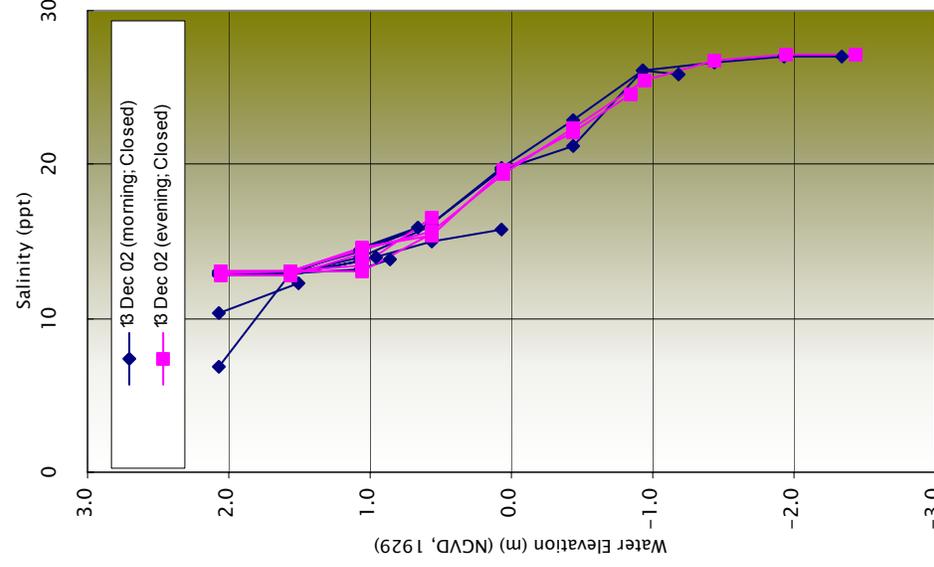
Figure 11.1 Temperature, dissolved oxygen and salinity surface to depth profiles for December 13, 2002, Carmel Lagoon.

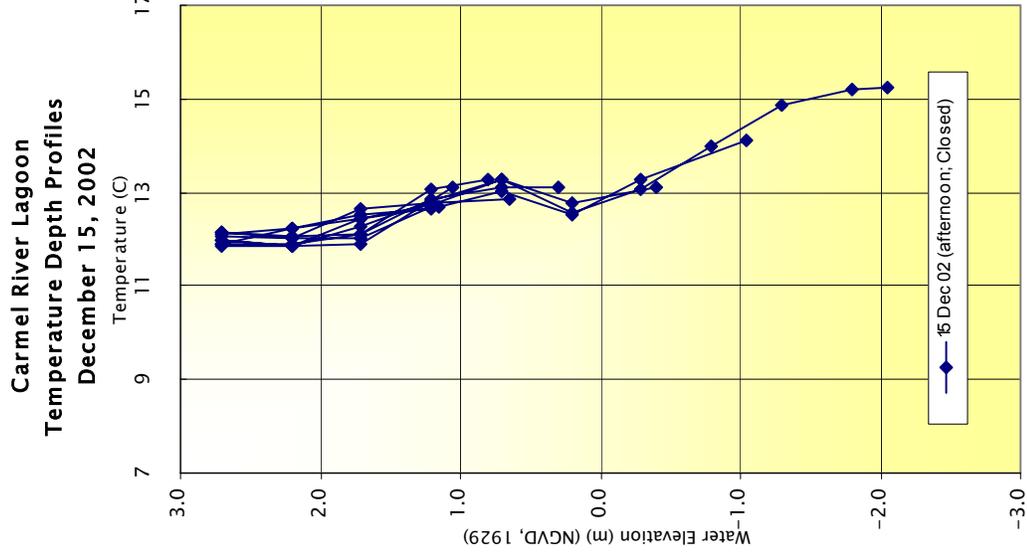
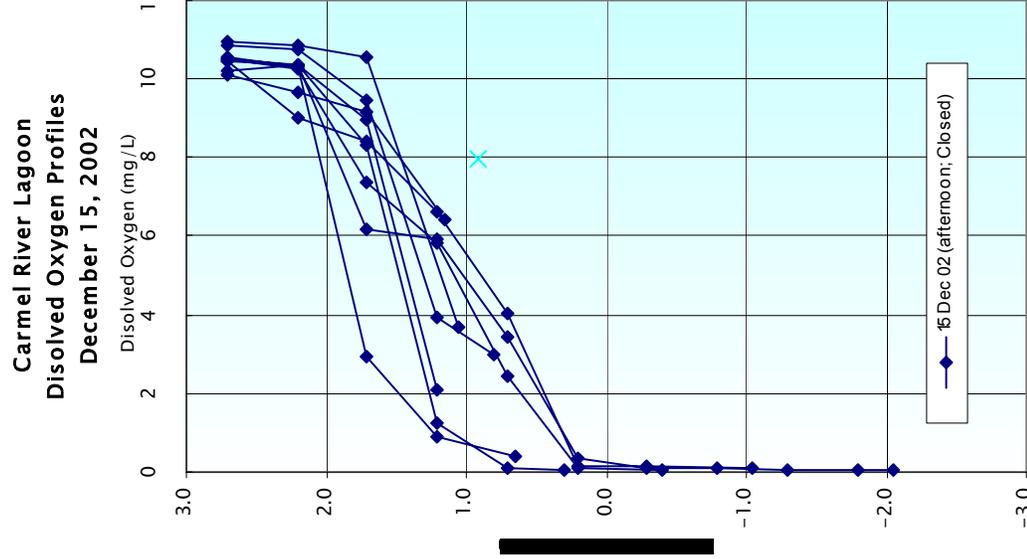
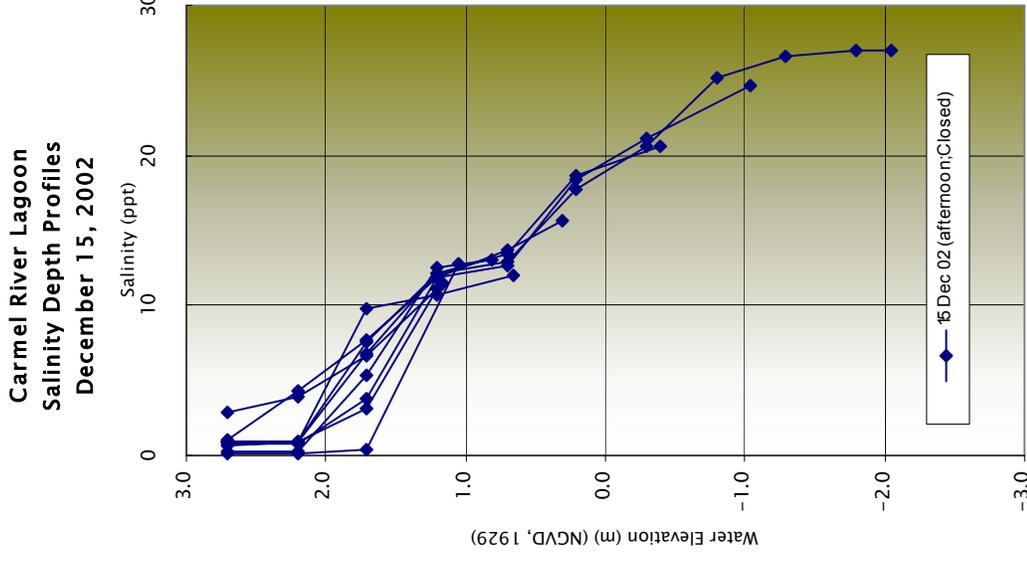
Figure 11.2 Temperature, dissolved oxygen and salinity surface to depth profiles for December 15, 2002, Carmel Lagoon.

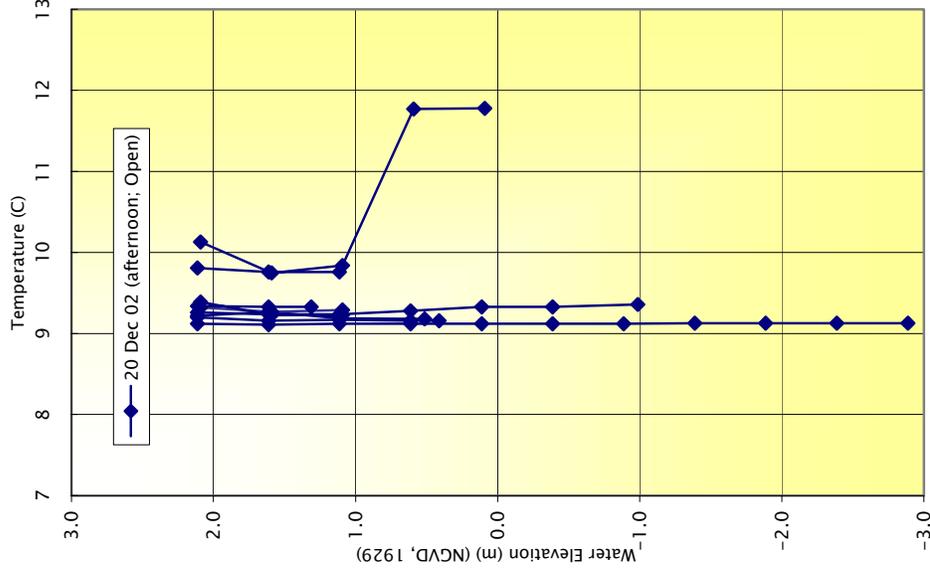
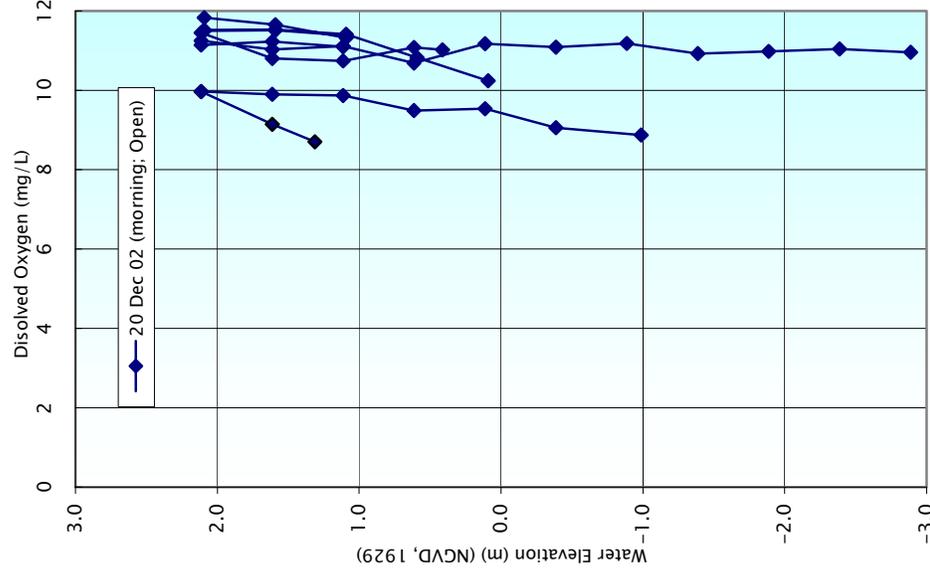
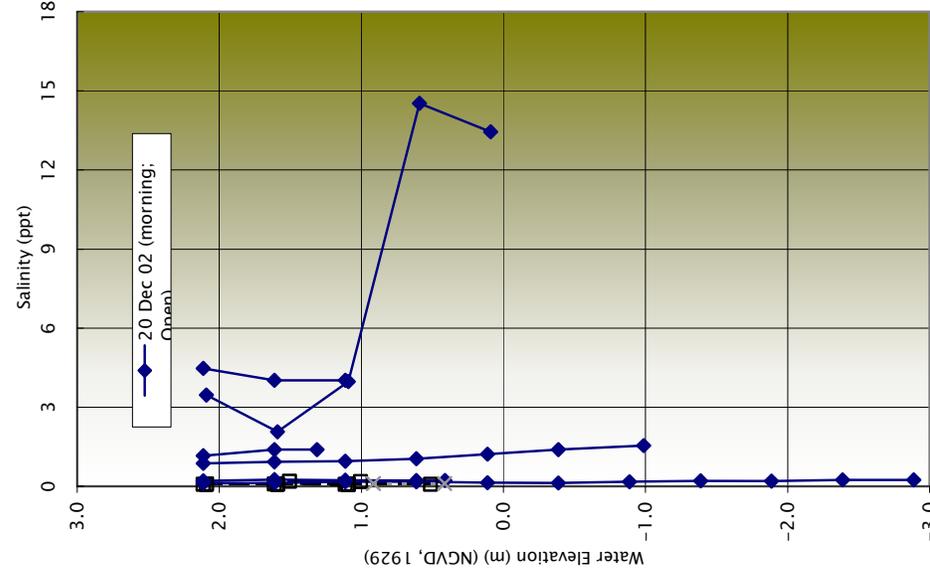
Figure 11.4 Temperature, dissolved oxygen and salinity surface to depth profiles for December 20, 2002, Carmel Lagoon.

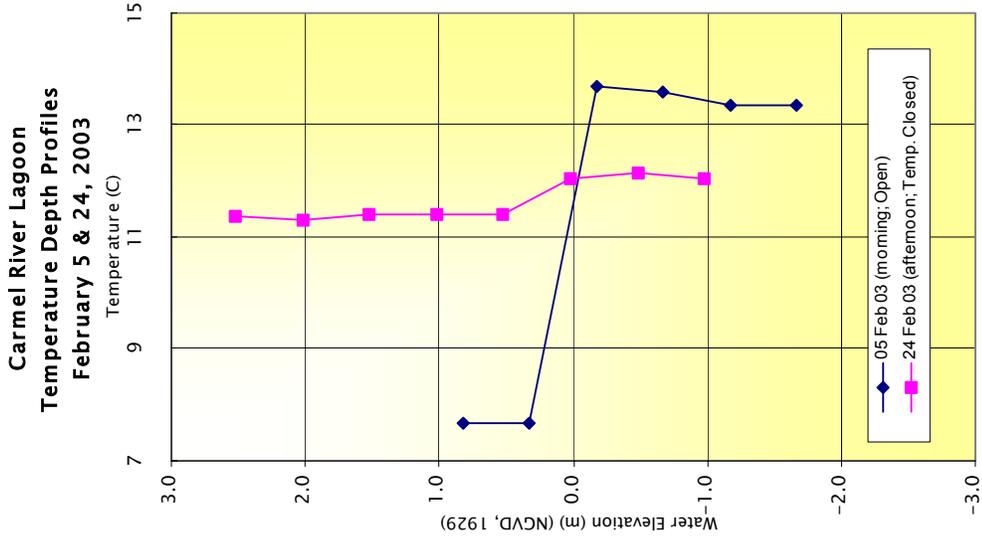
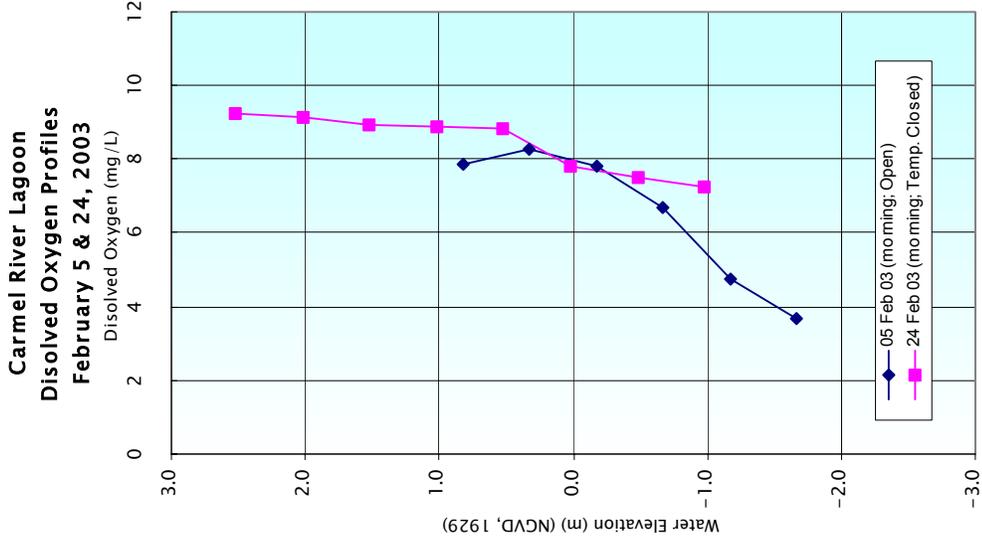
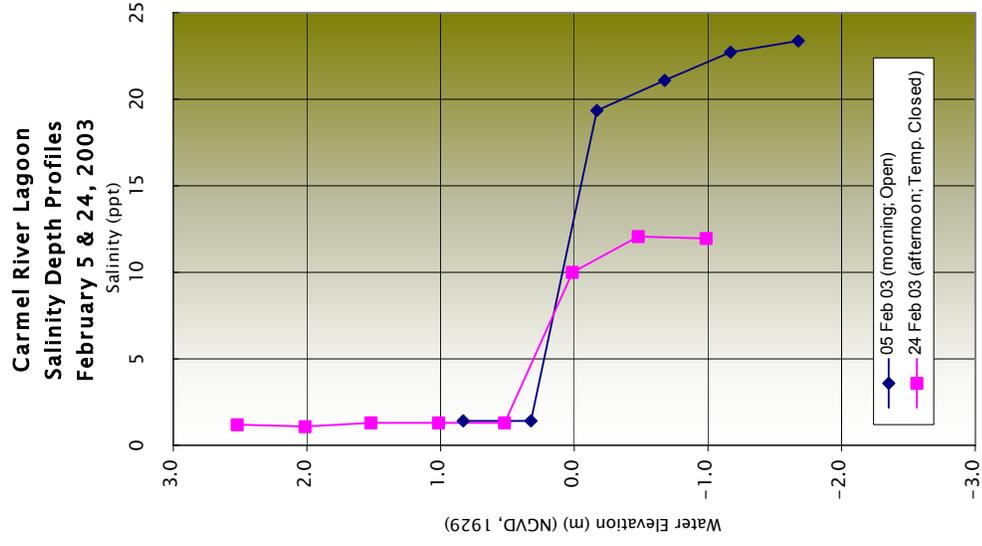
Figure 11.6 Temperature, dissolved oxygen and salinity surface to depth profiles for February 5 & 24, 2003, Carmel Lagoon.

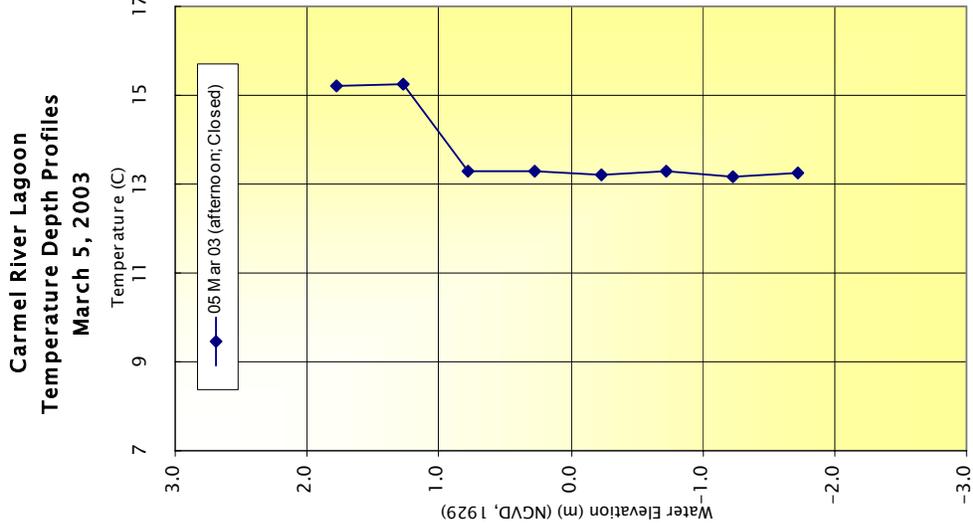
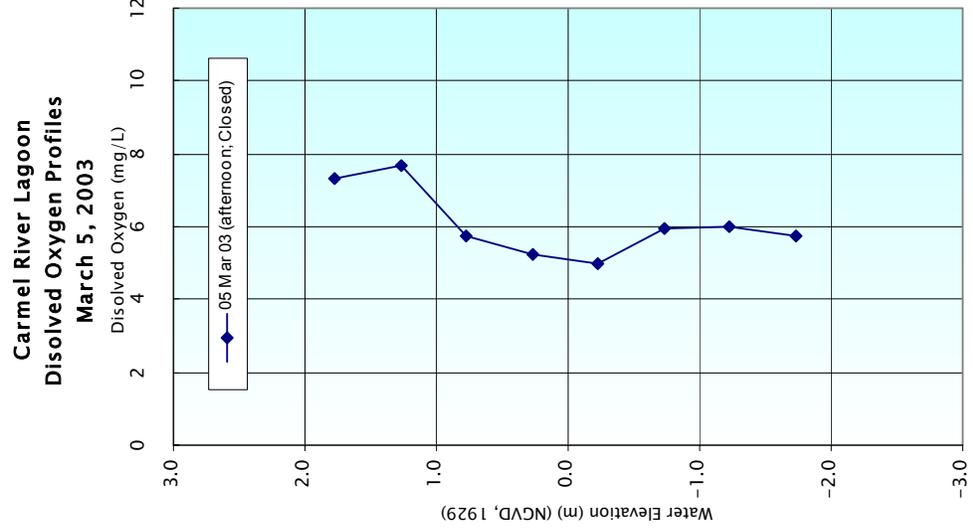
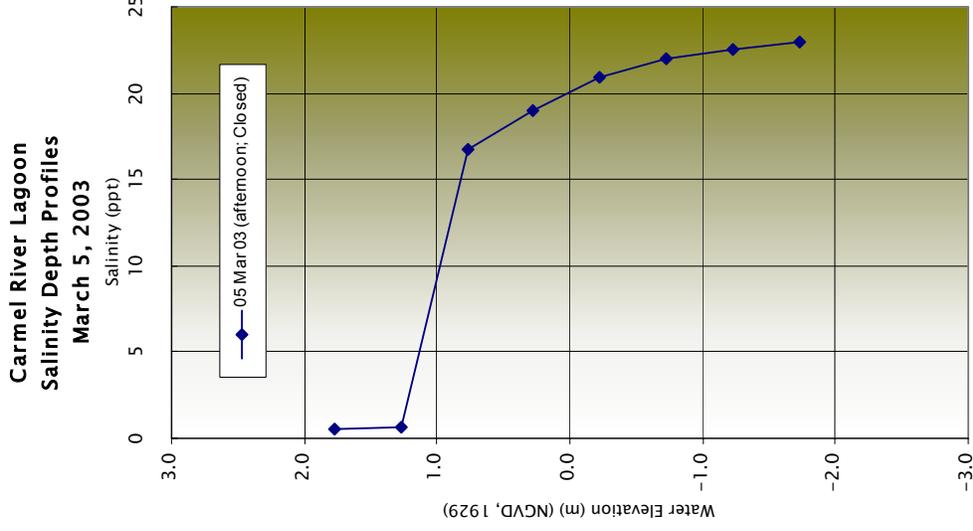
Figure 11.7 Temperature, dissolved oxygen and salinity surface to depth profiles for March 5, 2003, Carmel Lagoon.

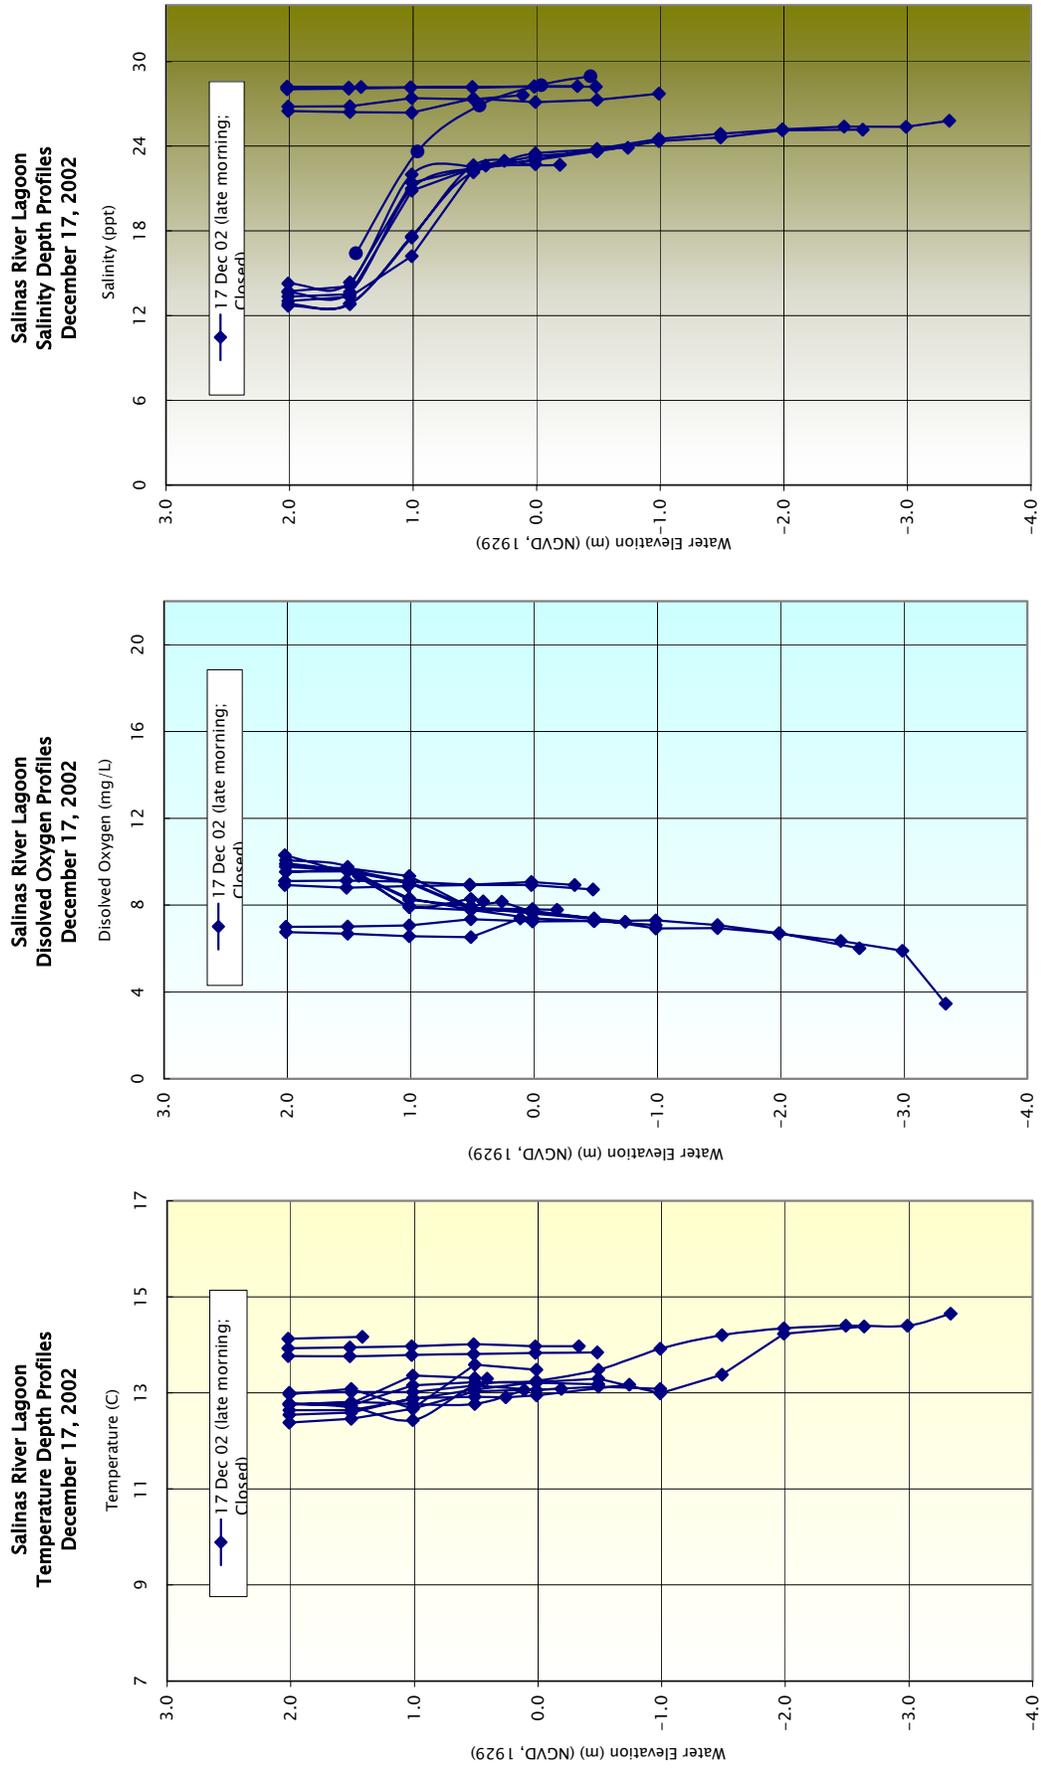
Figure 11.8 Temperature, dissolved oxygen and salinity surface to depth profiles for December 17, 2002, Salinas Lagoon.

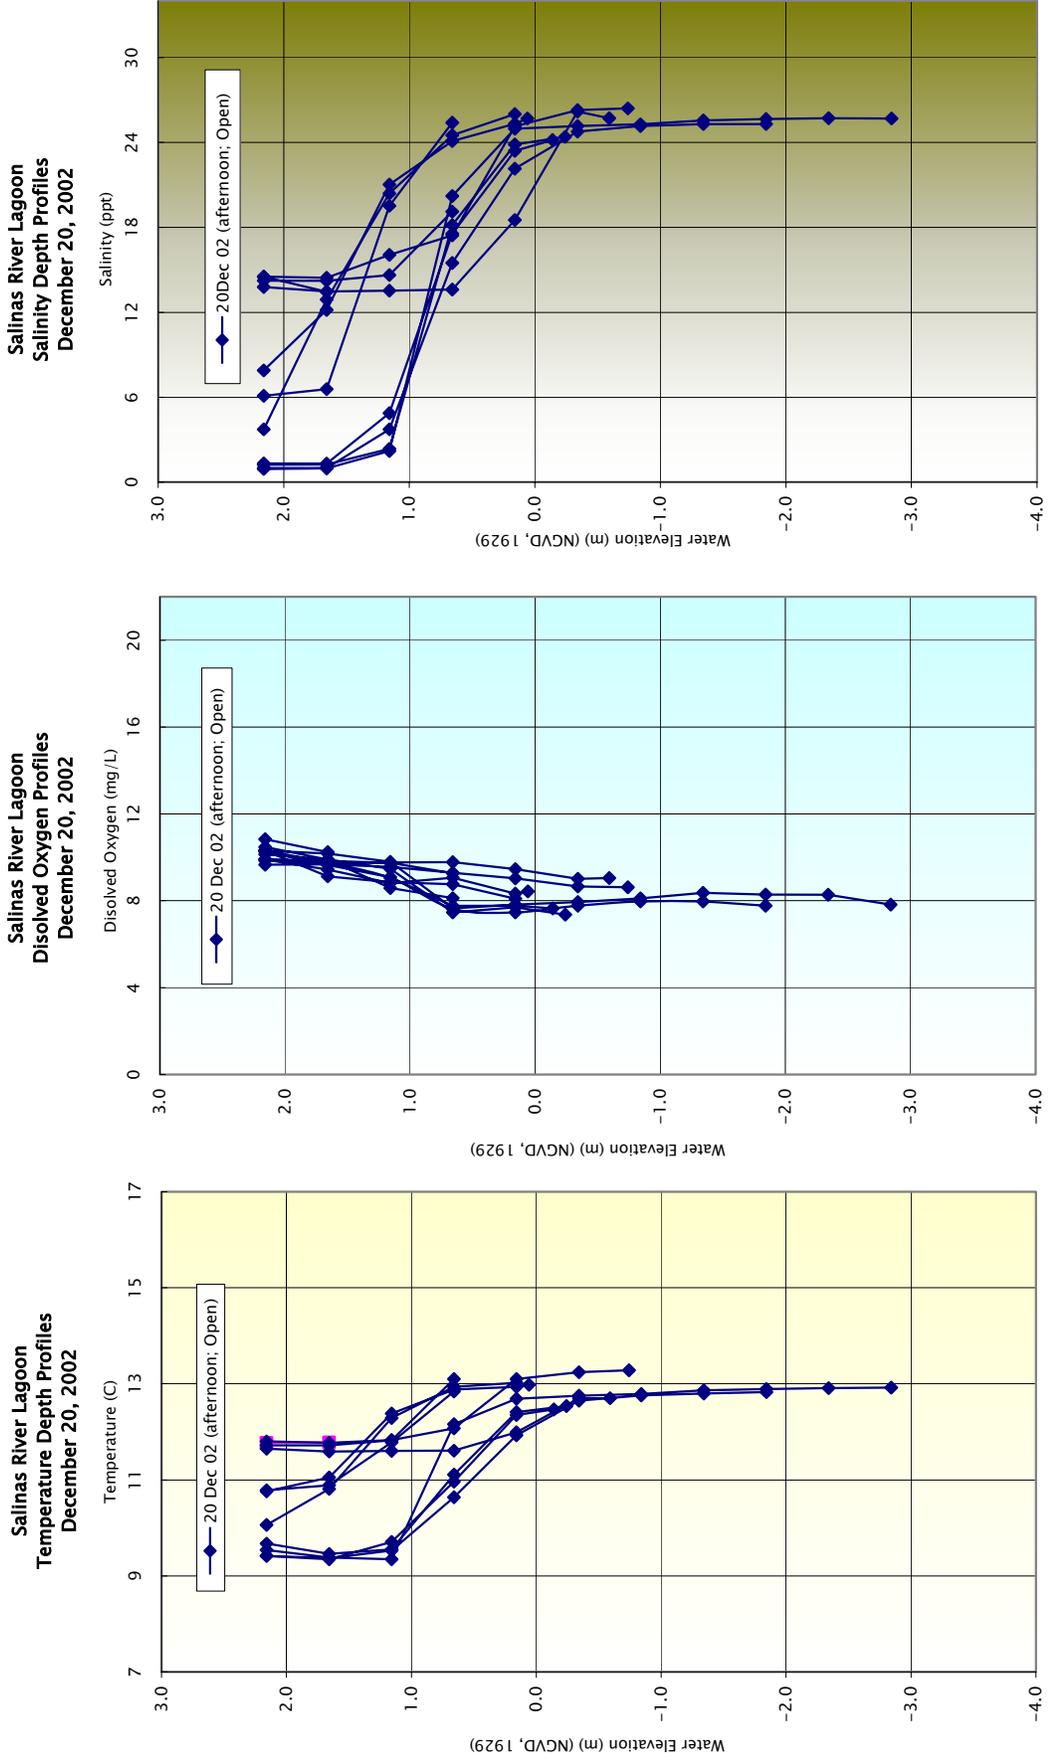
Figure 11.9 Temperature, dissolved oxygen and salinity surface to depth profiles for December 20, 2002, Salinas Lagoon.

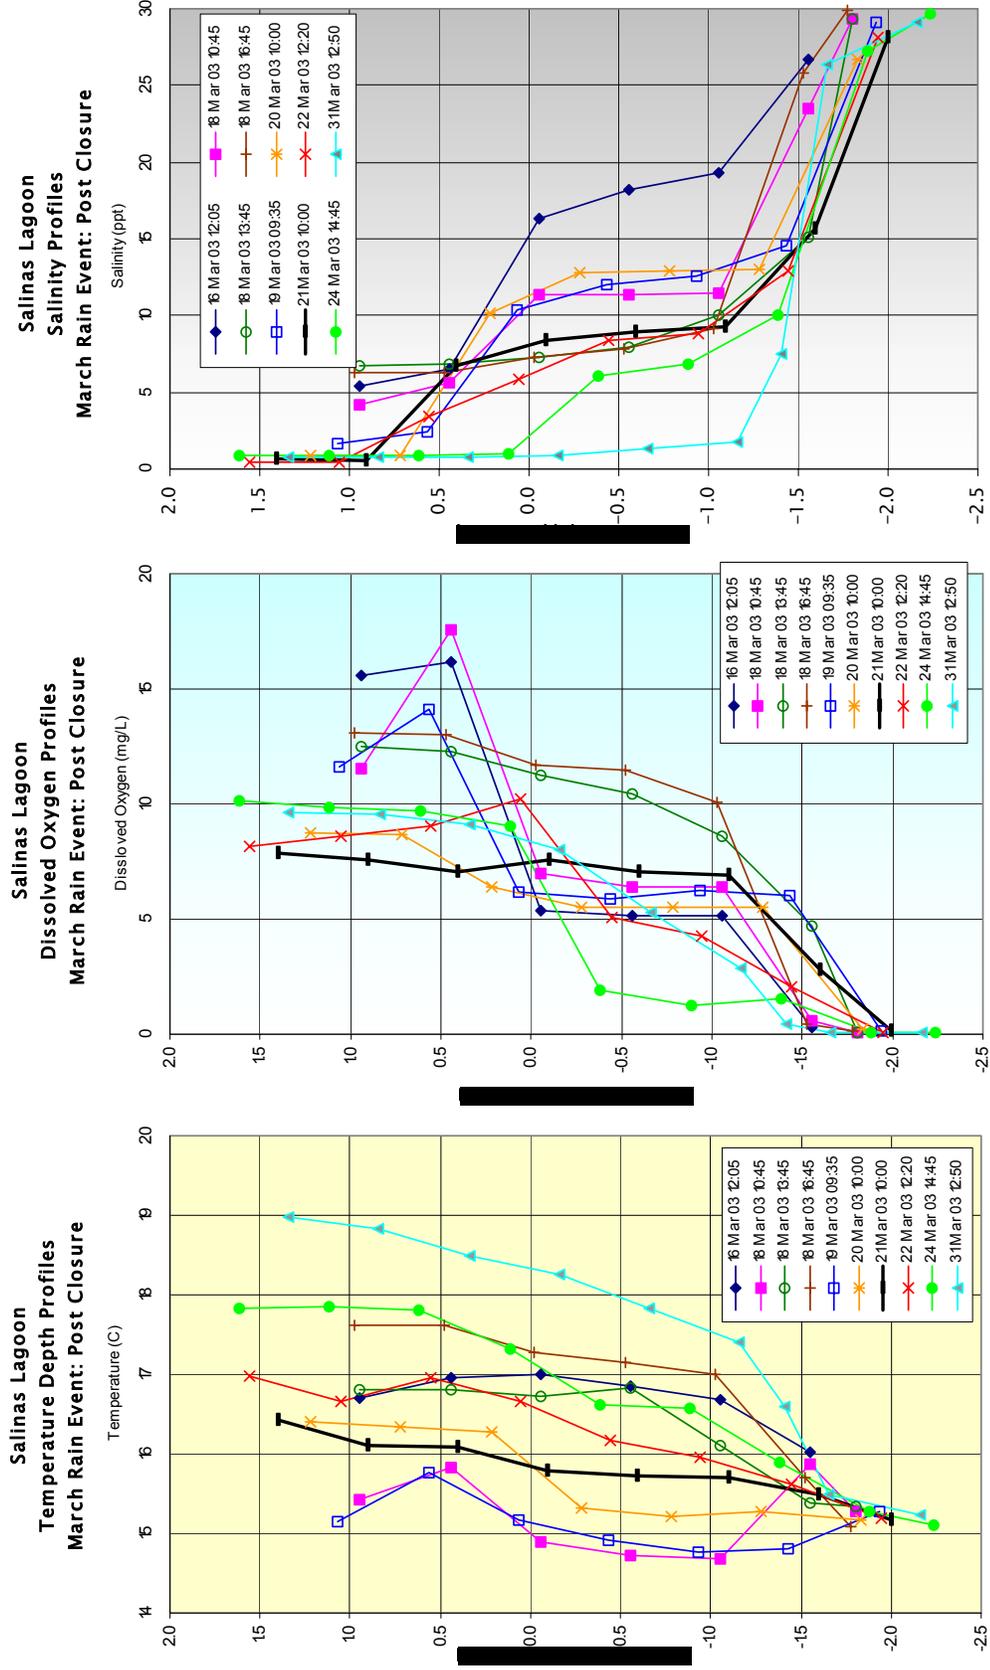
Figure 11.12 Temperature, dissolved oxygen and salinity surface to depth profiles for March rain event, Salinas Lagoon.

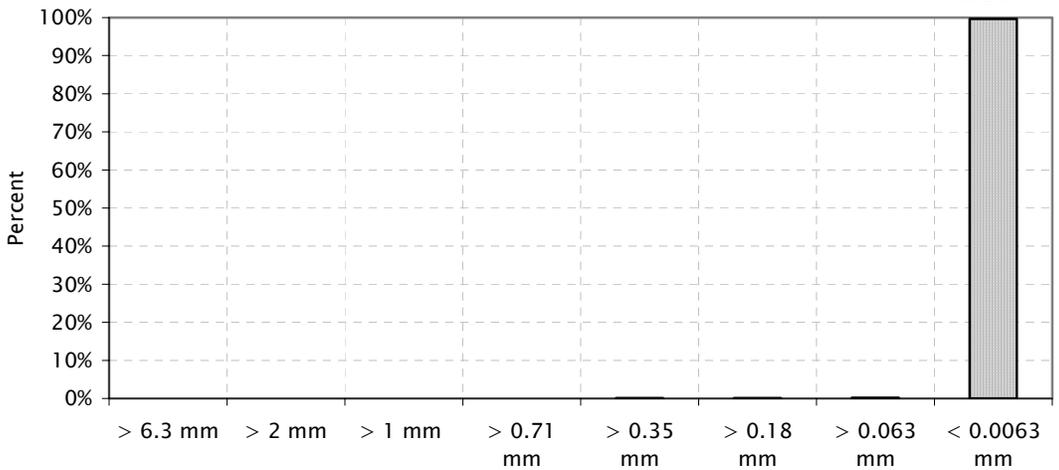
**Salinas Lagoon Bottom Particle Size Distribution
Pre Breach Twin Bridges Deep Downstream (Zone 7L)**

d 50
