Report No. WI-2004-11
31st July 2004

The Watershed Institute

Introduction to Geomorphic Monitoring on Fort Ord BLM Lands: 2001 to 2004

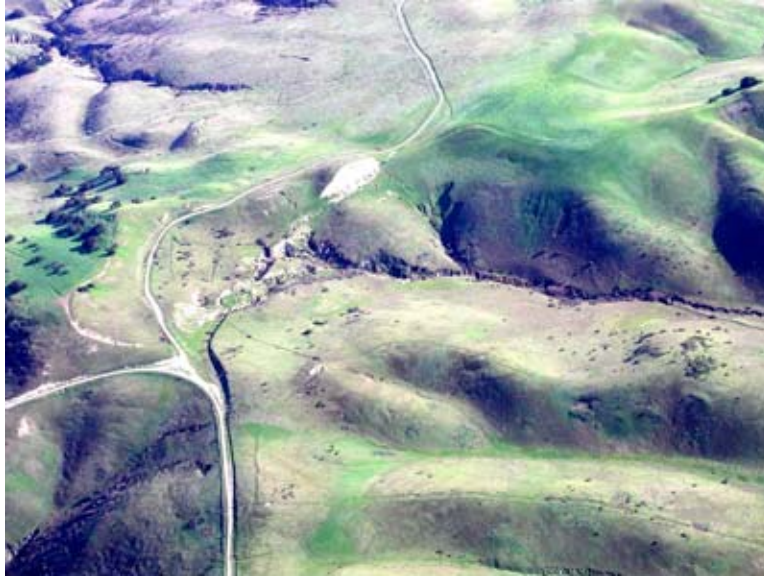
Figure 4: Oblique aerial photograph of Skyline Gully from a fixed-wing aircraft (2004). Eastward view.

The Skyline gully system (Figure 4 & Figure 7) is located near the intersection of Oil Well and Skyline Roads (point 2; Figure 1). It is one of the largest gully systems in the NRMA. The gully system was greatly enlarged during the 1997–1998 El Nino winter rains. Large subterranean soil pipes formed in numerous locations, fostering the development and growth of gullies. A large headwall scarp is now present that was not present in early 1995 when blimp-borne photos were taken (Figure 17). This landslide likely developed during the same El Nino winter as the Owl landslide (Figure 15).

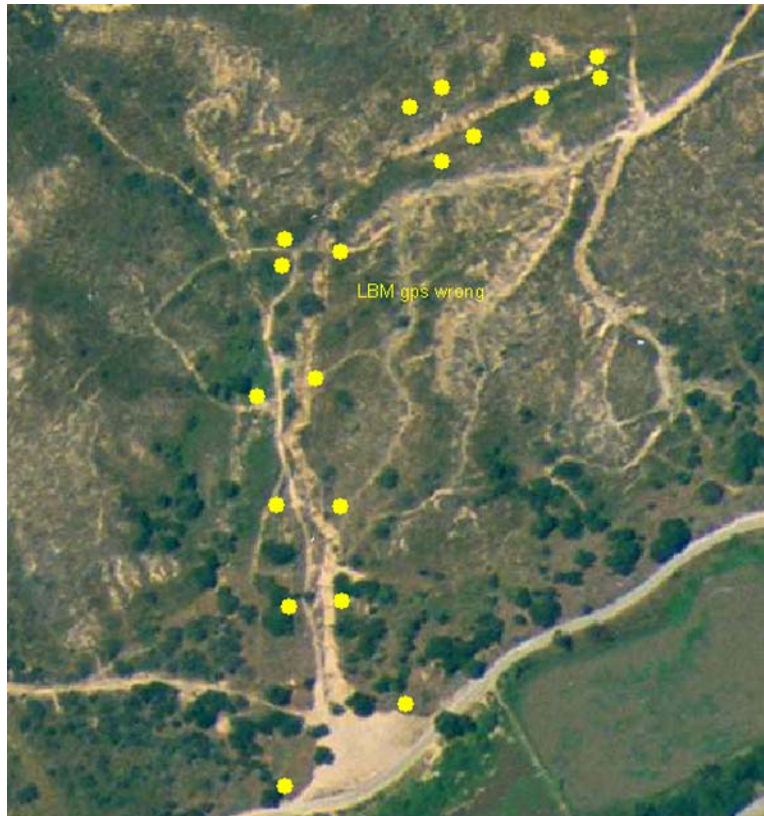
Figure 5: Cross section survey benchmark locations plotted on orthorectified digital aerial photograph of Mudhen Gully (2001). Image is approximately 400 m wide. North toward top.

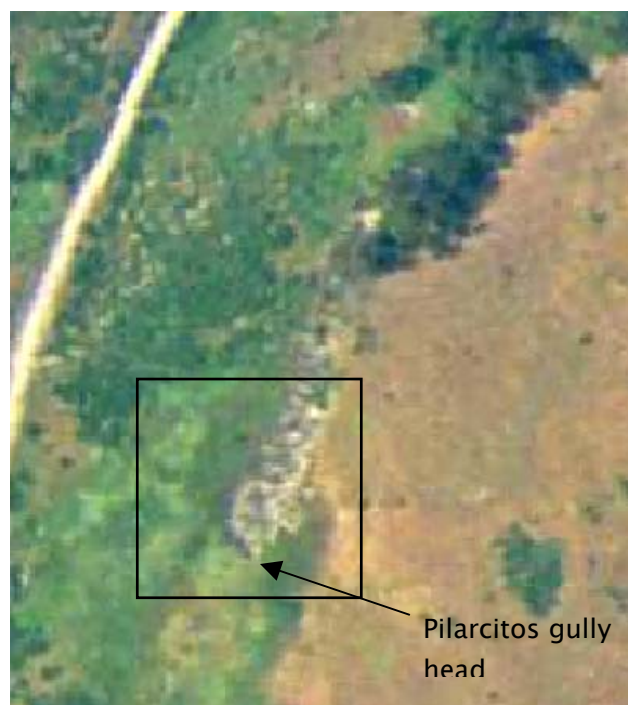
Figure 6: Orthorectified, 1-m resolution, digital aerial photograph of Pilarcitos (2001) Gully. North toward top. Box is approximately 60 m wide. Box shows position of Figure 12.

Digital, fixed-wing aerial photography with a resolution of one meter (e.g., Figure 6) is readily available on the internet, and is considered standard for analyzing landscapes. KAP photos offer a much higher resolution image over a smaller area (e.g., Figure 12).

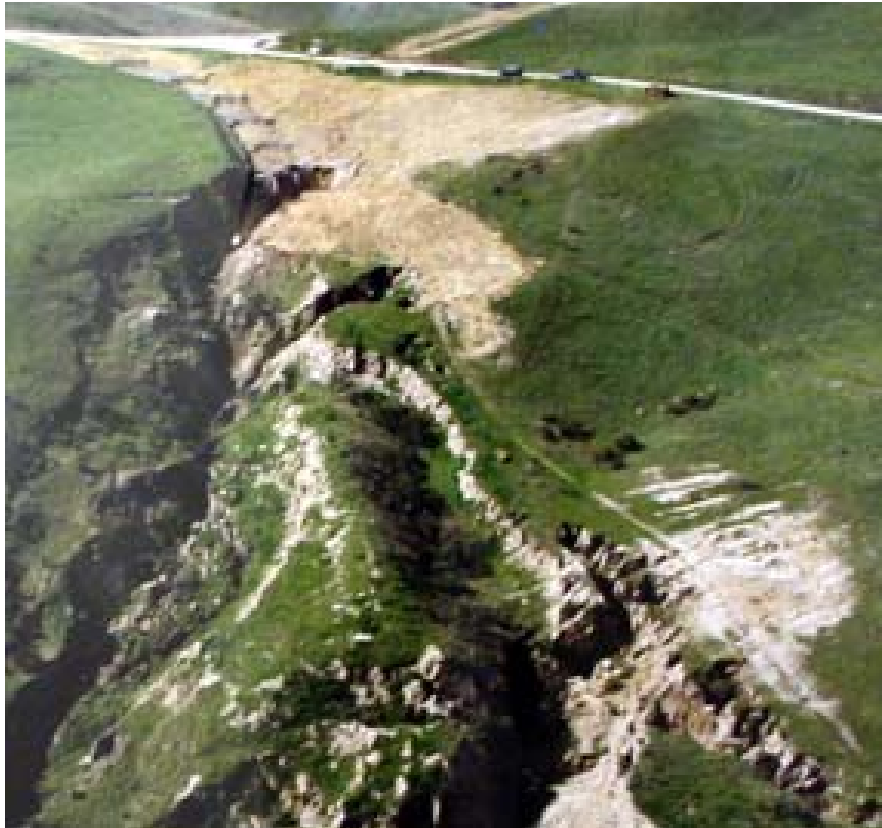
Figure 7: Blimp-borne aerial photograph of Skyline Gully (ca. January 1995). Compare with Figure 1 for detail. Note cars for scale. Westward view.

Small, radio-controlled, lighter-than-air craft can carry a small payload that includes a camera. Low altitude photography results in very clear images with extraordinary resolution, far exceeding that obtainable from a fixed-wing aircraft. In the first months of 1995, early staff of the then nascent CSUMB Watershed Institute hired a consultant to take a dirigible-borne aerial photography at a number of their concurrent restoration sites. We have access to several of these images (Figure 7) for comparison with our more recent photographs.

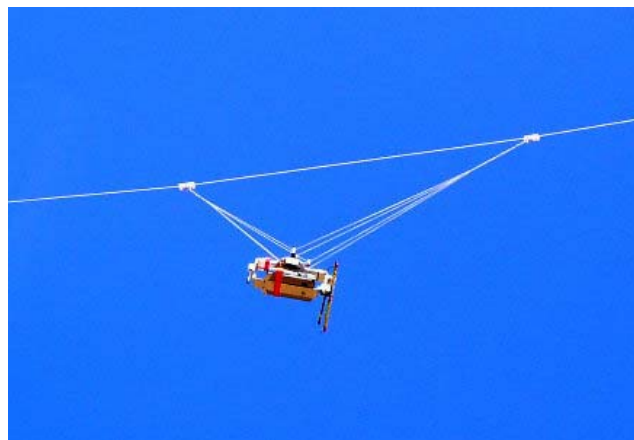
Figure 9: Camera rig is suspended from kite line by a picovet suspension system that utilizes tiny pulleys and line to keep the camera platform level at a wide range of kite-string angles.

We have a 30 square foot soft Sutton Flowform kite, custom camera platform (Figure 9; Brooks Leffler, <http://homepage.mac.com/kyteman/>), radio control gear, 150 m of strong line, and a

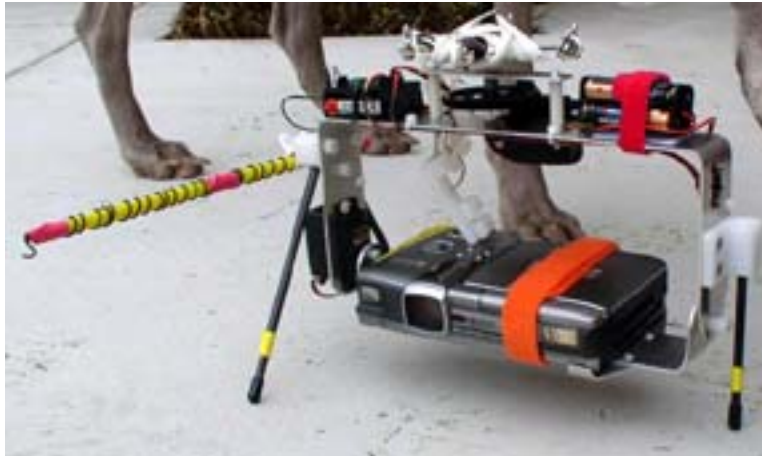
Figure 10: Detail of wireless camera mounted in camera platform. The yellow wand supports the antenna wire. Picovet rig is wound around the top bracket.

wireless digital camera (Figure 10). The radio control gear is used to aim the camera once the camera platform is aloft. We are still learning the best techniques for aiming the camera, and anticipate rapidly improving our success.

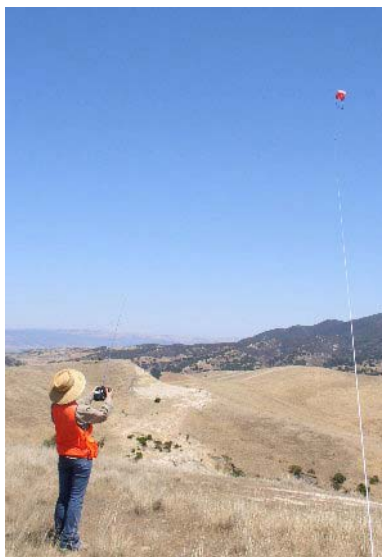
Figure 11: On days with marginally enough wind, the kite operator is busy avoiding camera damage while an assistant operates the radio controlled camera.

At present, we are aiming the camera using radio-control gear while we see the orientation of the camera from the ground (Figure 11). We have the camera set to automatically take a photo every 30 seconds. We also have the technology to raise the camera platform on large helium-filled balloons on very calm days.

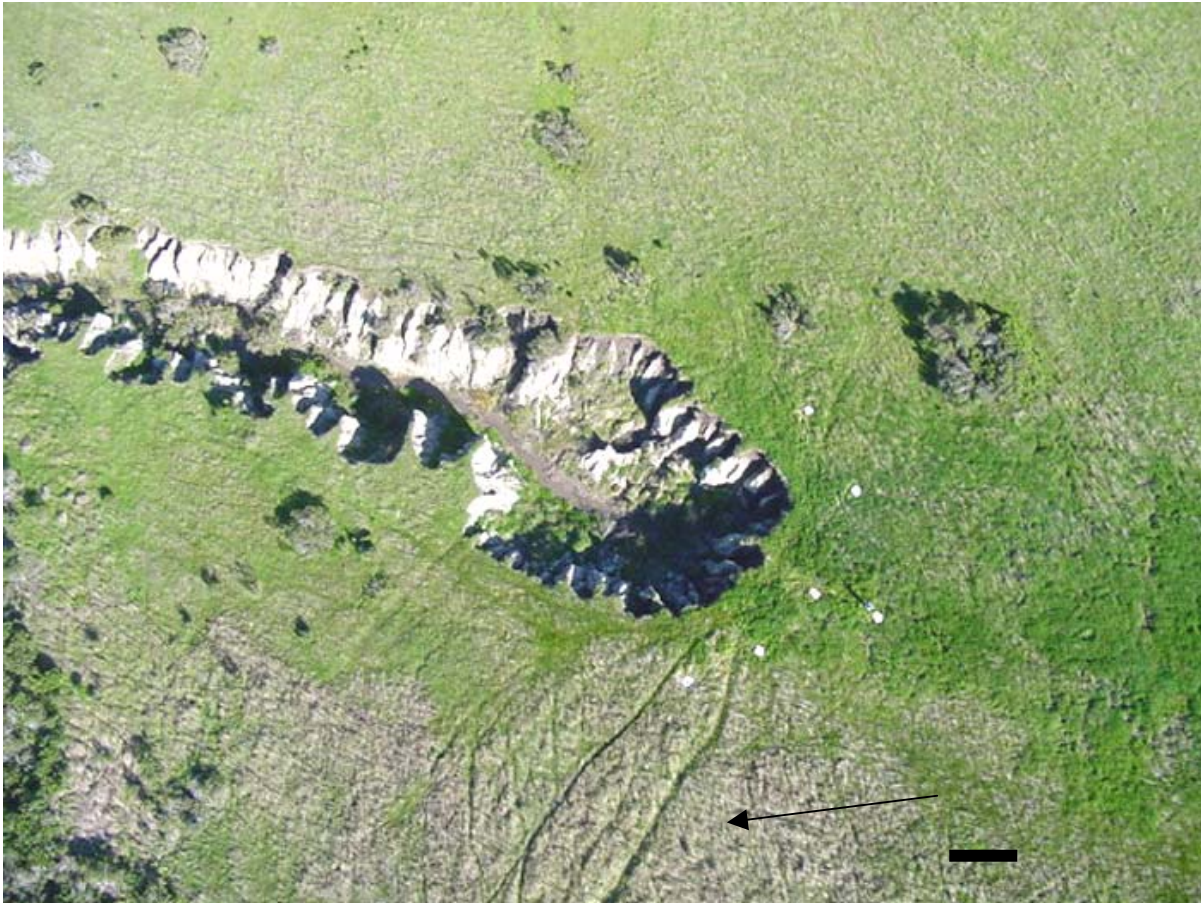
Figure 12: Kite-borne aerial photography with white markers laid out to test accuracy and precision (Hall, 2003). Arrow is approximately north. Bar is 5 m long. Compare with boxed region of Figure 6 showing same feature in a 1-m resolution aerial photograph.

A test of georeferenced orthorectified kite-borne aerial photography precision was performed by Elvie Hall (Hall, 2003). A feature on the ground that is 7.93 m long was measured as 7.92 m and 7.98 m respectively in a GIS environment using two independently created kite aerial photographs (Hall, 2003). That level of horizontal precision, 1 cm to 5 cm, is comparable to the horizontal precision of our ground based cross section surveys using a taut 50-m tape.

A subsequent test of kite photography produced the image of Pilarcitos in Figure 12. The six white squares are targets placed 5 m from the gully head (Figure 12). Subsequent GIS measurements of two independently-derived orthorectified images of the gully and targets indicated an average accuracy of between 0.08 m and 0.09 m (e.g., Table 3). Orthorectification was based upon several differentially-corrected GPS points using a GeoExplorer II handheld receiver.

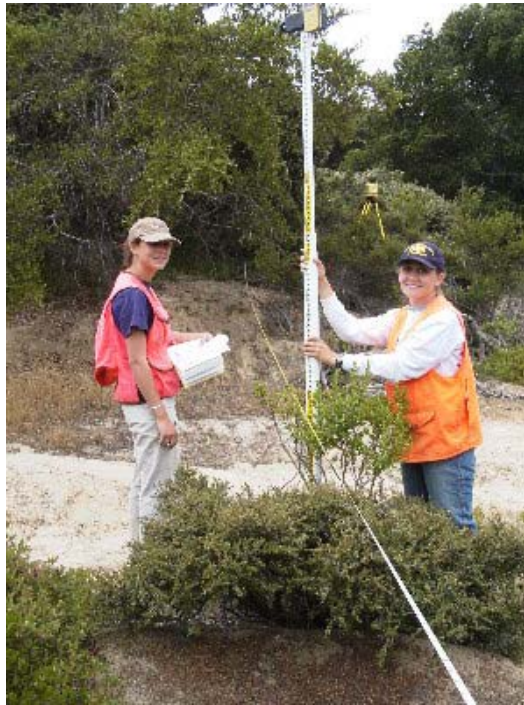
Figure 13: Rotating laser level with 50-m tape drawn between benchmarks at a Parker Flats survey site.

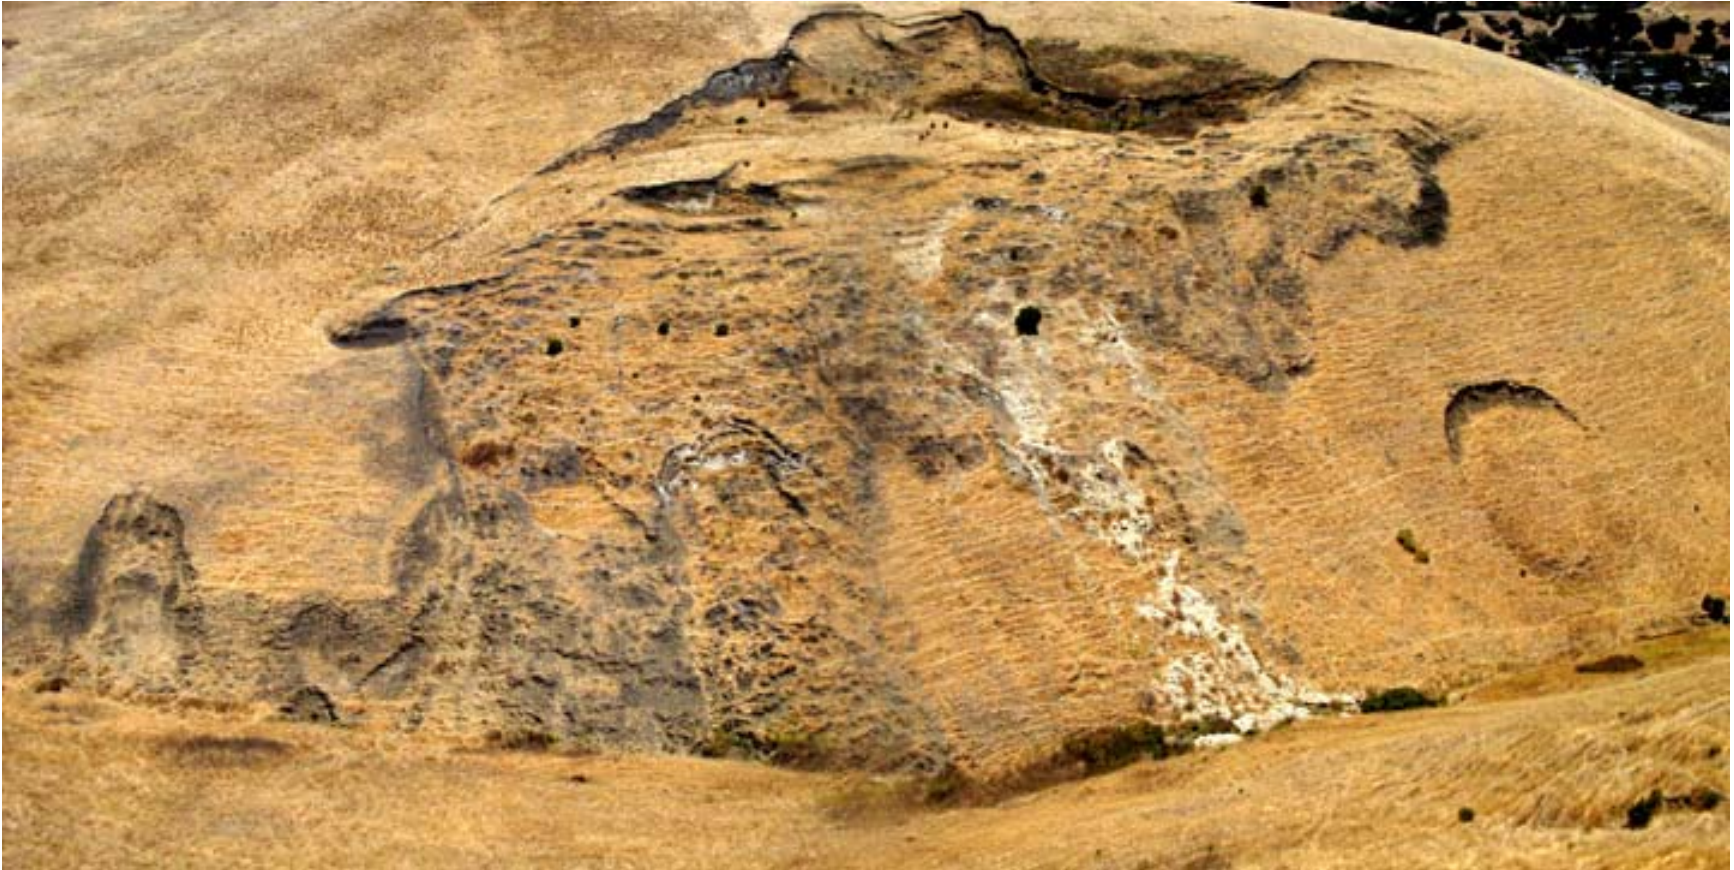
The Owl landslide (Figure 15) is located in a narrow, “v” shaped valley intersecting Oil Well Rd. (point 1; Figure 1). It is the largest potentially active landslide we have identified in the NRMA. Aerial photographic evidence (Figure 16) shows that the landslide was not present on 9/20/1997, in the months immediately preceding the major storms of the 1997–1998 El Nino event. An image taken on 8/22/98, in the summer following the El Nino rains, clearly shows the geometry of the headwall scarp and “owl” wing. Although the earlier photo shows some hummocky topography typical of colluvial creep, the headwall scarp and wing are absent. This comparison strongly implicates the winter storms, which brought an annual total of 47.19 inches of rain, 230% of the normal.

Figure 15: Panoramic view of The “Owl” landslide taken with kite aerial photography (See Figure 8). Photo taken July 26, 2004. The image is a composite of two images that were “stitched” together into one image. View is to the west.

We have used a total station set at benchmark OC–1 (Table 4) to monitor the relative motions of 36 benchmarks we set in a rectangular grid across the landslide. There are benchmarks set outside the slipped region as well for reference. Three surveys of the benchmarks have been performed November 2002, October 2003, and July 2004. The October 2003 survey suggested an average of 3 cm of slip on the benchmarks toward the southwest (downhill). The 2004 data have not yet been compared to previous surveys. During the time of our survey there have been relatively normal winters and one significant earthquake (Paso Robles December 2003).

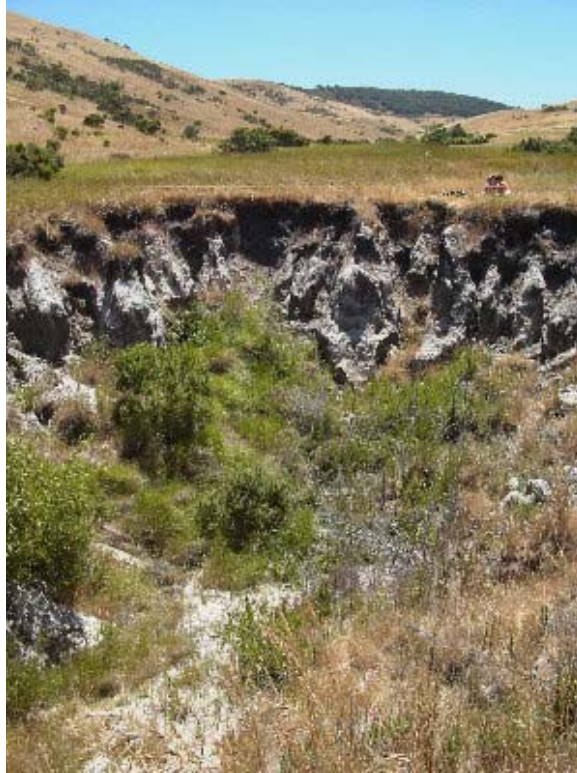
Figure 20: Ground-based photograph of Pilarcitos gully (June 2004). View is to southwest, up valley past steep gully head. Gully head scarp is 6.5 m tall (Figure 21).

Ground-based photography shows the gully head and non-gullied valley bottom up gradient (Figure 20). Figure 21 shows the longitudinal gradient of Pilarcitos gully surveyed in July 2002. The head has migrated approximately 0.5 m up valley since 2002.
