*Central
Coast
Watershed
Studies*

Carmel River Lagoon Enhancement Project: Preliminary water quality report

Publication No.: <Not published yet>.
Preliminary report dated:
18th November 2004

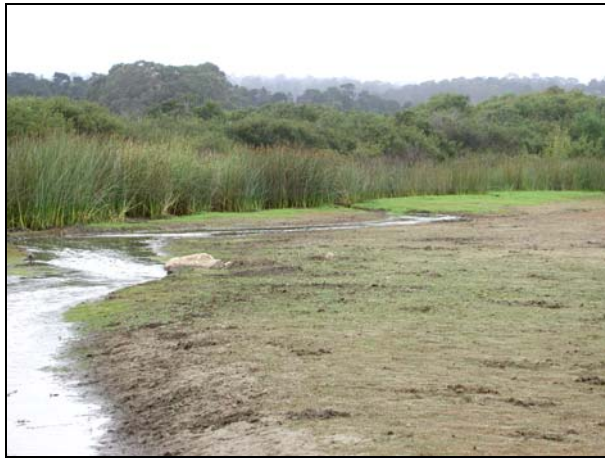
Figure 2-1 Small channel feeding CAWD release into the South Arm, 26 July 04.

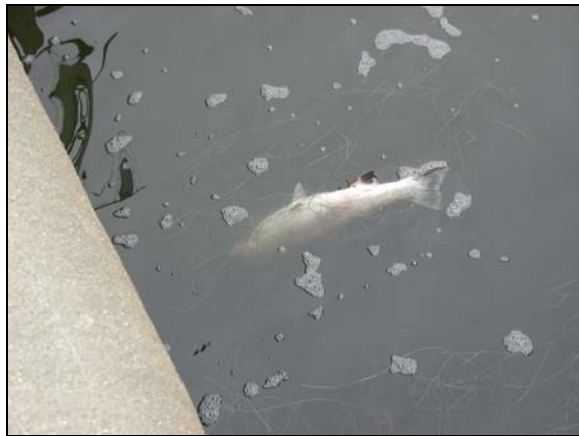
Figure 2-3 dead steelhead found next to the South Arm pipe, 28 July 2004.

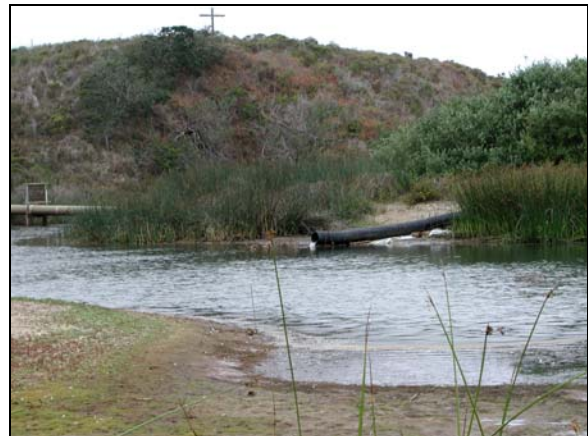
Figure 2-4 Corrugated pipe feeding well water into the South Arm, 6 August 2004.

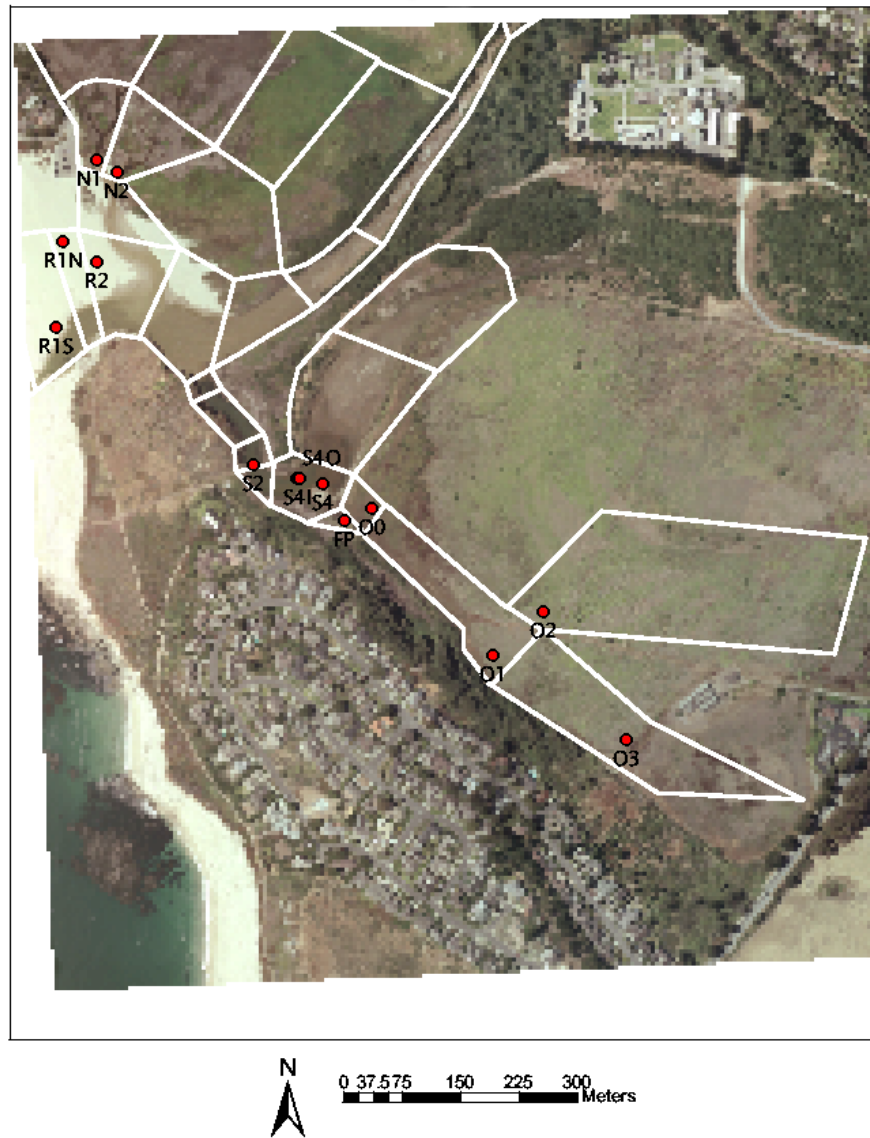
Figure 4-1 Sampling zones and sites (red dots) at the Carmel River Lagoon (new excavation not shown).
Note: sites S4O and S4I are in the same spot.

To facilitate comparison of past and present data collected in specific parts of the lagoon, Casagrande et al. (2003) divided the lagoon into discrete sampling zones. These zones were adjusted for the present study to include the newly excavated portions of the lagoon. Figure 4-1 shows the layout of zones and the specific sampling sites used during the present study. The 'N' sites are in the North Arm zones, the 'R' sites are in the River zones, the 'S' sites are in the South Arm zones, and the 'O' sites are in the newly excavated Odello zones. Sites were selected in consultation with NOAA Fisheries (J. McKeon, pers. comm.). Detailed descriptions appear below.

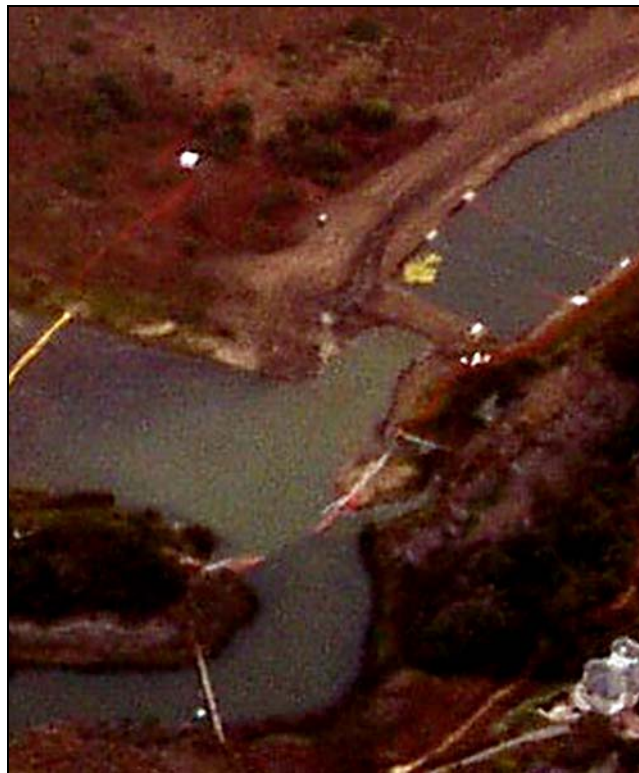
Figure 6–1 Aerial photo showing both sides of the silt curtains (S4O is to the bottom right of the curtains, S4I is to the left) after excavation in the South Arm, 22 September 2004.

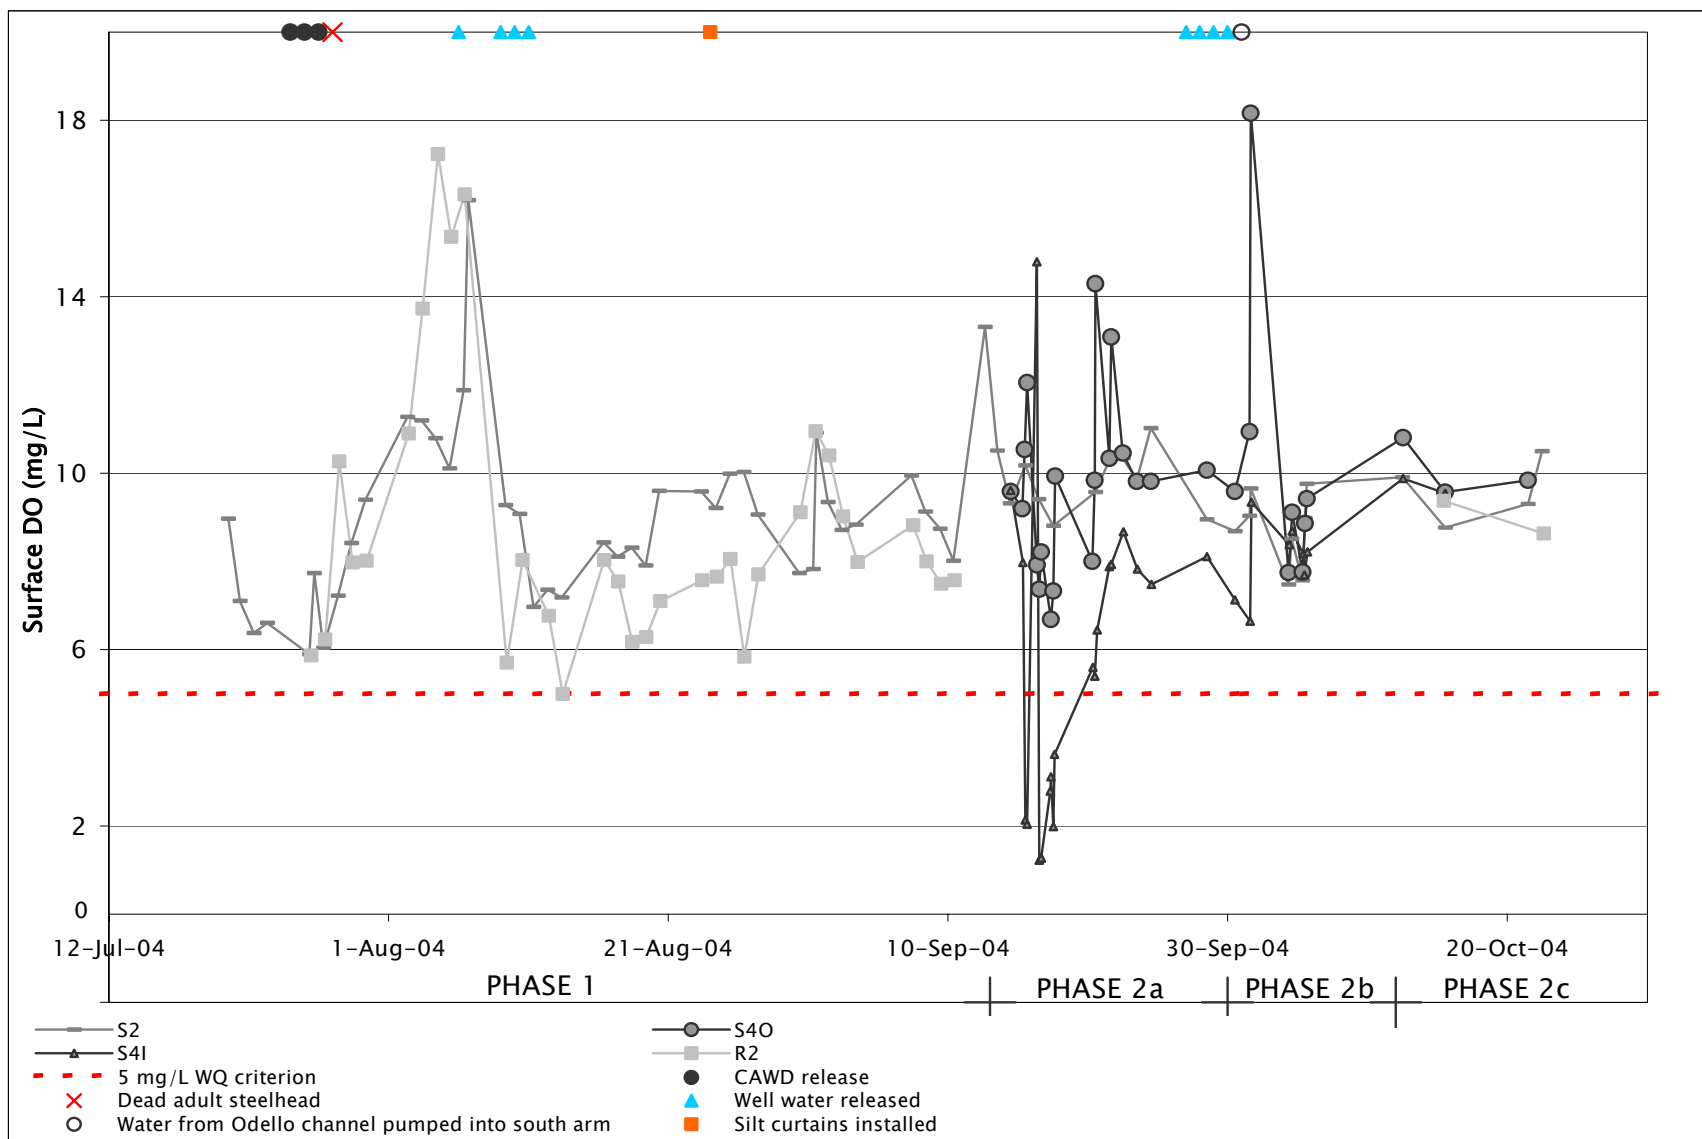
Figure 6-3 Time series of DO surface measurements taken from S2, S40, S4I, and R2.

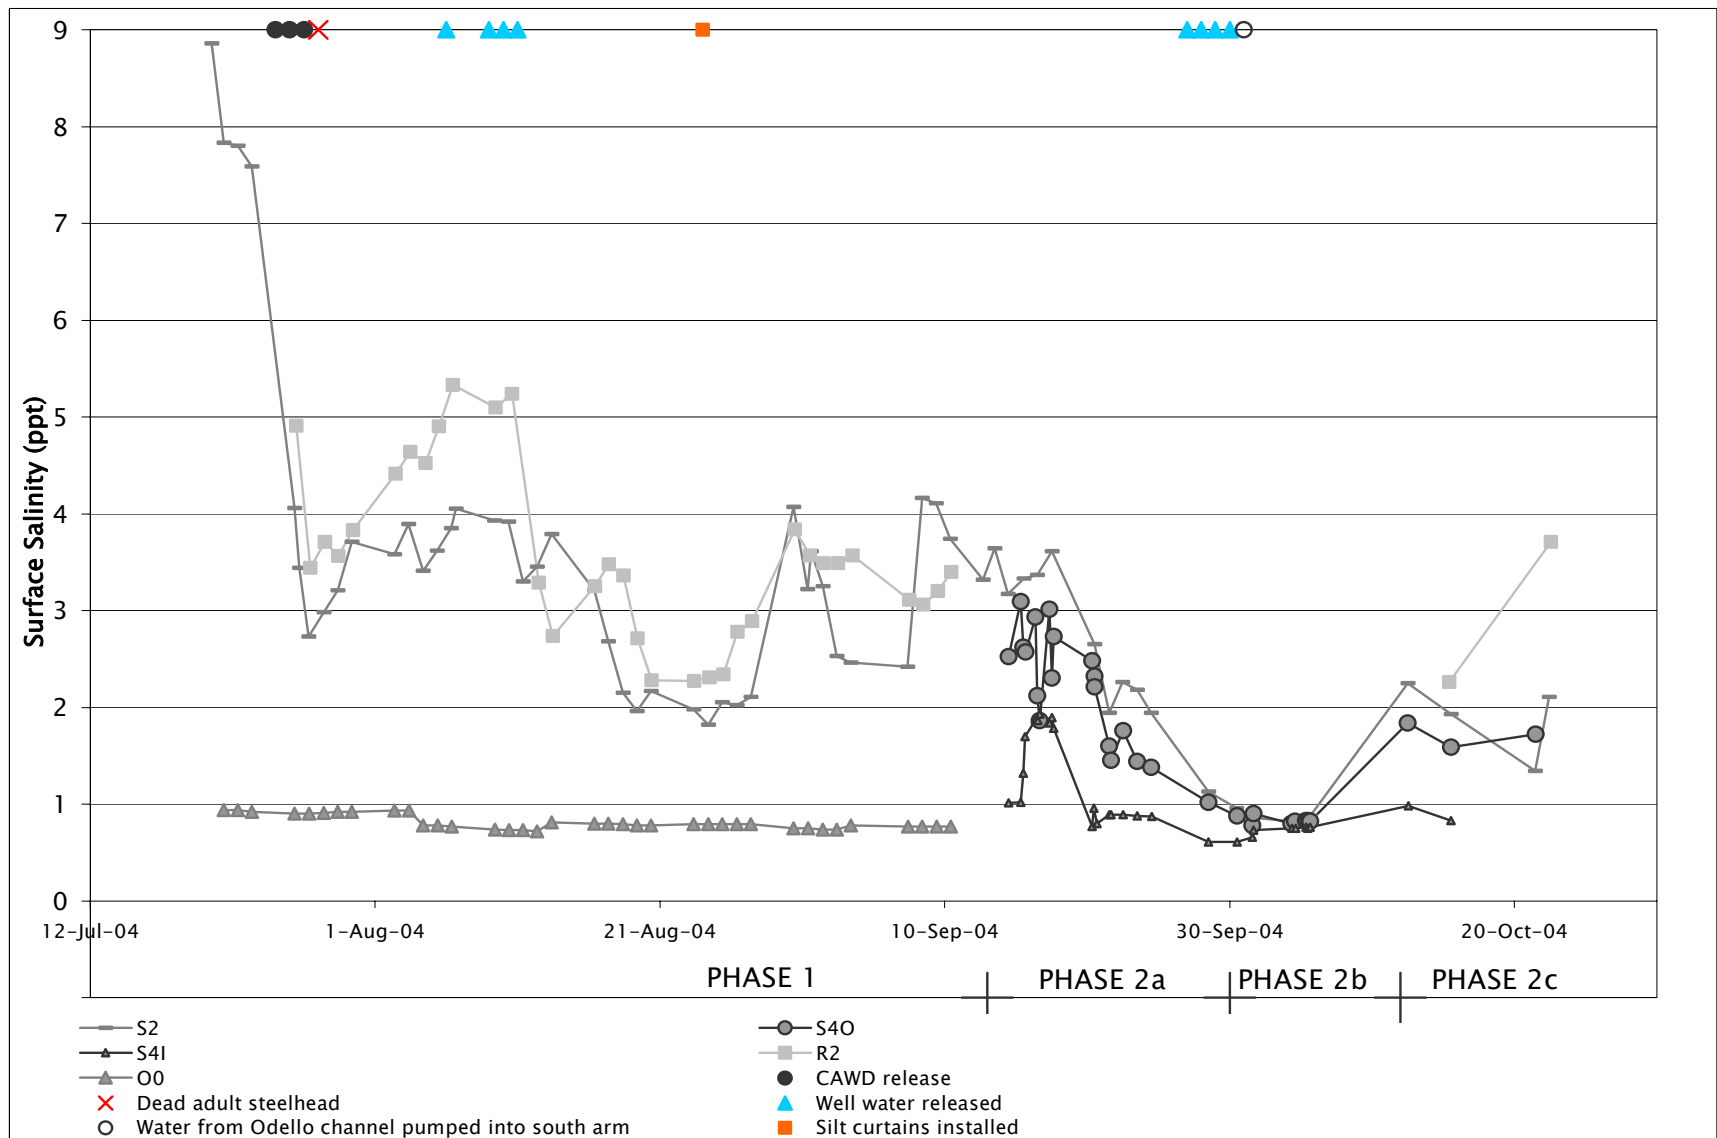
Figure 6–4 Time series of salinity surface measurements taken from S2, S40, S4I, R2, and OØ.

Water at the surface stayed relatively fresh at all sites for the duration of the sampling period (Fig. 6–4), although there was a season–long freshening trend from about 5 ppt down to less than 1 ppt, punctuated by brief influxes of salt associated with wave action. This is consistent with trends observed by Watson &

Casagrande (2004, pages 32–33). These authors discuss the freshening trend, suggesting continual groundwater replenishment as a possible cause.

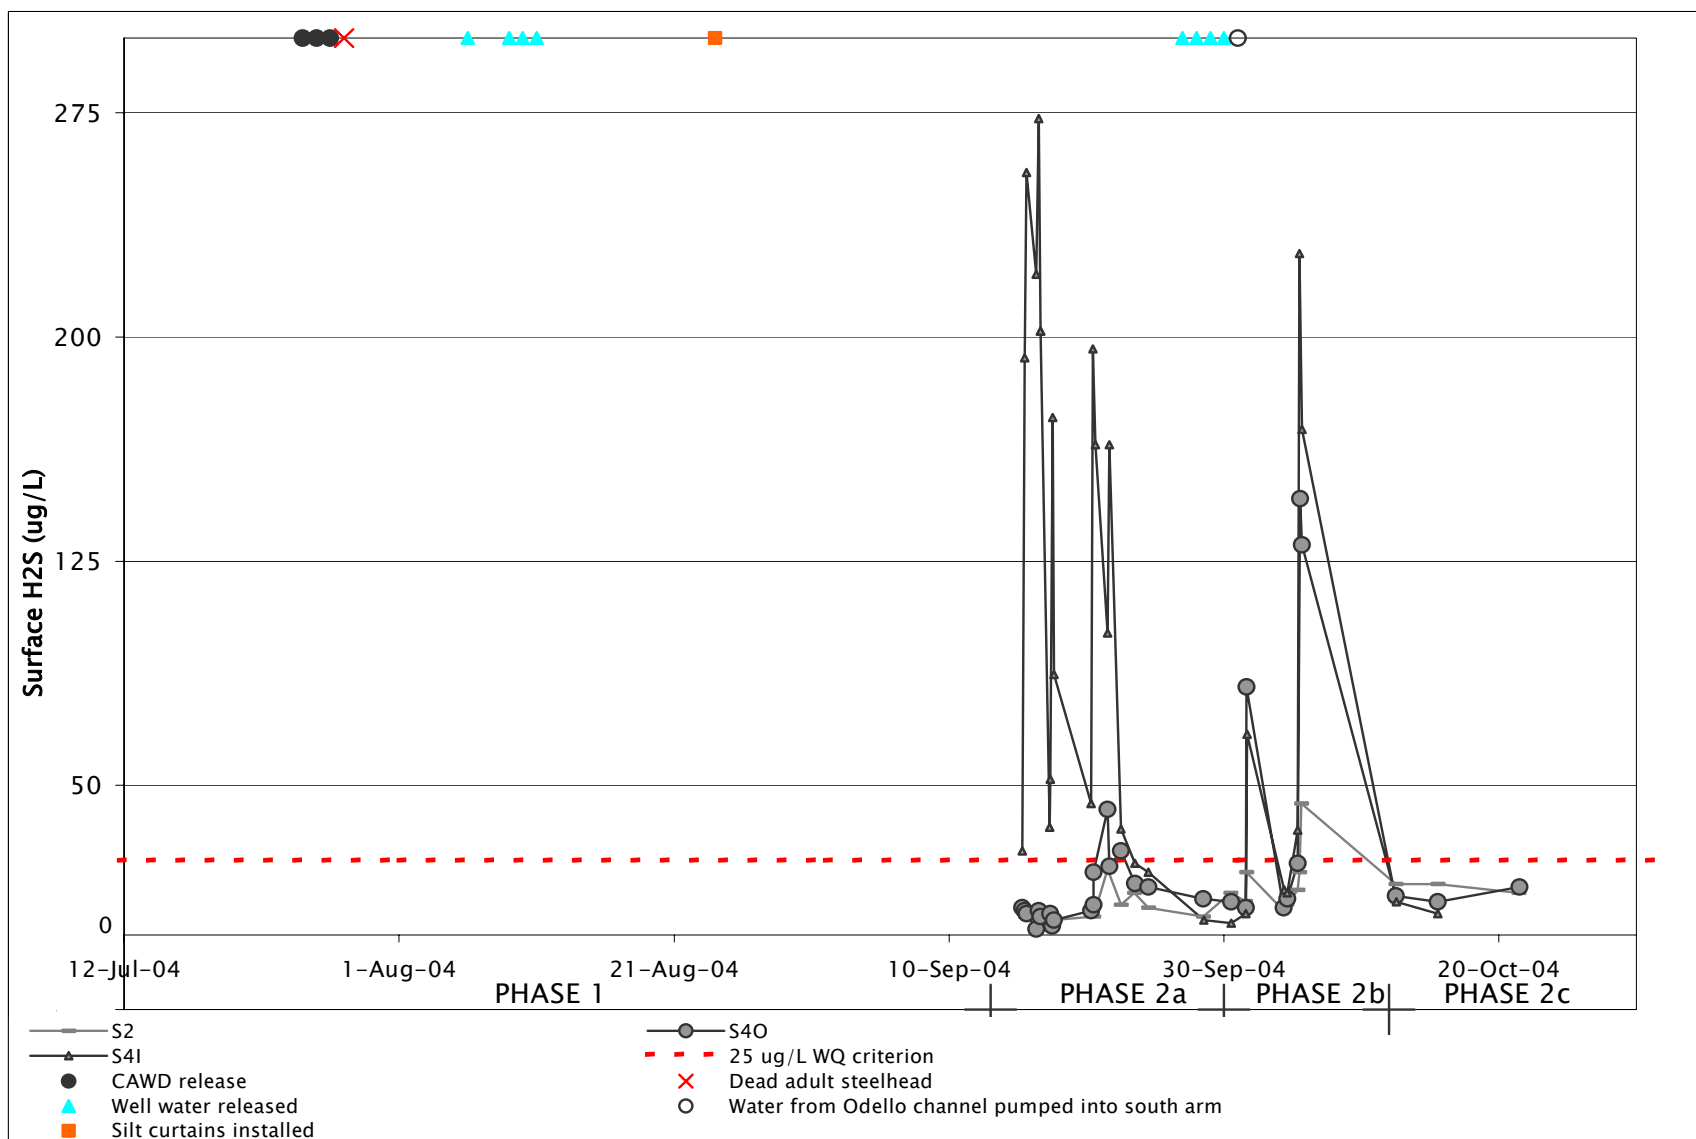
Figure 6-5 Time series of H₂S surface measurements taken from S2, S4O, S4I, and R2.

Hydrogen sulfide concentrations consistently failed to meet the 25 µg/L water quality objective inside the silt curtains, but usually met objectives at sampling sites outside the curtains in the original lagoon area (Fig. 6–5). Concentrations inside the curtains increased whenever underwater excavation occurred, and gradually declined to safer concentrations in the hours and days thereafter. Concentrations immediately outside the curtains failed to meet the objective on a few occasions, more so when the silt curtains were bowed outward – possibly a consequence of reduced wave and tidal action leading to a reduction in water level in the original lagoon. Concentrations gradually decreased moving away from the outside of the curtains toward the outfall pipe and the River mouth area of the lagoon. The sharpest reduction in surface H₂S occurred over the silt curtains themselves. Note that the 25 µg/L objective reviewed for H₂S toxicity was based on 72-hour and 96-hour mortality tests on rainbow trout eggs. It is probable that smolts would tolerate higher concentrations, especially if they only lasted a few hours – as is the case for the data outside the silt curtains.

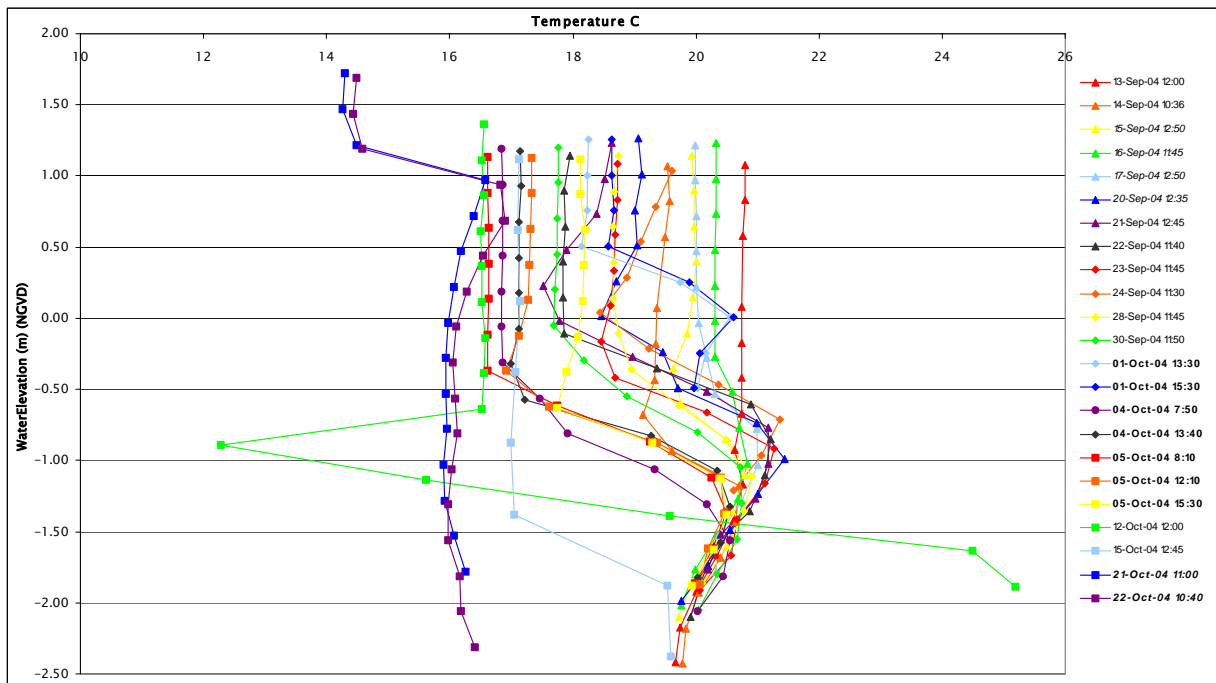
Figure 9-2 Depth profiles of temperature at S2 during Phase 2.

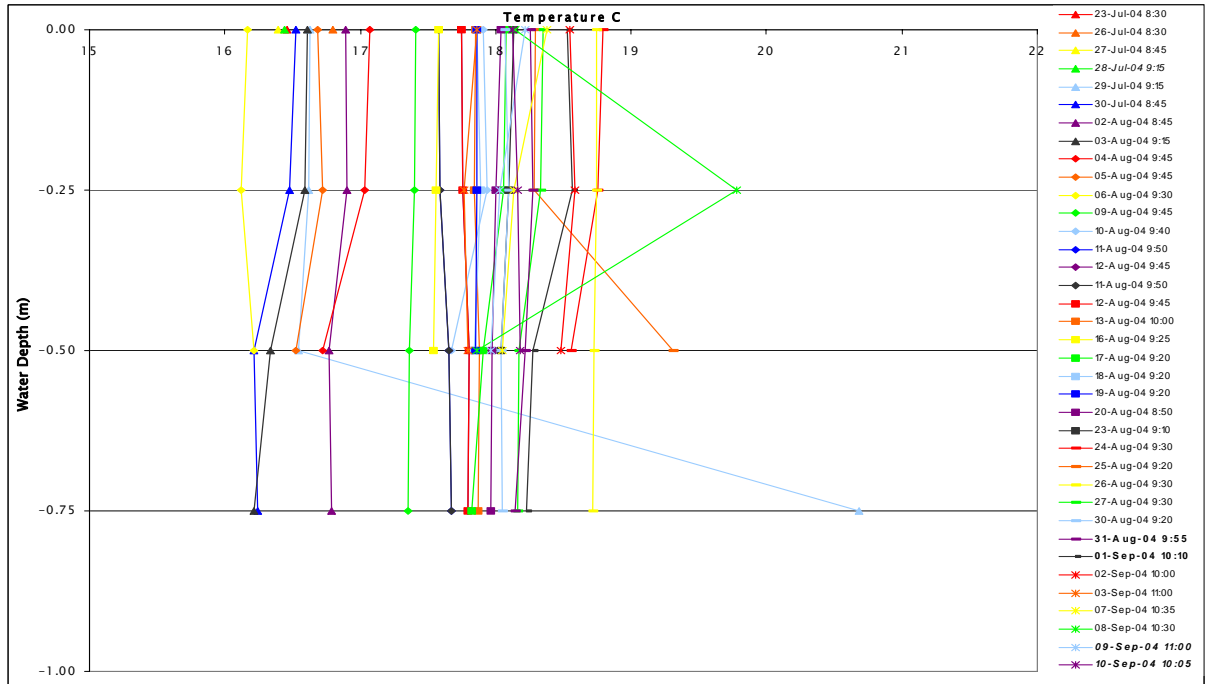
Figure 9-20 Depth profiles of temperature at FP during Phase 1.

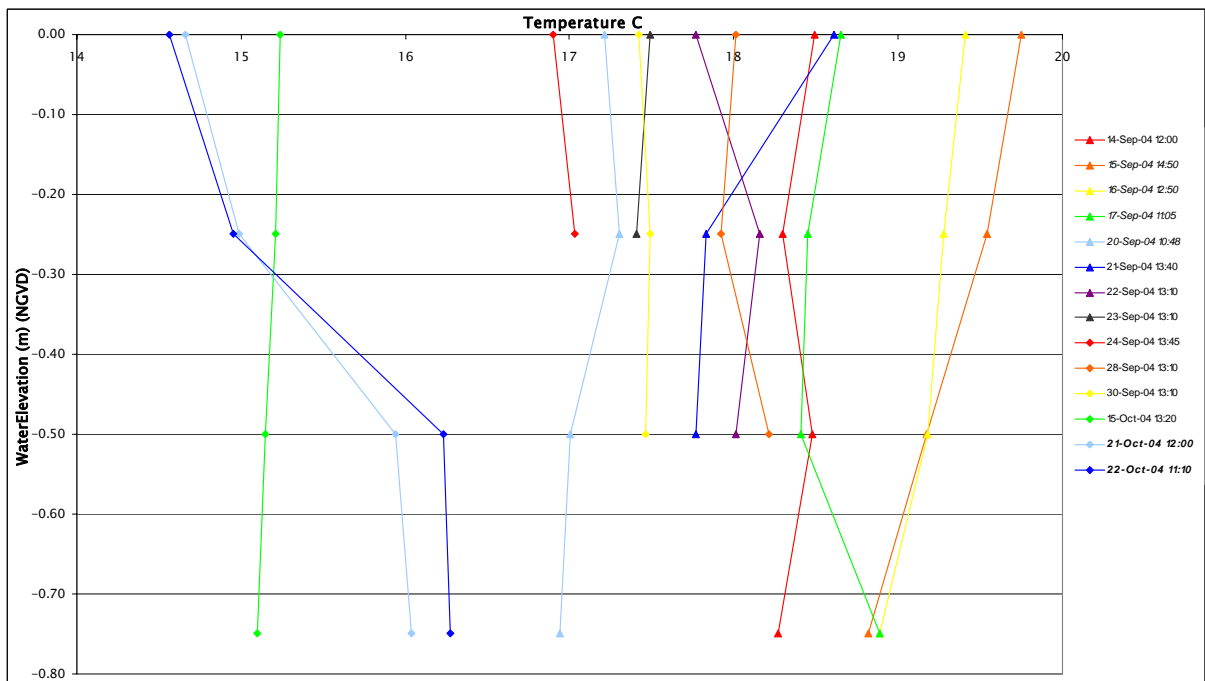
Figure 9-19 Depth profiles of temperature at FP during Phase 2.
