Prepared for the
Monterey City Harbor Master

Publication No. WI-2015-05

A Small-Scale Beach Nourishment Project in Monterey, California

CSUMB Class ENVS660 Fall 2015:

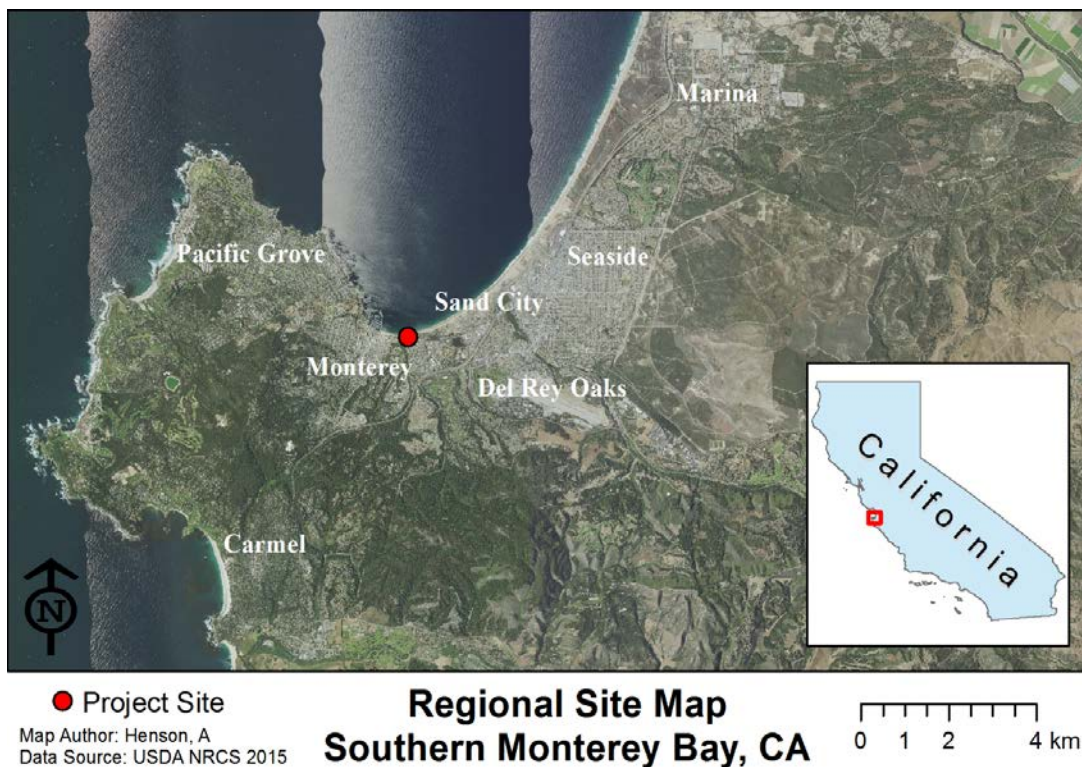
Figure 1. The regional site map. Del Monte Townhomes is located in the South Monterey Bay littoral cell, which has the highest mean erosion rate in the state (Hapke *et al.* 2006). Long-term future erosion rates adjacent to the project site are estimated to be $\sim 10\text{--}30\text{ cm yr}^{-1}$ (PWA 2008; ESA PWA 2012).

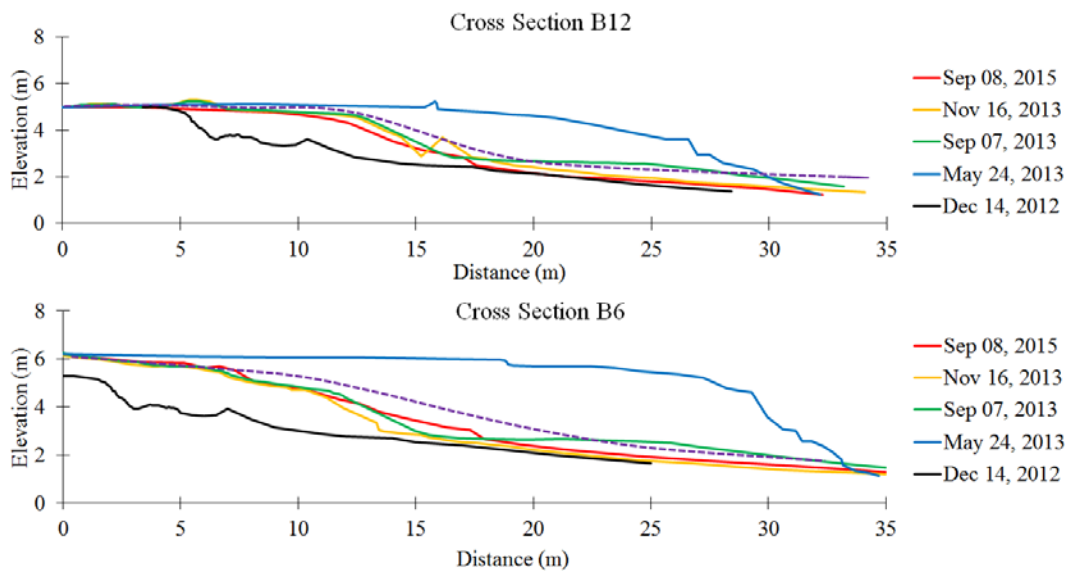
Figure 7. The nourished area cross sections B12 and B6, represent the change of Section B. The amount of sediment gained and lost over in this section is well represented by these cross sections. The dashed line indicates an assumed berm location after the second nourishment event, which is unknown.

The nourishment area (Section B) lost a total of roughly 4870 m³ of sand from May 24, 2013 to September 8, 2015 (Fig. 7; Table 1). This volume represents roughly 59 % of the total nourishment volume of 8300 m³ applied over two events (2012/2013 and 2013/2014) (Table 1).

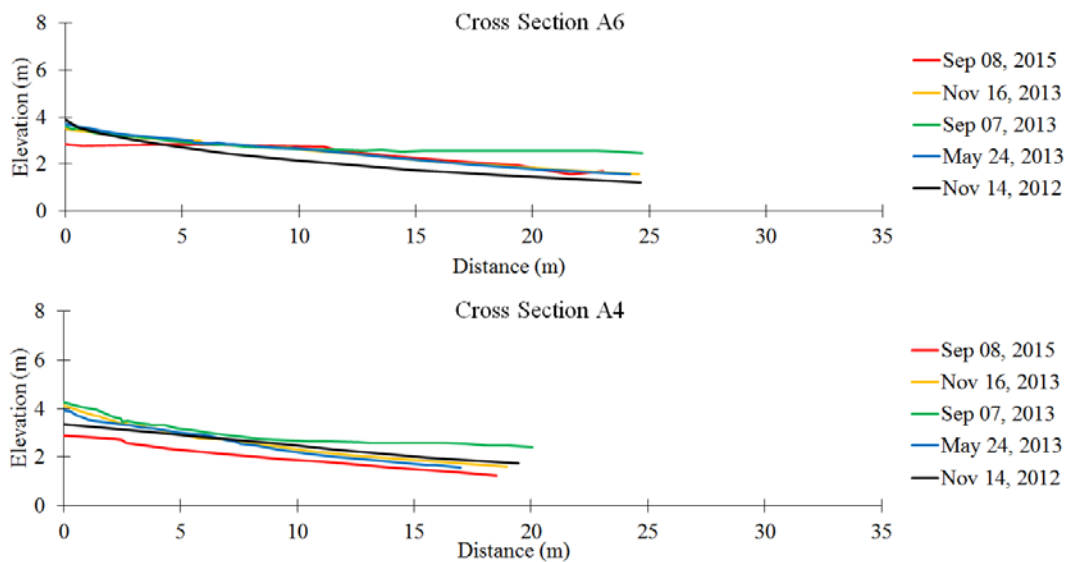
Figure 8. Control area A cross sections 4 and 6. Little change in sediment volume over time, with minimal impact associated with the nourishment events.

The control areas of Del Monte beach (Sections A and C), did not exhibit major erosion or deposition from December 7, 2012 to September 8, 2015 (Fig. 8 and Fig. 9). Both areas were minimally impacted by the initial nourishment, shown in the increase in sand from the pre-nourishment survey on December 7, 2012 to the post-nourishment survey on May 24, 2013. The cross sections closer to the nourishment area were influenced more by the nourishment events than those farther away.

Cross sections from control area A were analyzed to quantify sediment loss over time. Two cross sections were selected to represent control area A. A total of 205 m³ of sand was lost from May 24, 2013 to September 8, 2015 (Fig. 8; Table 1).

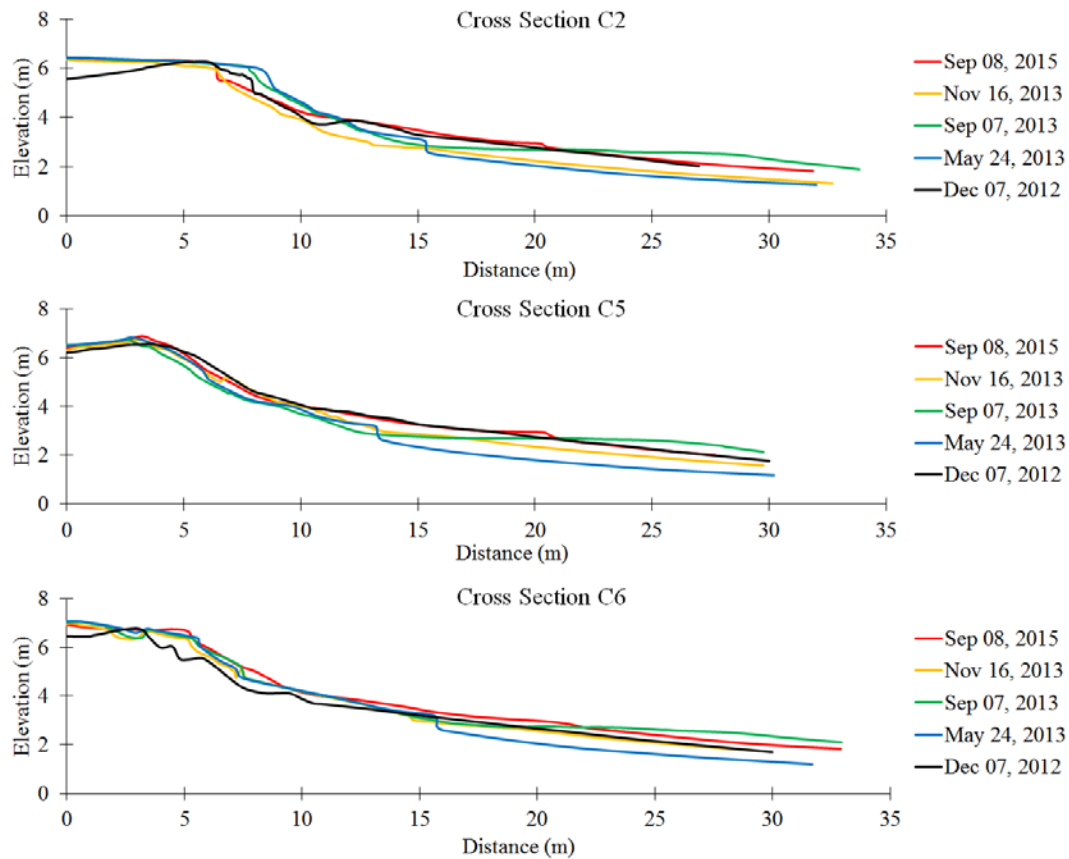
Figure 9. Control area C, cross sections 2, 5, and 6 showing very little change in sediment volume over time. Larger change can be seen nearer the nourished area, which may be associated with overlap of nourishment

Likewise, cross sections from control area C were also analyzed to quantify sediment loss or gain over time. Three cross sections were selected to represent control area C. Control area C gained a total of roughly 640 m³ of beach sediment from May 24, 2013 to September 8, 2015 (Fig. 9; Table 1). Most of this sediment appears to be in the toe of the berm, and the berm scarp fluctuated minimally.

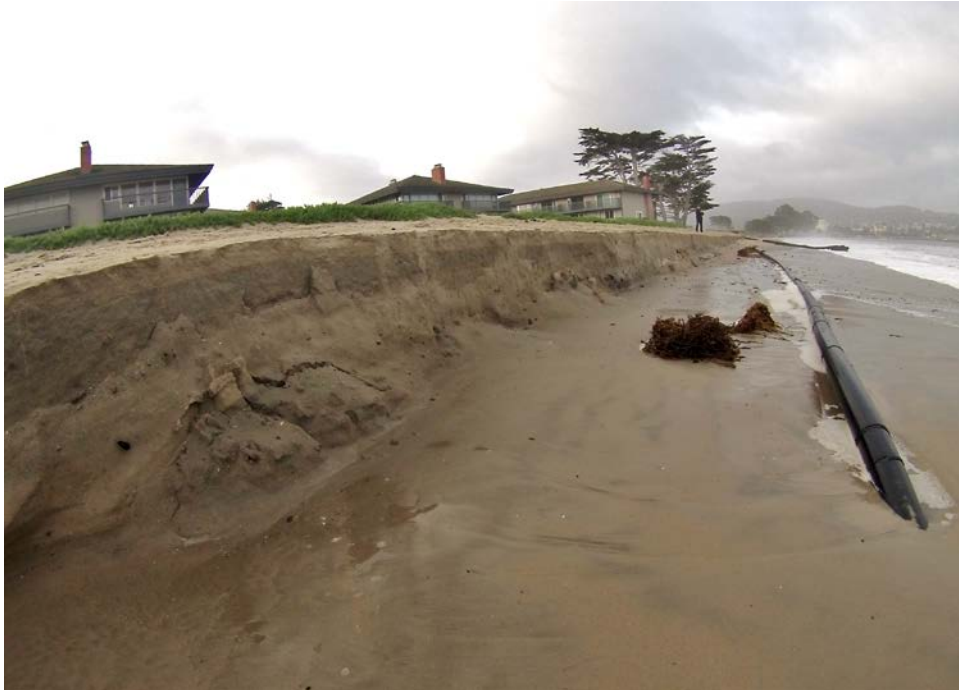
Figure 11. Significant berm erosion, indicated by tall erosional scarp, occurred during the king tide of 12/21/2014. The extent of erosion is indicated by the exposed black dredge slurry pipe, which had been buried under the berm.

Wave energy recorded at the buoy is greatly diminished through diffraction as the swells reach the north-facing beach at the study site, yet significant erosion occurred during the study. Two other erosion mechanisms were observed. The berm was degraded by people walking on the berm slope,

and periodic high tide events caused significant retreat, even when large swells were not present (Fig. 11).
