Report No. WI-2018-10
15 April 2019

The Watershed Institute

Hydrology and Water Quality of the Big Sur Land Trust Property in Carr Lake

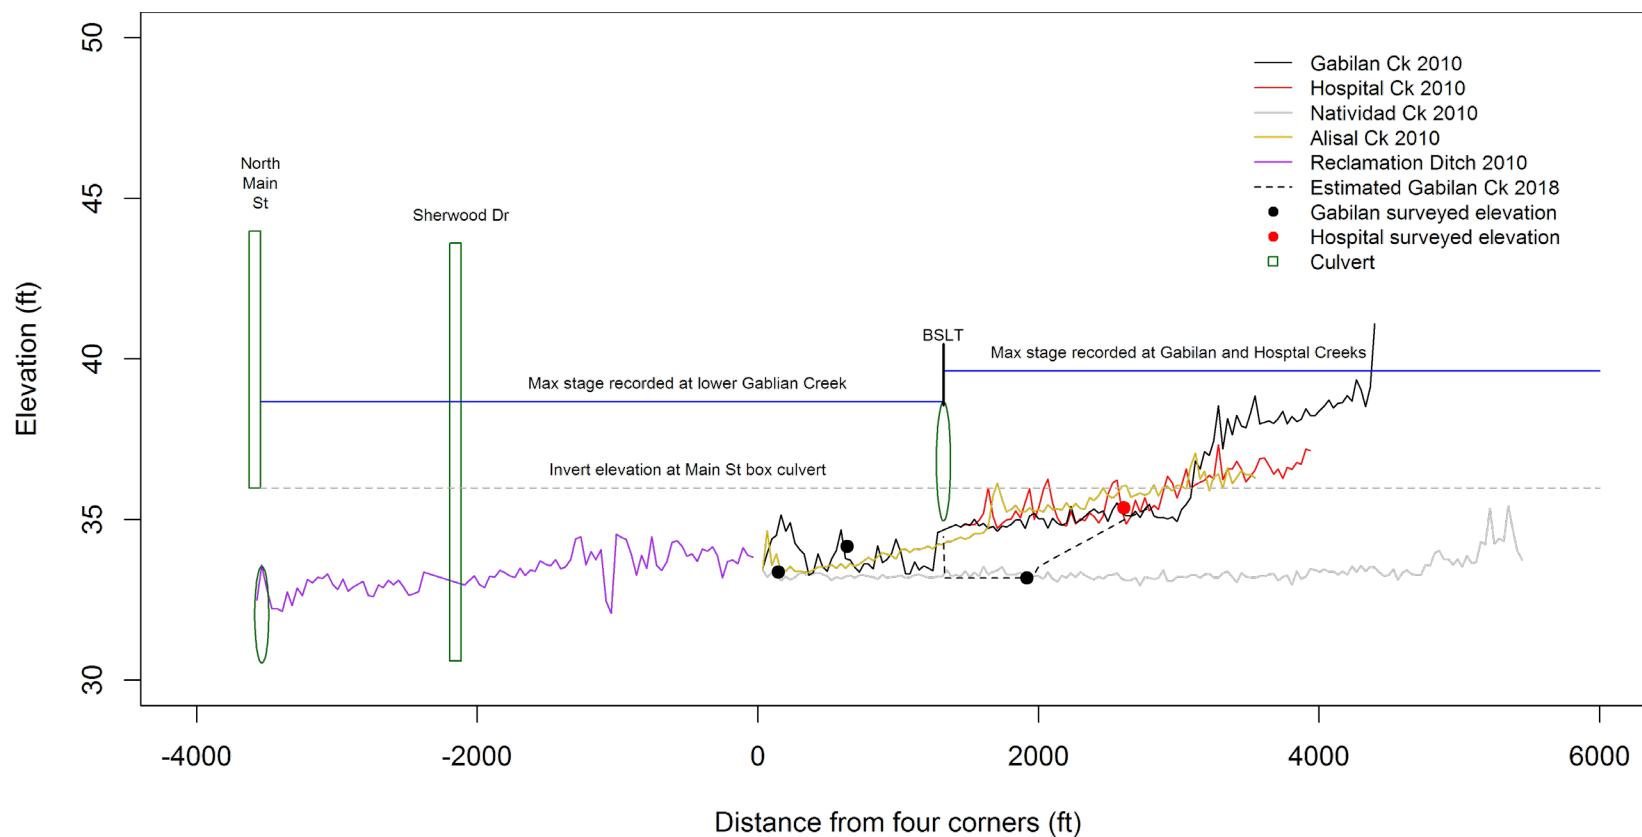
Figure 6. Longitudinal Profile of streams in Carr Lake, showing hydraulic controls such as culverts. The jagged lines of the stream profiles are probably a result of sampling variation due to limitation in the spatial resolution of the LiDAR data. “Real” profiles likely have more gradual elevation changes.

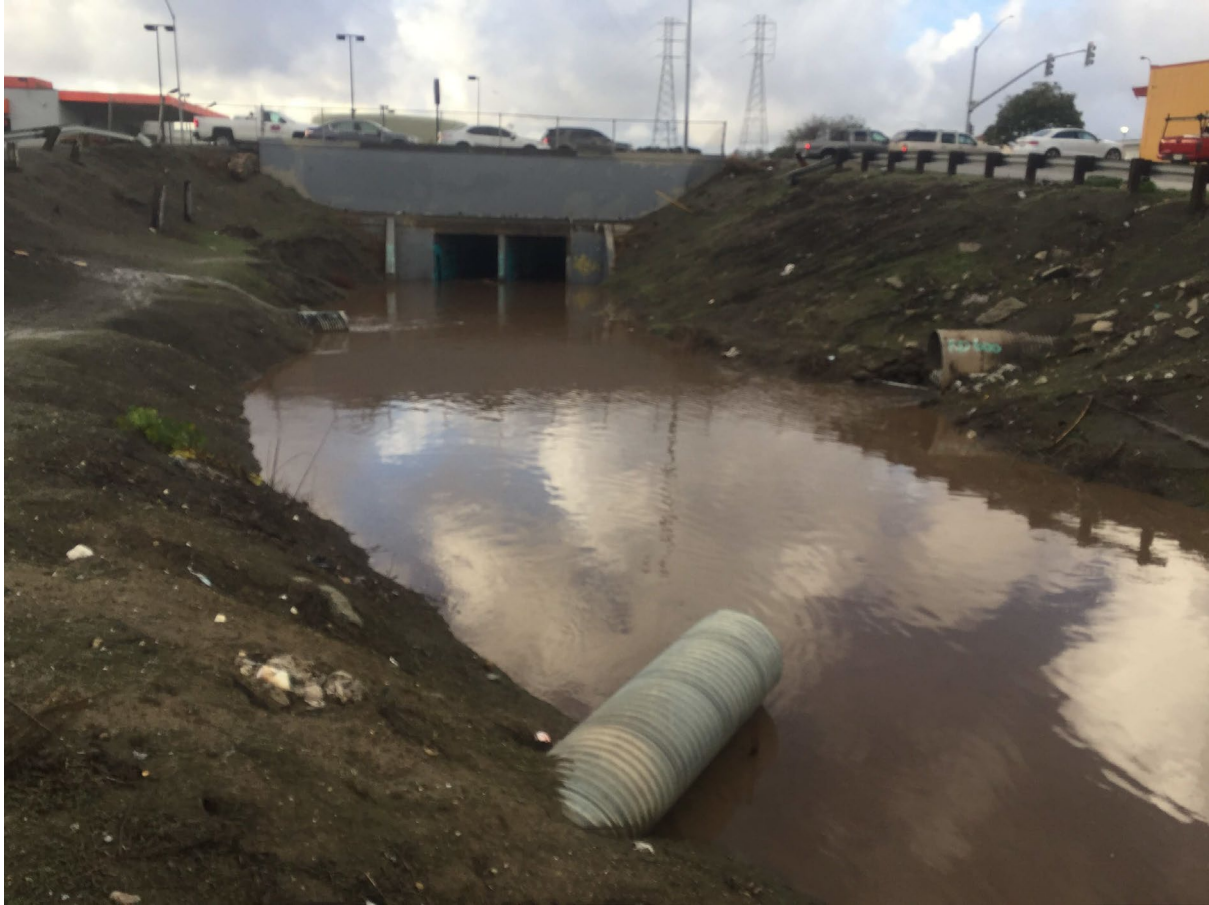
Figure 7. North Main Street culverts on November 29, 2018 after heavy rain. The small 36-inch culvert is under water.

The North Main Street culverts are a two-level system consisting of a lower 36-inch culvert which transports low flows and two upper 8 ft box culverts which become the outflow during high flow conditions (Fig. 7). It is well documented that the North Main Street Culverts are a choke point for water exiting Carr Lake (Schaaf and Wheeler 1999). The North Main Street culverts have the greatest control of stage at Carr Lake, with the invert of the upper 8 ft box culverts being 0.5 feet higher than the most upstream and highest thalweg elevation on BSLT property at Hospital Creek, suggesting that the entire BSLT property experiences backwater effects during flooding conditions.

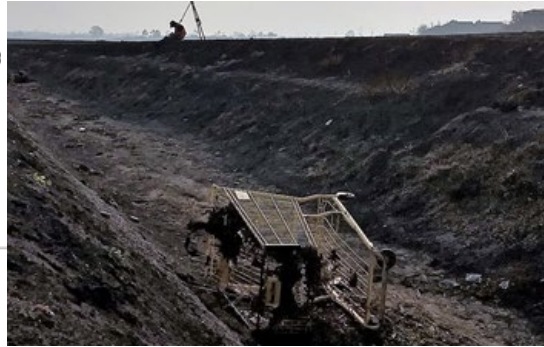
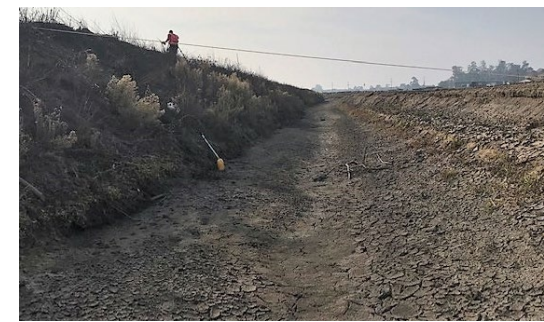
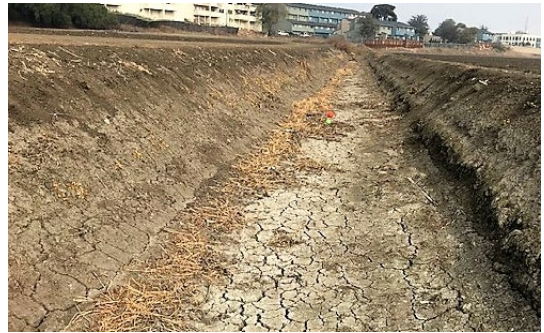
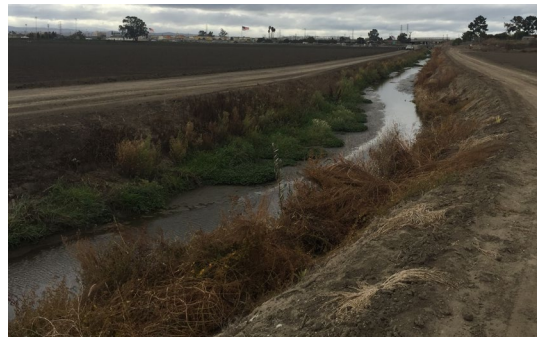
Figure 8. Cross sections and respective images of Site 1 (A, B), Site 2 (C, D), Site 3 (E, F), and Site 4 (G, H).

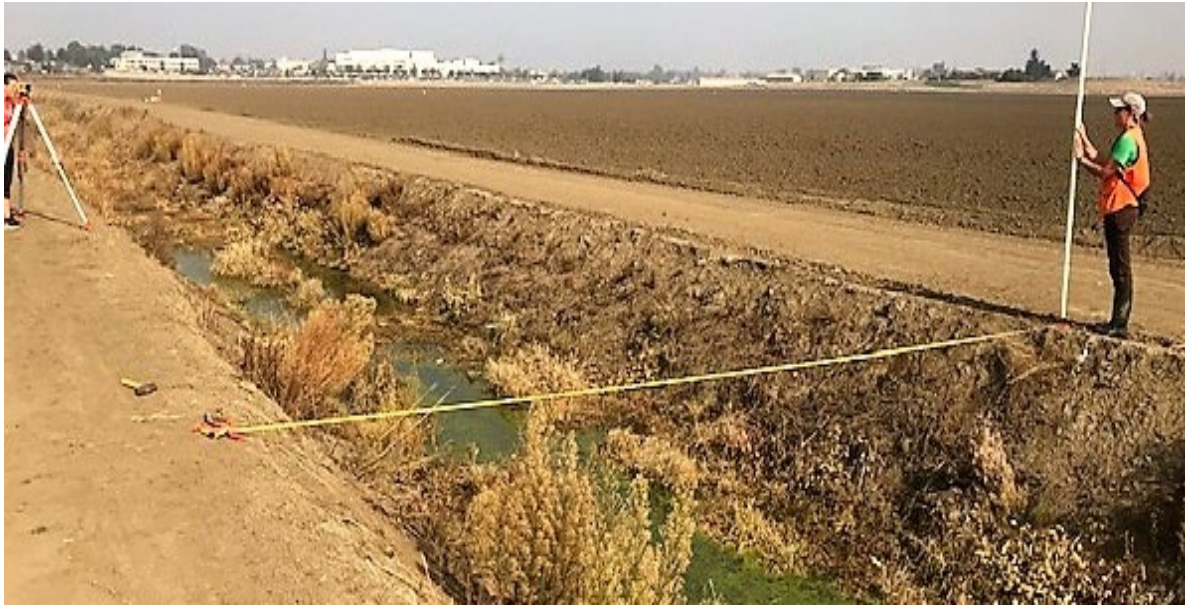
Figure 9. Site 4 experiencing dry-season ponding before first flush event.

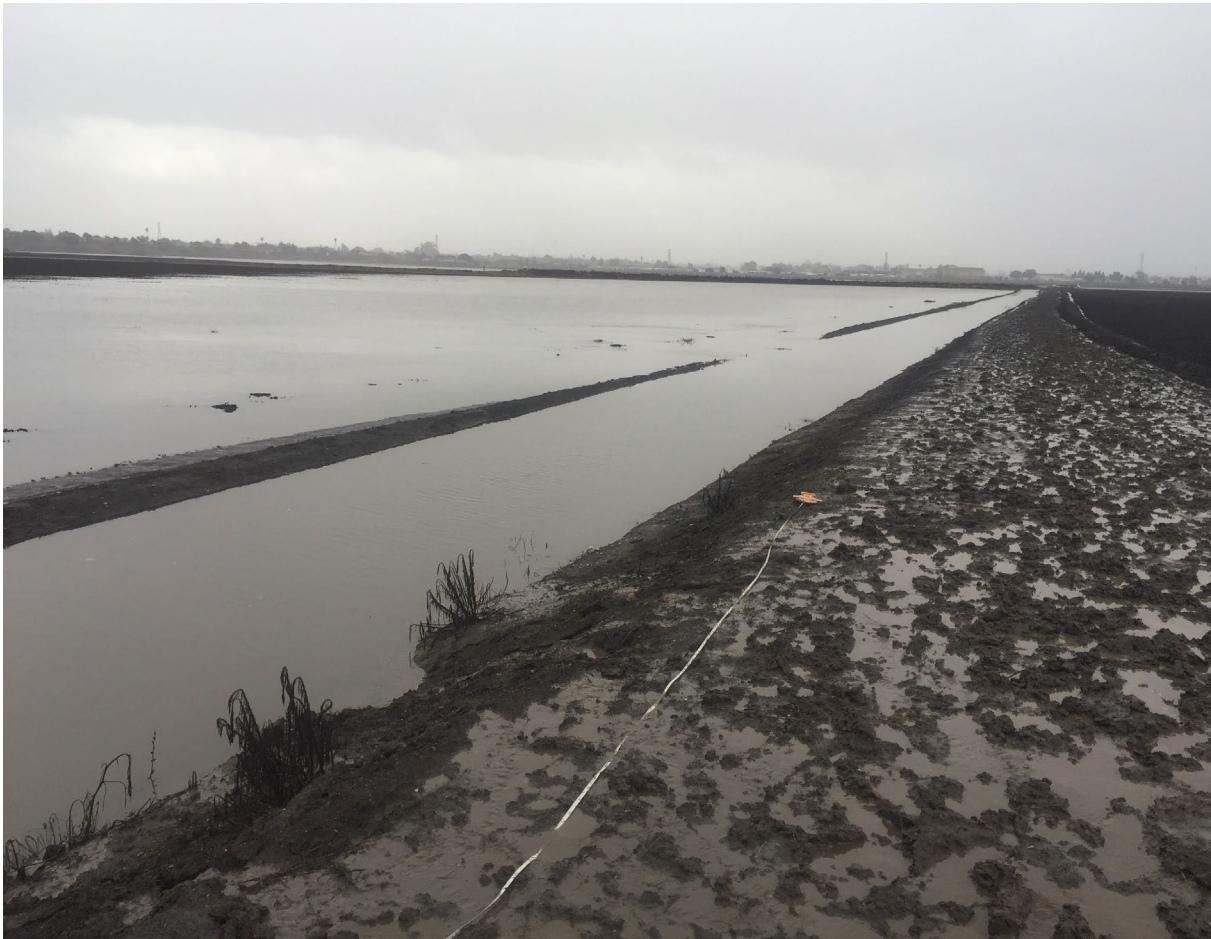
Figure 10. A 10-meter measuring tape at Site 1 for measuring flow on November 29, 2018.

Under the high flow protocol, the float method was utilized to measure average velocity (Appendix B). We threw a buoyant object in the creek to measure flow since water levels were too high and unsafe for wading. We recorded the rate at which the buoyant object traveled 10 meters downstream (Fig. 10). The float method was repeated three times and averaged before calculating velocity.

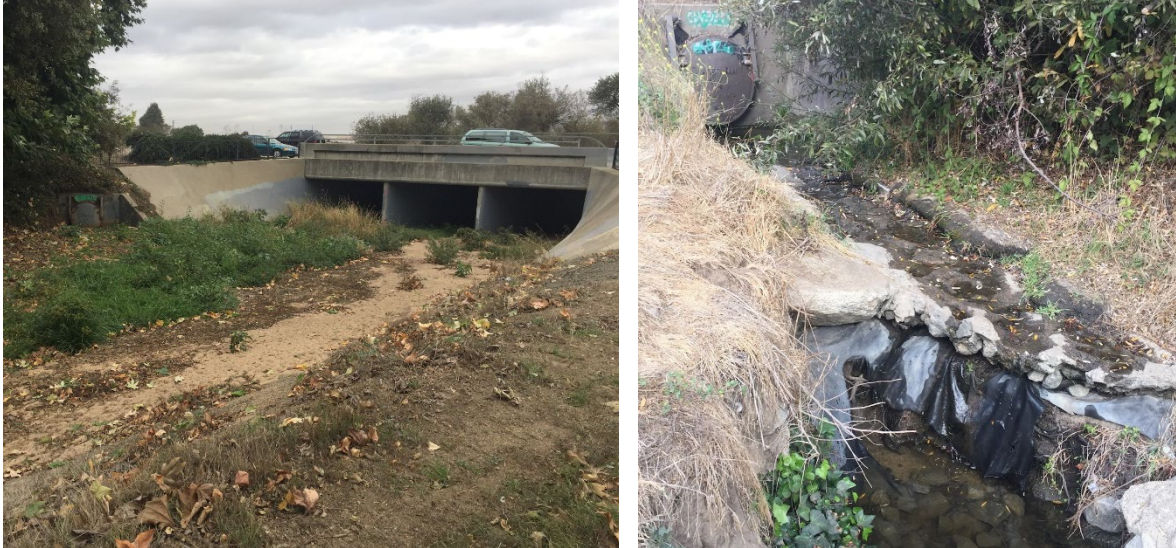
Figure 16. On November 21, 2018 sampling event, the Gabilan creek is dry at East Boronda Road (left) indicating water sampling may not be from agricultural runoff. Gabilan creek does have water flowing at Coventry Street (right) showing urban runoff.

flow at this time, suggesting that water in the channels was mostly generated from urban runoff (Fig. 16). Water quality samples were collected during this event.

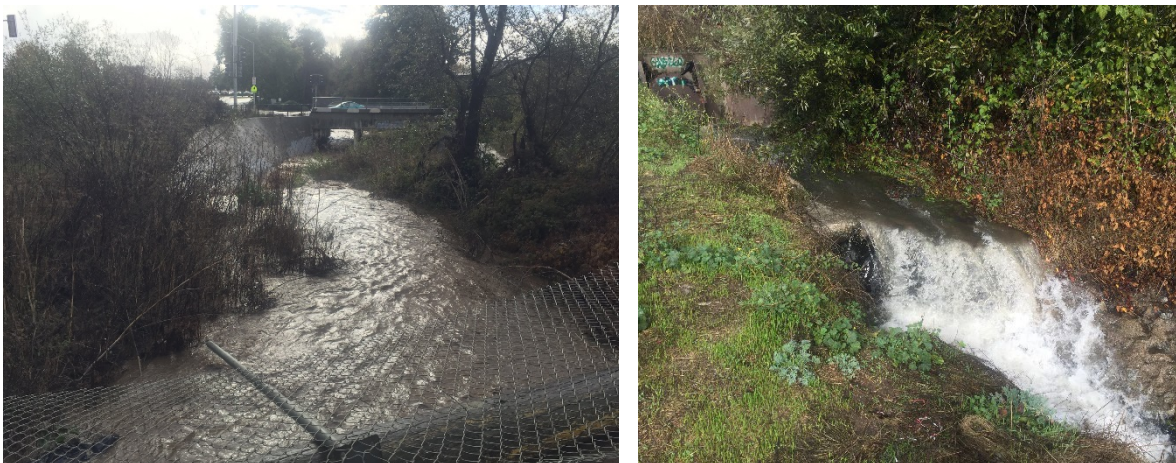
Figure 17. On the November 29, 2018 sampling event, the Gabilan creek at East Boronda Road (left) indicating agricultural runoff. Gabilan creek at Coventry Street and Hyannis Circle (right). High water flow in both areas indicates water sampling may be from both agricultural and urban runoff.

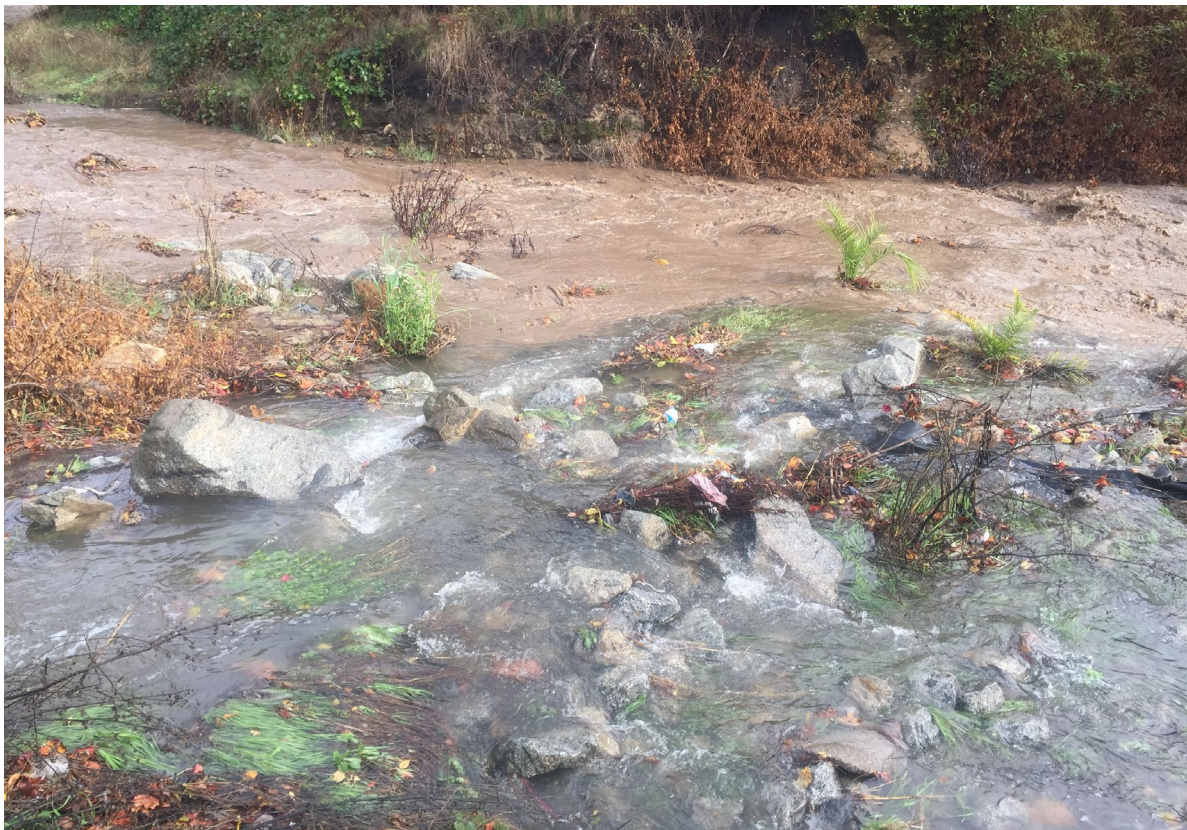
Figure 18. During the November 29th sampling event, water mixing was observed between clear urban runoff and turbid upper watershed runoff at Coventry Street and Hyannis Circle.

flooding with turbid water. While we believe that the water flooding Carr Lake was a mix of agricultural and urban runoff, we can't be certain that water observed coming from upstream of East Boronda Road had enough time to flow to Carr Lake due to the timing of our photographic evidence (Fig. 18). Photographs of the agricultural runoff were taken while samples were collected, leaving no proof that this water was flowing long enough to reach Carr Lake. However, the turbidity of the water, the rising hydrograph and a picture of urban and agricultural runoff mixing upstream suggest that this water likely included agricultural mixing (Fig. 18).

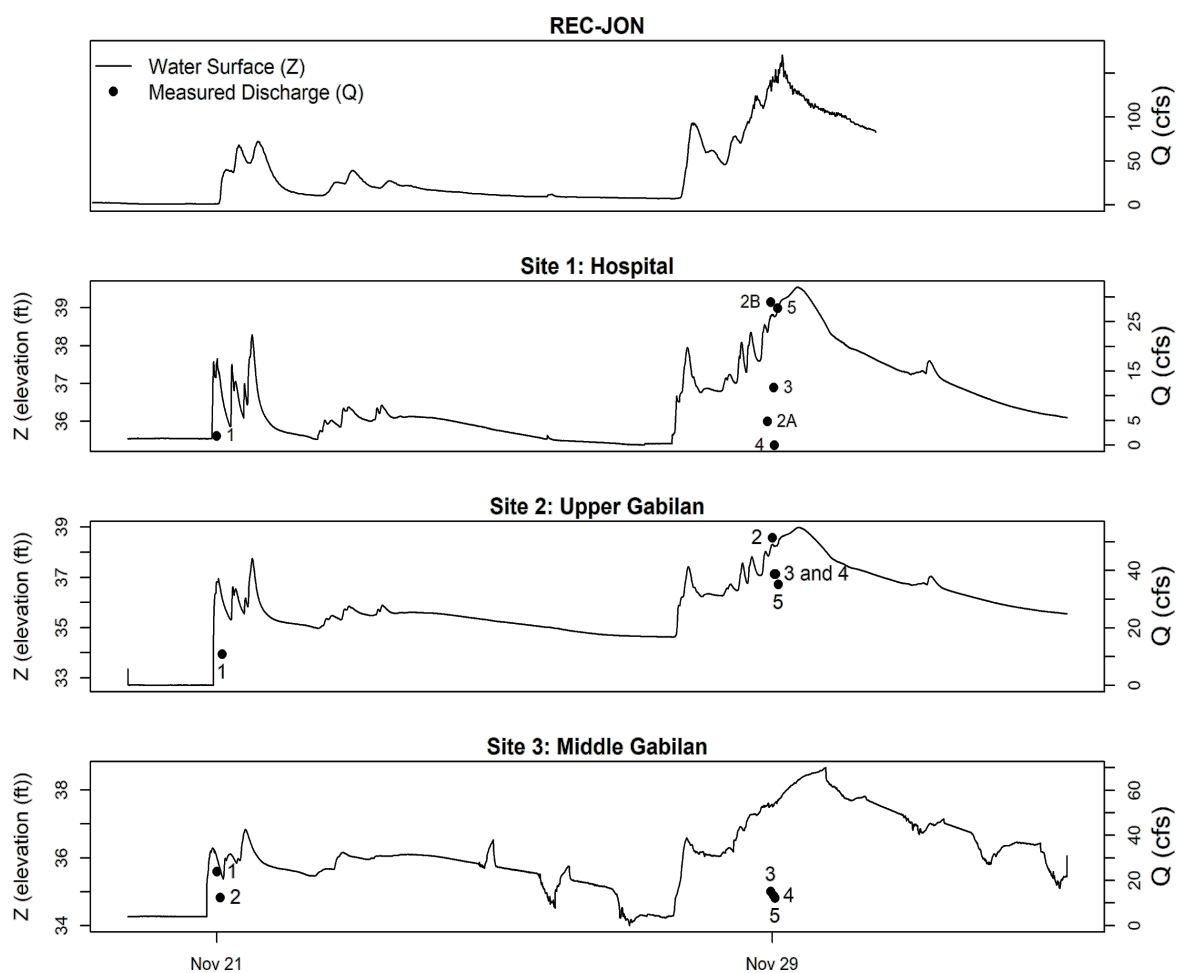
Figure 20. Water Surface Elevation (WSE) and calculated discharge at sites 1–3 compared to USGS Reclamation Ditch gage downstream.

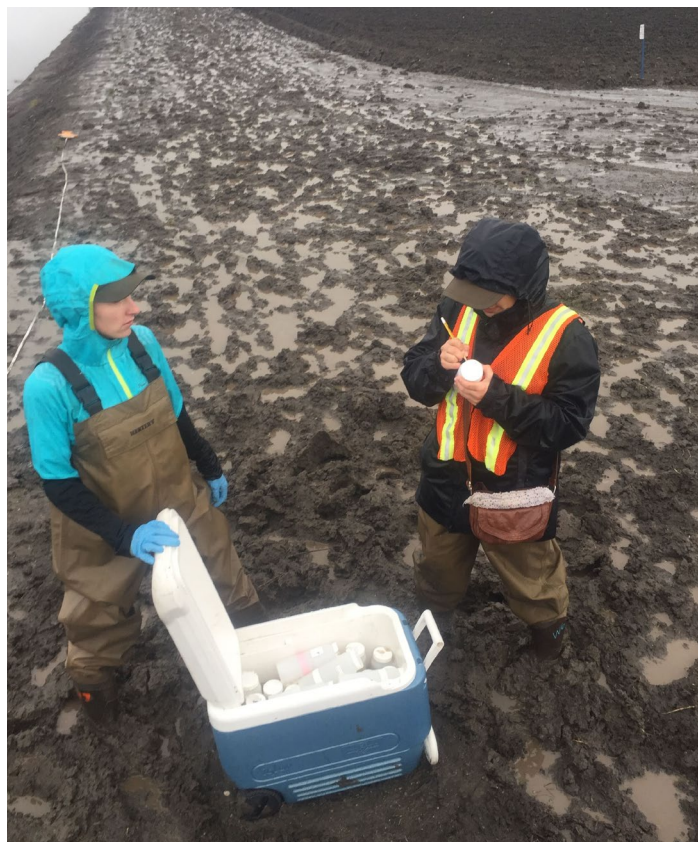
Figure 22. Water quality sampling on November 29, 2018 at Site 1.

effort to evaluate variation in analyte concentration that may be occurring between each location at a given moment. Due to required sampling technique for TSS, each sample was collected using a DH-48 sampler. Initially, each sample was collected at equally spaced intervals along the width of the channel surface water. However, due to the flashy nature of both tributaries wading became unsafe, resulting in sample collection that took place from the streambank. Each DH-48 bottle was labeled with the date and time the sample was collected (Fig. 22). In addition to samples collected using the DH-48 sampler, a dip sample was also collected for each sampling interval and later used during sample preparation to triple rinse buckets used to consolidate samples.

Once all samples had been collected the water was transported to a campus laboratory at CSUMB. To begin sample preparation a 5 L mixing container was acid washed using a 10% hydrochloric acid solution then triple rinsed using water from the dip sample collected at each sampling interval. Water from each DH-48 bottle designated for a specific sampling site and interval were combined in a mixing container to produce

one homogeneous solution that represented that specific sampling event. Starting with TSS and TDS, each sample was measured and stored in the correct container under the proper conditions specified for that analyte (Table 4).

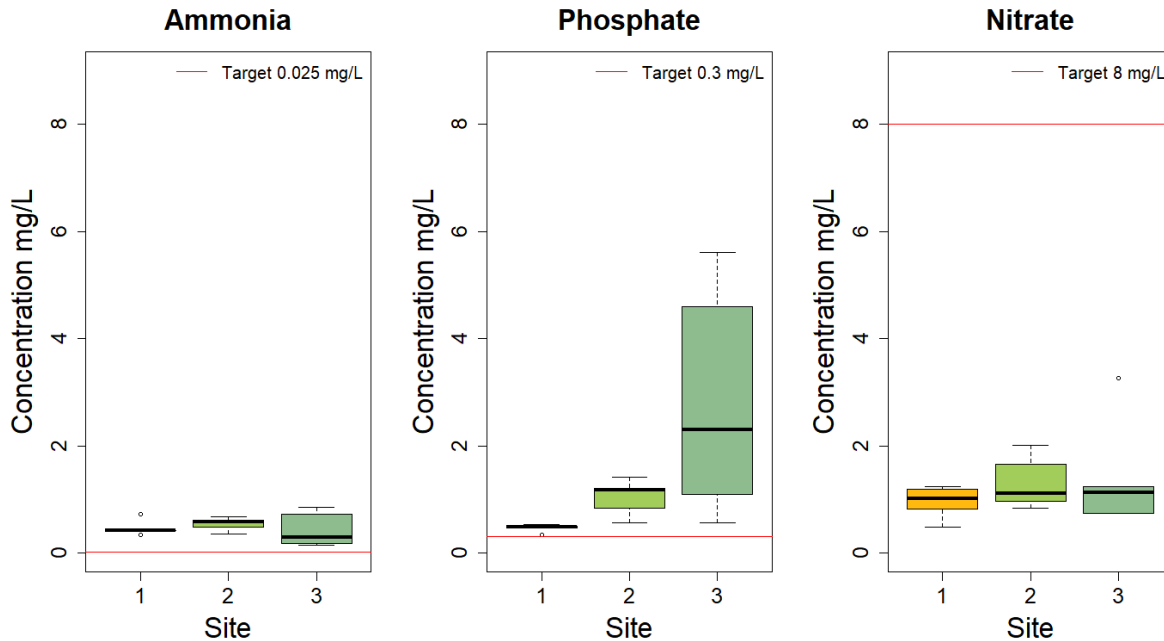
Figure 23. Nutrient levels at the three sites. Ammonia and phosphate levels were consistently greater than the target level of water, for all sites. The opposite is true for nitrate, falling below the recommended threshold.

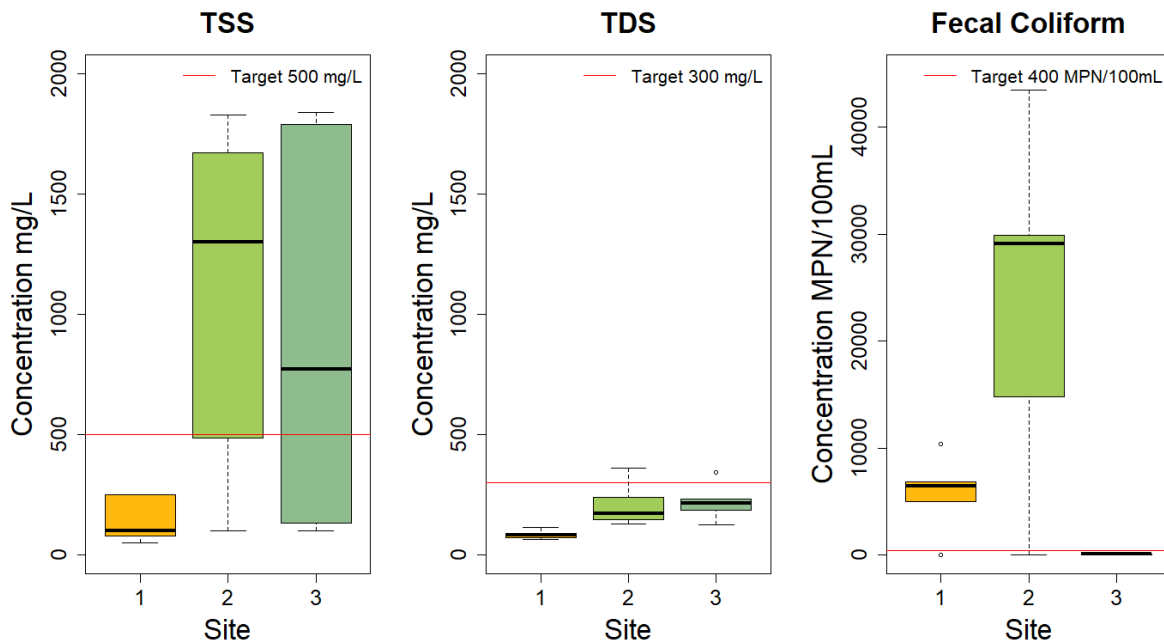
Figure 24. Levels of total suspended solids (TSS), total dissolved solids (TDS), and fecal coliform for the three sites. High levels of sediment were transported, indicated by the high TSS, especially at sites 2 and 3. TDS is within the target range. Fecal coliforms are much higher than the threshold at sites 1 and 2, mostly due to elevated levels on the second day of sampling.

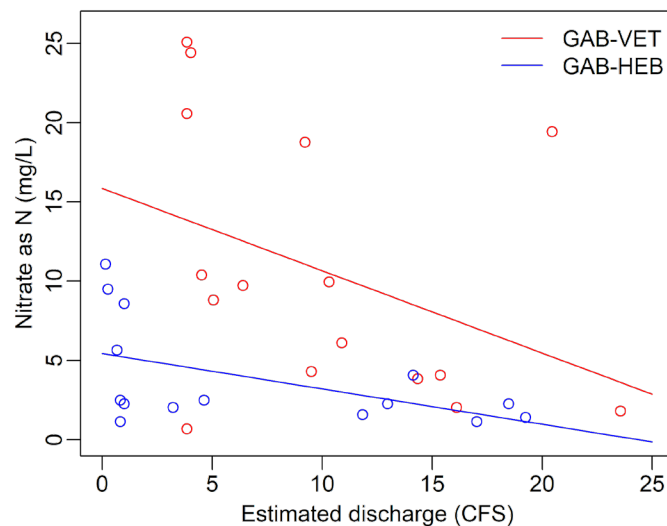
Figure 26. Evidence for dilution of nitrate concentration by high flows derived directly from rainfall and surface runoff. Discharge was estimated from stage based on a rating curve derived from actual discharge measurements. Data source: Watson & Casagrande (2006). Best-fit lines are based on simple linear regression.

As noted above, nitrate levels appeared anomalously low when compared with context to previous sampling. However, closer examination of the context revealed evidence that – based on data from previous studies – nitrate levels could be expected to be at their lowest in late fall and during strong rainfall – both of which were the case for all of the samples taken during this study (Figs 25 & 26).

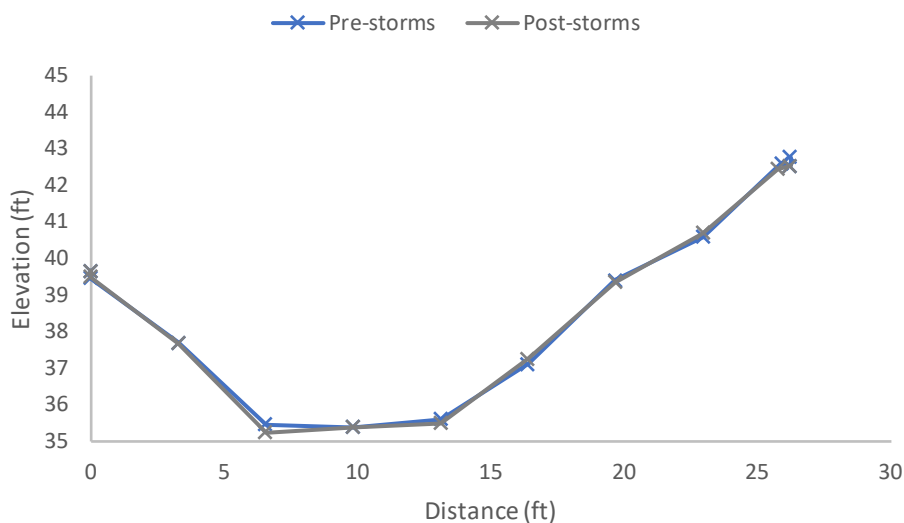
Figure 27. Pre- and post-storm surveys at Site 1 on Hospital Creek. The “x” indicates survey shots.

was a hard, easy to distinguish surface. The post-storm surveys were conducted while the channel was wet, and the channel bottom was less clearly defined due to an upper layer of muck and swelling of the soil. This may have had an effect on the results of our survey.

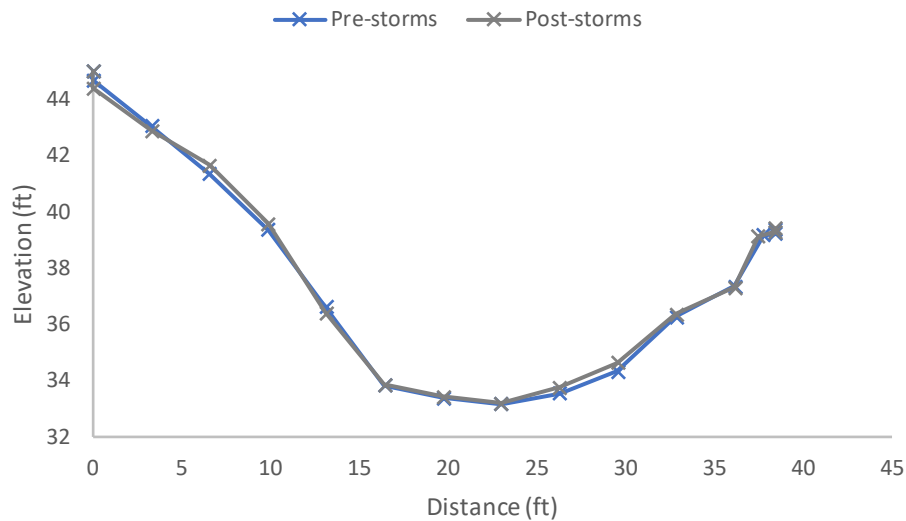
Figure 28. Pre- and post-storm surveys at Site 2 on Gabilan Creek. The “x” indicates survey shots.

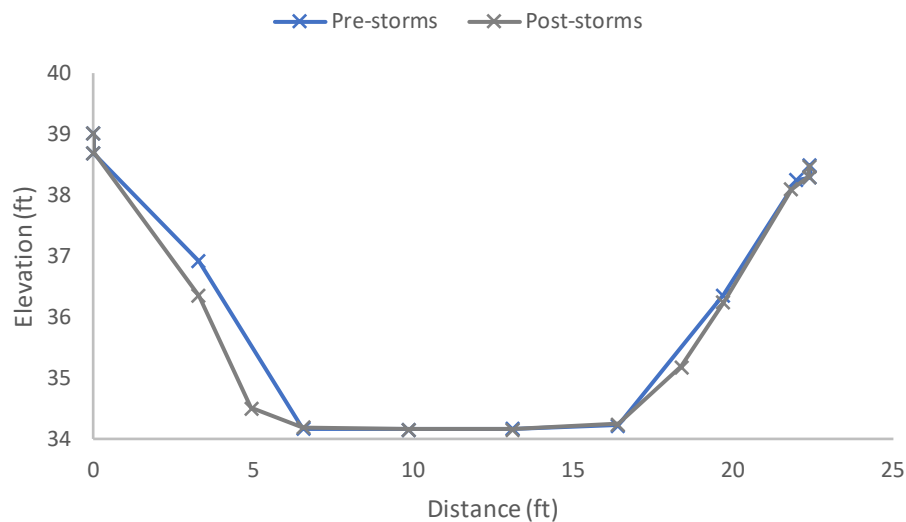
Figure 29. Pre- and post-storm surveys at Site 3 on Gabilan Creek. The “x” indicates survey shots.

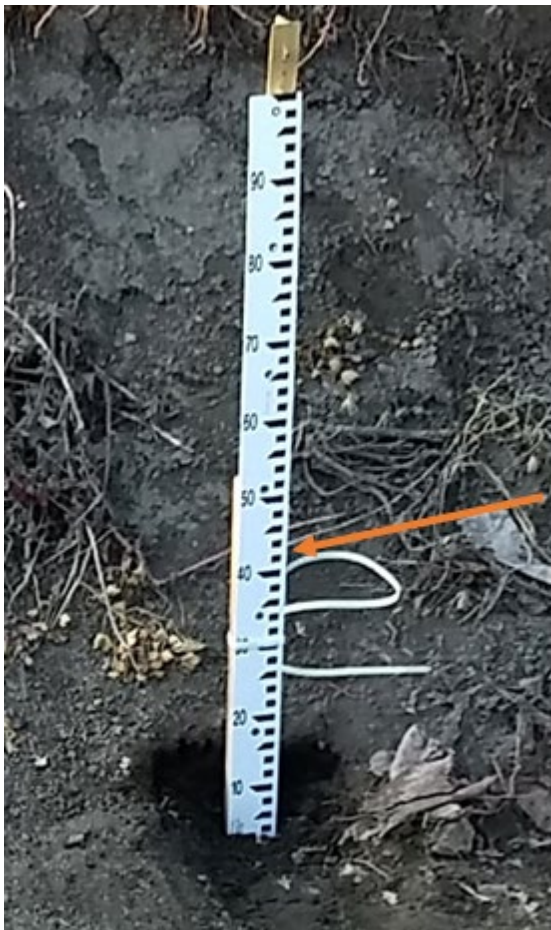
For example, the stage reading at the arrow on the image would be 41.6

The staff plate should be hydraulically connected to the lowest flows – this means that there should be a channel connecting the staff plate to the channel bottom.
