Publication No. WI-2016-10
27 September 2016

San Clemente Dam Removal Sediment Impacts: Year One Report

CSUMB Class ENVS 660 Fall 2016:

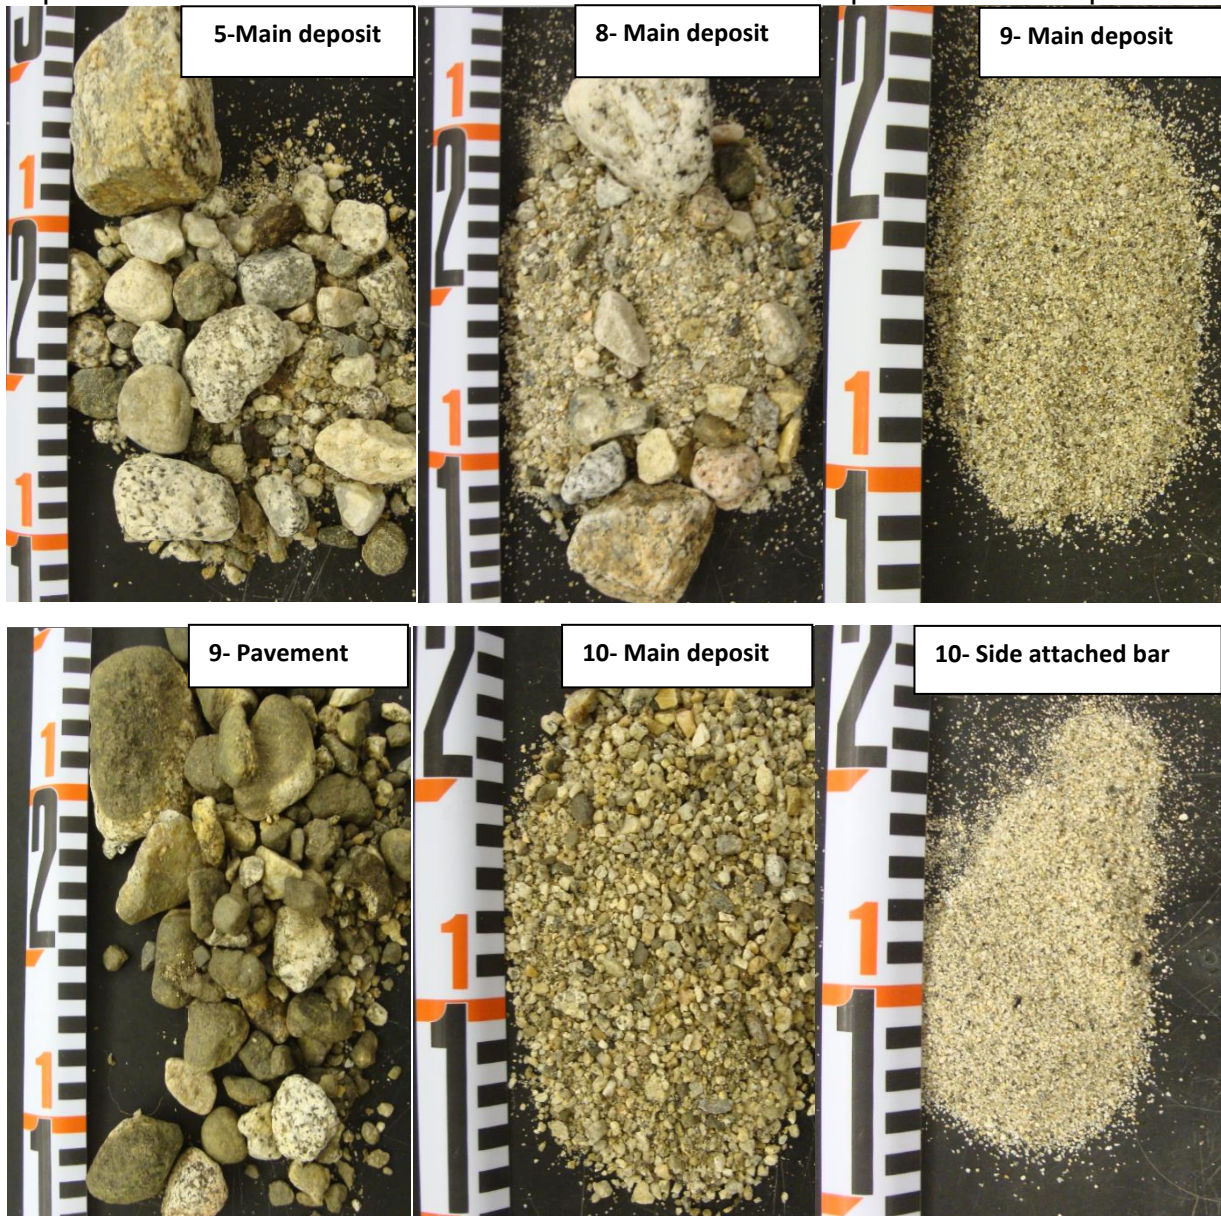
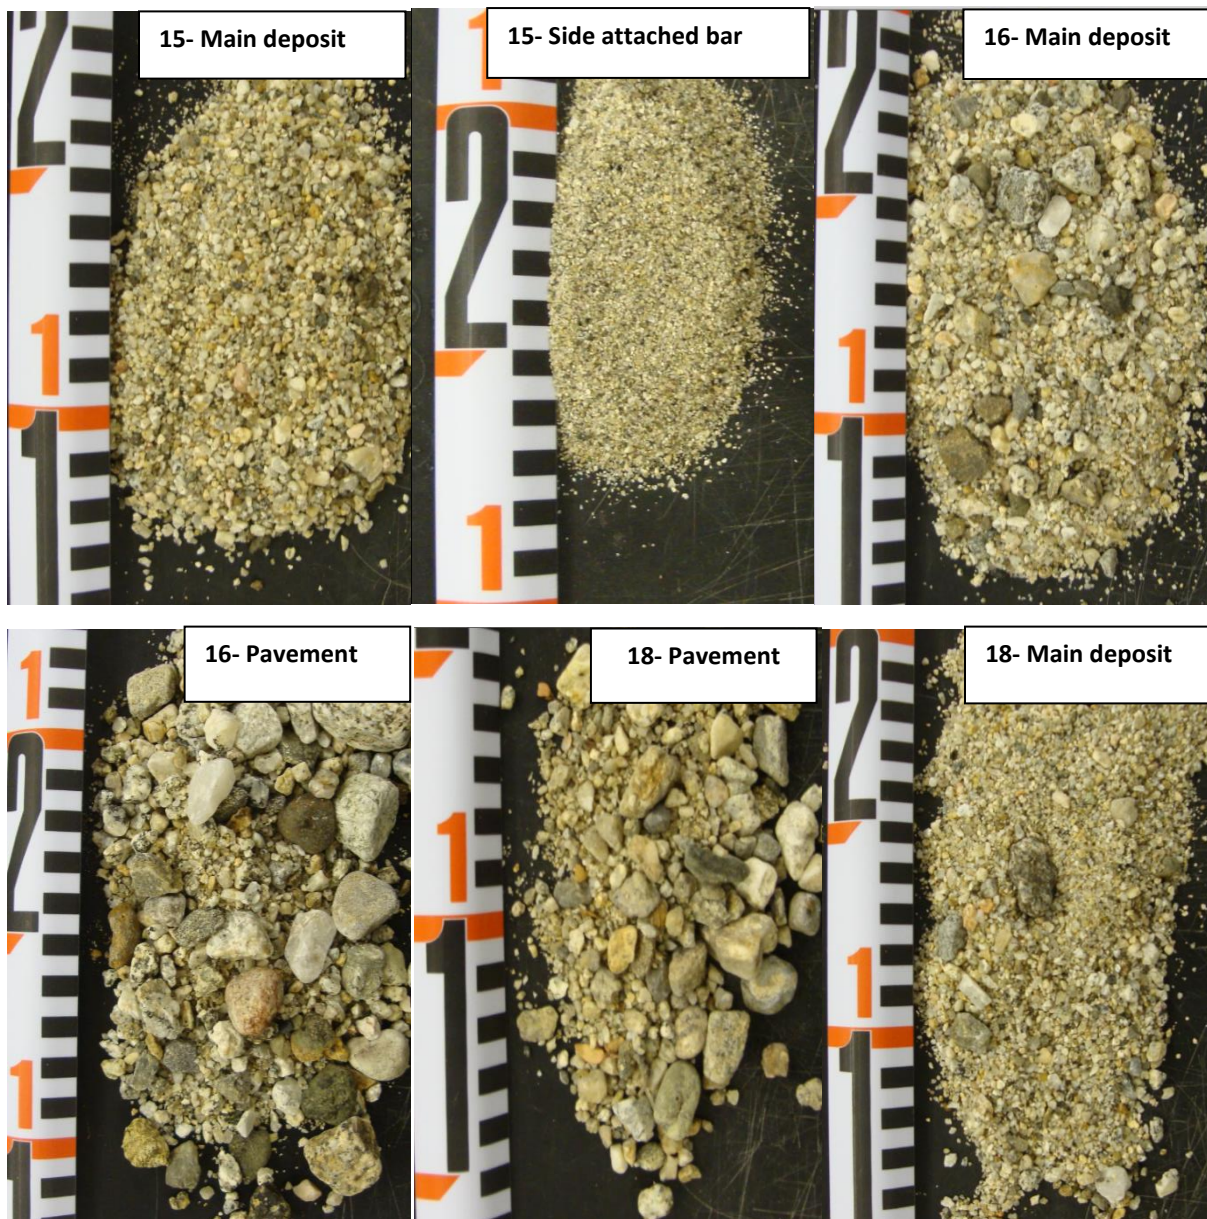
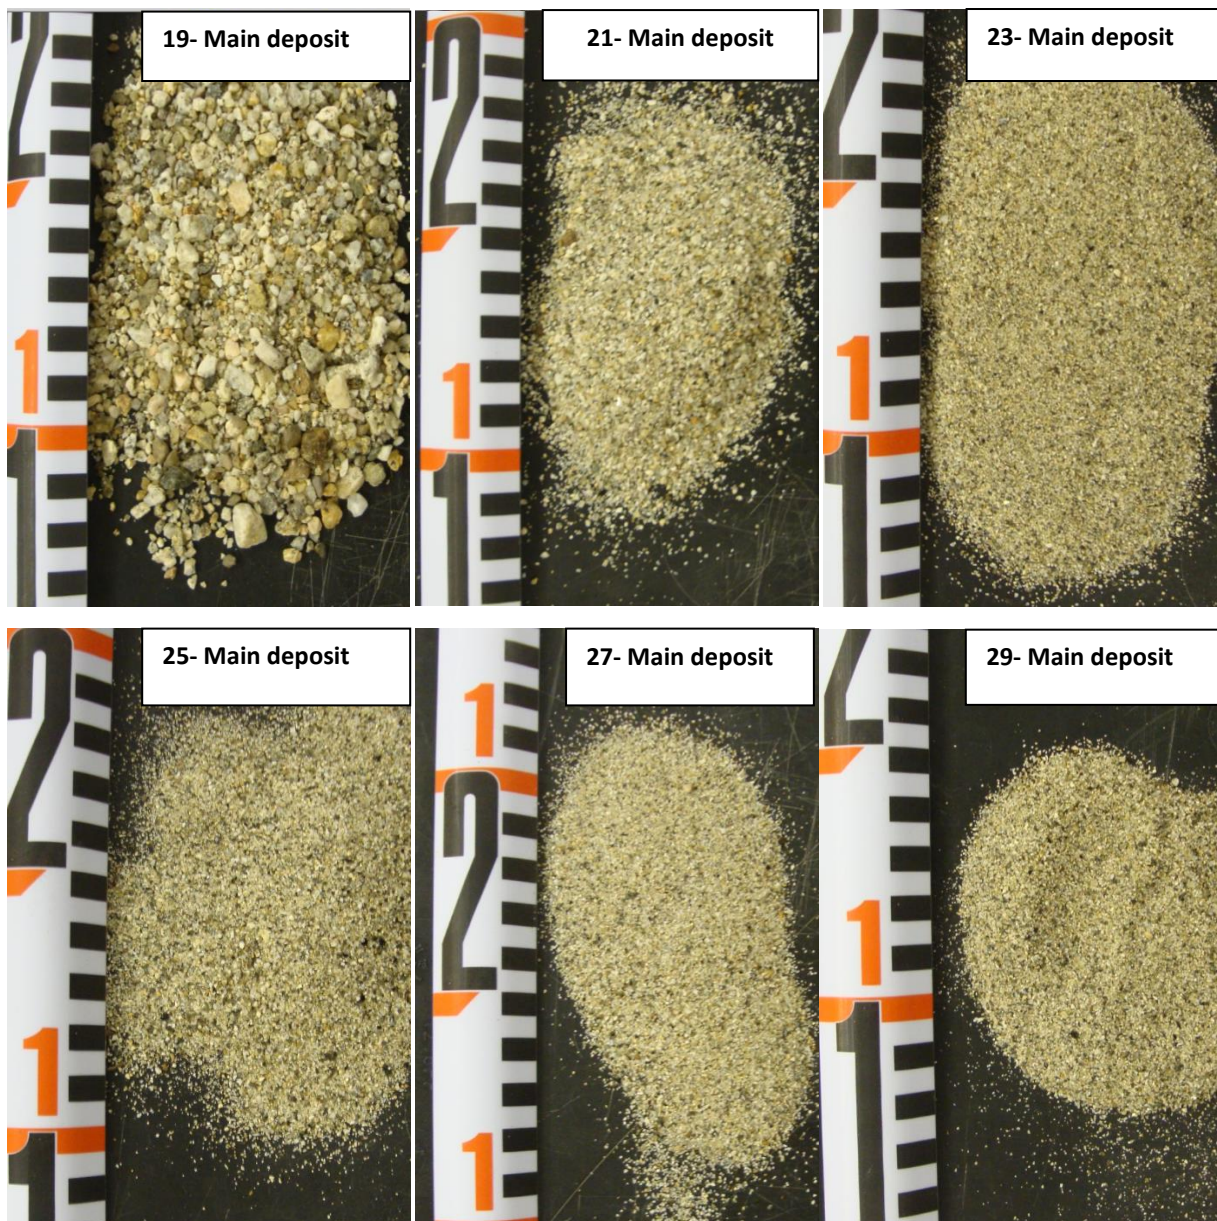
Images of sand, pavement, and general pool fill sediment samples. Labels represent the deposit identification number and the location of each sample within the deposit.
