Publication No. WI-2021-03

**The Watershed Institute**

## **Post-fire Debris Flows in the Carmel Watershed: Assessing USGS Predictions and Impacts on Steelhead Spawning Gravel**

CSUMB GEOL 460 Class:

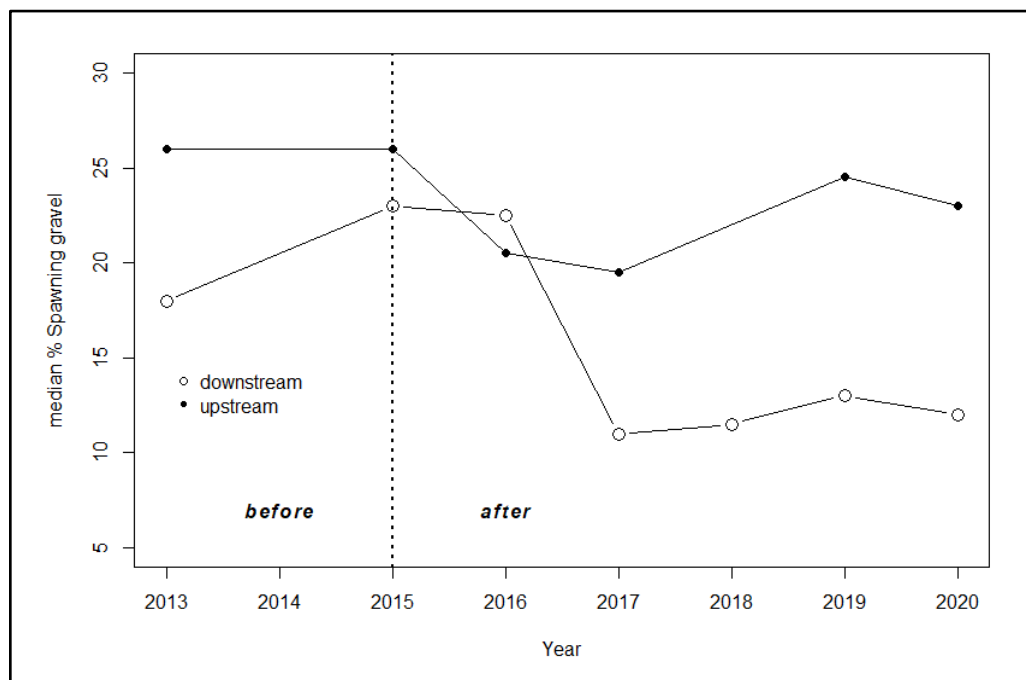
*Figure 2: Changes in percent spawning gravel upstream and downstream of the San Clemente Dam before and after its removal in 2015. The upstream data may be interpreted as the “control” in a Before-After-Control-Impact analysis*

Historically, wildfires and natural mass wasting events like debris flows have not been the sole factors influencing spawning gravel availability at our study site. The removal of the San Clemente Dam, the largest dam removal project in California, had a profound effect on spawning gravel abundance. Studies evaluating the effects of the dam removal on spawning gravel have determined that spawning gravel amounts in the Carmel River have significantly decreased since dam deconstruction in 2015 (Figure 2; Harrison et al. 2018, Chow et al. 2016, TetraTech 2016). This severe decrease in spawning gravel abundance may be attributed to the river reconstruction process, which roughly consisted of a river reroute, sediment trapping and reservoir isolation, weir and riffle pool construction, and plunge pool construction (TetraTech 2016; Smith et al. 2020).

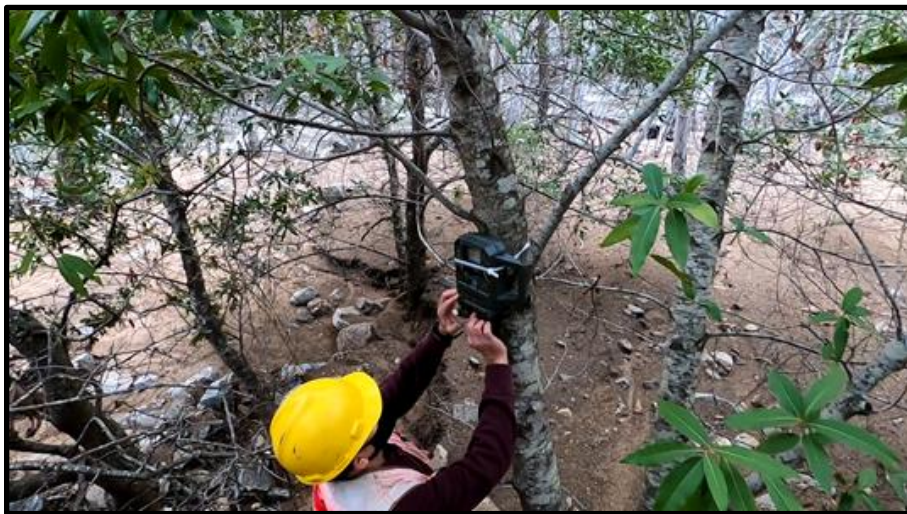
*Figure 3. Game camera set up to face basin mouth.*

Game cameras (Figure 3) were secured to trees at the mouths of basins HI and JK (Figure 4), and a 0.2 mm event-based tipping rain gage was installed prior to a forecasted January 27th, 2021 high intensity rain event. The game cameras were set to take photos in 15-minute intervals. Following the storm, time-stamped images were recovered from the game cameras, and precipitation data were retrieved from the Onset RG3-M rain gage. The rain gauge was located 732 m and 886 m, respectively from the two game cameras. Time stamps from game camera photos were cross-referenced with precipitation data to determine precipitation intensity at the time of the debris flows. Continuous 15-minute precipitation intensities were calculated from the rain gage record to determine the intensity required to trigger debris flows from the study site slopes.

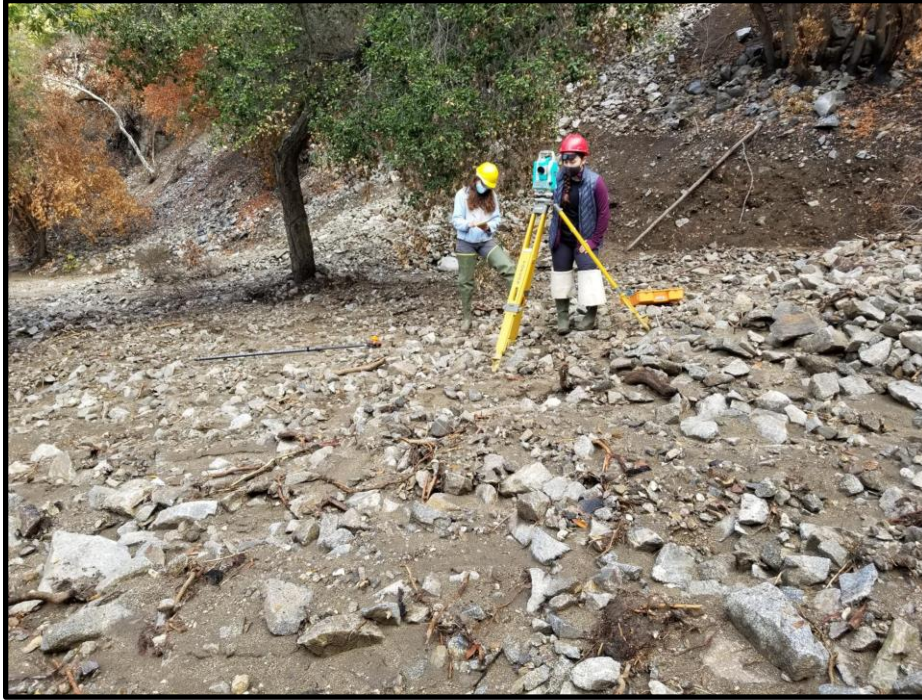
*Figure 5. Total station surveys of the basin deposits. Deposit shown are at the mouth of basin K.*

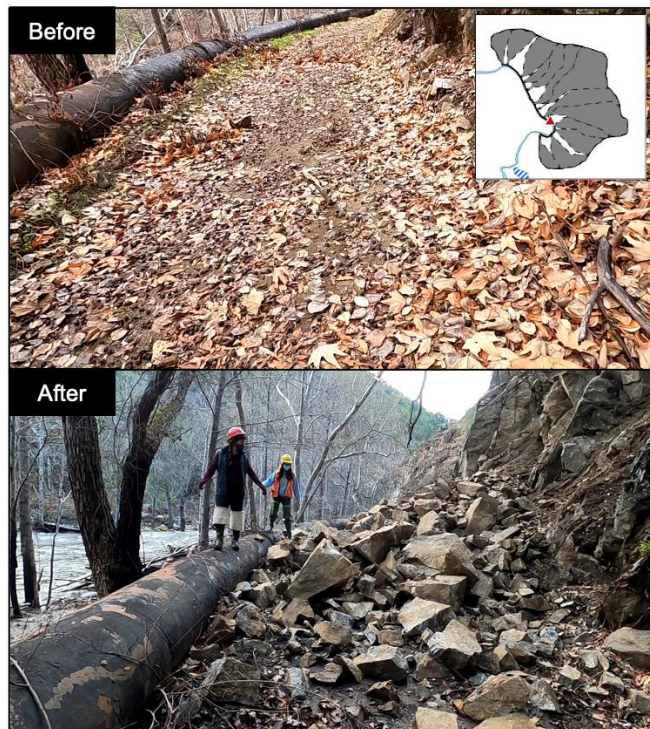
Figure 14. Rockfall 5 located between basins HI and J

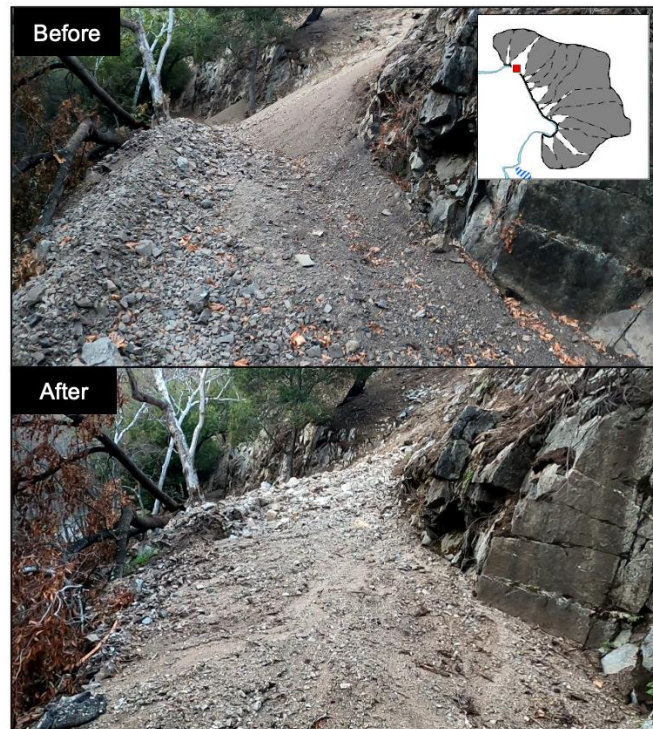
Figure 15. Unpredicted flow 2 located between basins B and C. Dry ravel was present before and after the rain event

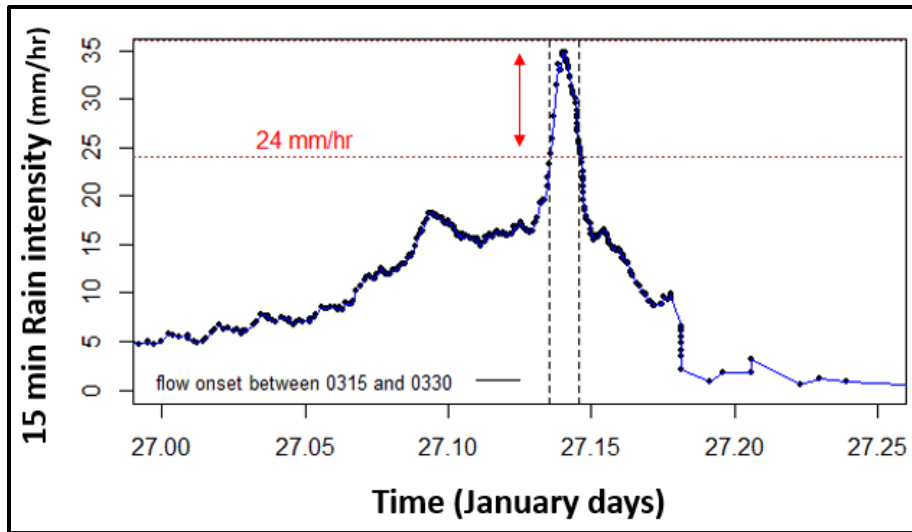
Figure 18. 15-min rainfall intensity during the debris flow triggering rain event (vertical dashed lines).

The timing of the rainfall intensity triggering the slope failures was constrained to have occurred between 0315 hr and 0330 hr on January 27 as observed using two game cameras that recorded the debris flow events simultaneously. During the 15-minute interval within which debris flows occurred, 15 minute duration rain intensities exceeding 24 mm/hr were observed, with a maximum 15 minute intensity of approximately 34 mm/hr (Figure 18).

Debris flow activity commenced once the 15-minute duration rainfall intensity exceeded 24 mm/hr (Figure 18). This value is precisely predicted by the USGS model. The exact triggering rainfall threshold could not be determined as the game cameras recorded photos only every 15 minutes. During the 15-minute interval that debris flows occurred, rain intensities exceeding 24 mm/hr were observed with a maximum intensity of approximately 34 mm/hr (Figure 18).

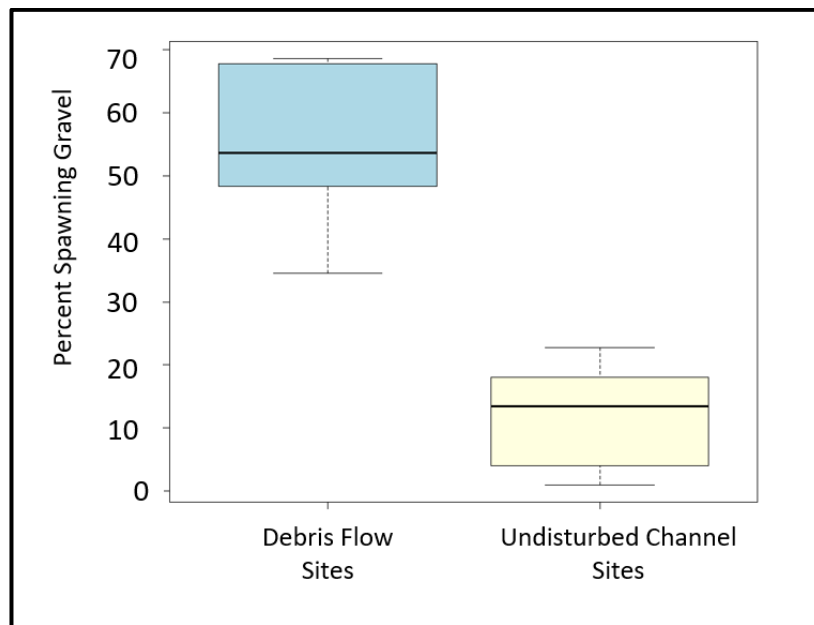
*Figure 19. Percent spawning gravel in debris flows compared to undisturbed Carmel channel sites.*

The median grain size of all deposits combined was approximately 53% (left box in Figure 19). Although many of the debris flows contributed spawning-sized gravel to the Carmel River, visual inspection of the river bed at each debris flow site showed that virtually no new spawning gravel was present. The condition of the river bed is represented by grain size counts taken 400 m upstream of the debris flow locations (right box in Figure 19). When comparing grain sizes in undisturbed channel sites to those in the debris flows, there is a statistically significant difference in percent spawning gravel. A Welch's t-test was used to compare the spawning gravel abundance in the undisturbed channel sites and the spawning gravel abundance in the sites that experienced debris flows, resulting in a p-value of 0.006. This comparison underscores the result that the

The post-fire debris flows observed at our study site were evaluated in order to determine if they delivered spawning gravel consistent with sizes required by Steelhead trout. Gravel counts conducted on the debris flow deposits and statistical analysis of this field survey data support the conclusion that the studied flows contained moderate to high concentrations of potential spawning gravel (Figure 19). The cumulative D50, 50 mm, falls within the general range of spawning gravel

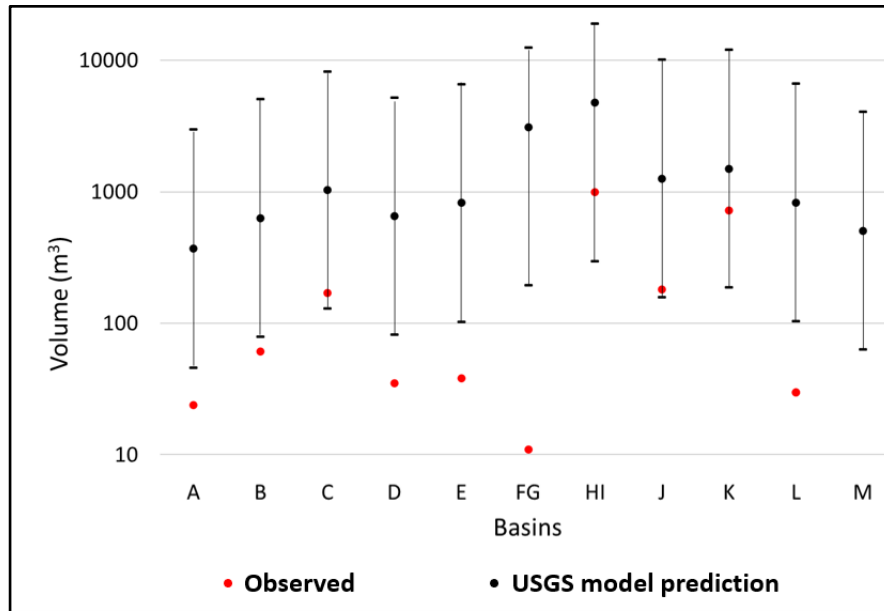
Figure 20. Chart comparing observed debris flows and volumes in basins with USGS predicted events. The black dots and whiskers indicate the averages and the 95% confidence intervals for the USGS model volume predictions. The red dots indicate observed volumes. Basin M produced no debris flows.

The USGS model correctly predicted debris flow events for all basins but one (basin M; Figure 20). Basins A-L all experienced debris flow events as predicted by the model. Rock falls were observed from basins with areas that were smaller than the 0.2 km<sup>2</sup> minimum threshold used in the USGS predictive model. Due to the USGS model's minimum basin size requirement, the model did not account for a total of five rockfalls and two debris flows in the study site.

Upon analyzing the USGS predictions and the field measured volume deposits, we found the deposits to be less than what was projected by the USGS (Figure 20). This may be partially explained by sediment transport during high river flows that followed the precipitation event. Of the ten debris flows predicted by the USGS model, eight of them (A-K) terminated in the Carmel river while one (basin L) terminated on the road adjacent to the river. Steep angular facets were observed at debris flow snouts that reached the river. This indicated that a portion of the debris flow materials had been eroded during the high flow events in the Carmel River. This partial debris flow erosion may account for the differences between USGS model predictions and the observed basin volumes.

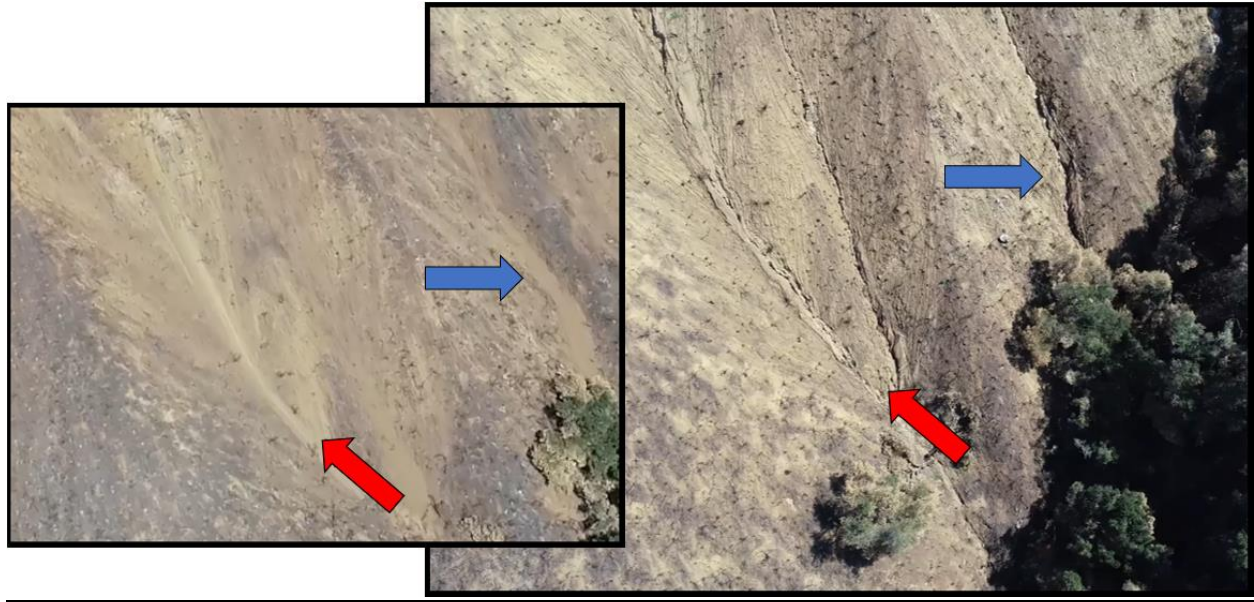
*Figure 21. Red arrow indicates a portion of the bassin H channel. Blue arrow indicates a portion of the bassin I channel. Before (left) shows the pre-debris flow channels full of colluvium. Post-debris flow after channels eroded to bedrock (right).*

Prior to the rain event, the basin channels were full of colluvium (Right box of Figure 21). After the high-intensity rain event, many channels had eroded to the granodiorite bedrock (Left box of Figure 21).

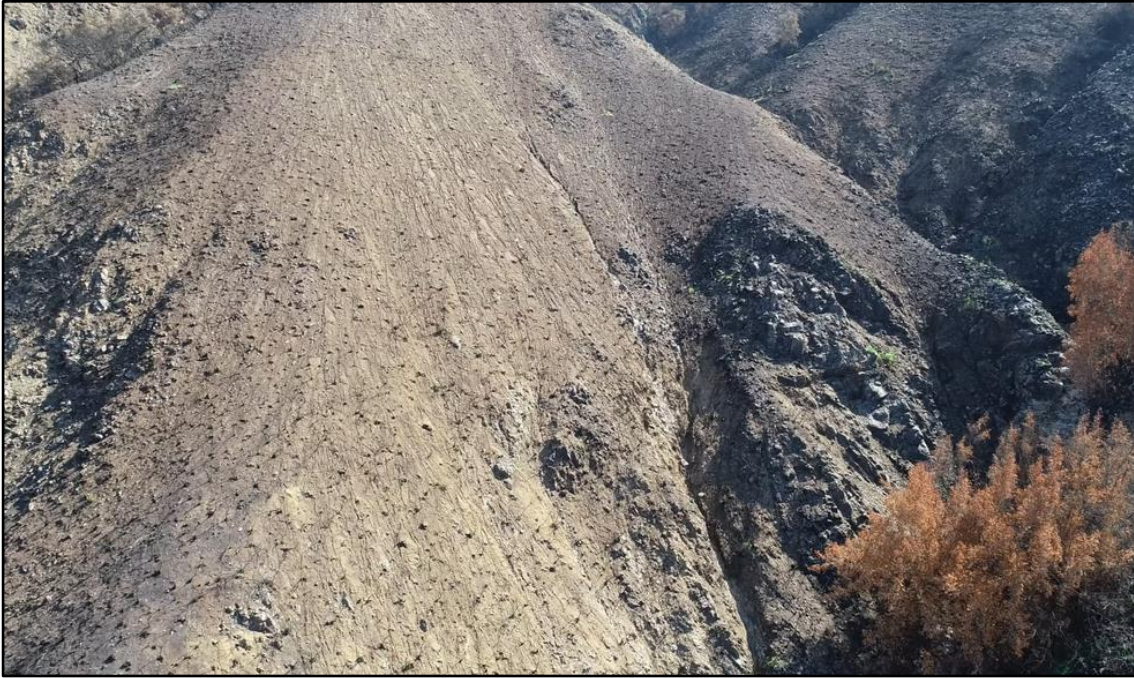
*Figure 22. Rilling and Gullying was observed in the majority of basins.*

Rilling and gullying were observed over the majority of the study area (Figures 22 and 23). This process is consistent with runoff-dominated sediment erosion rather than soil-slip slope failure. This type of erosion is known to originate from a lack of soil infiltration due to intense burns (Cannon et al. 2000). No scarring was observed that would indicate infiltrated soil-slip type debris flows.

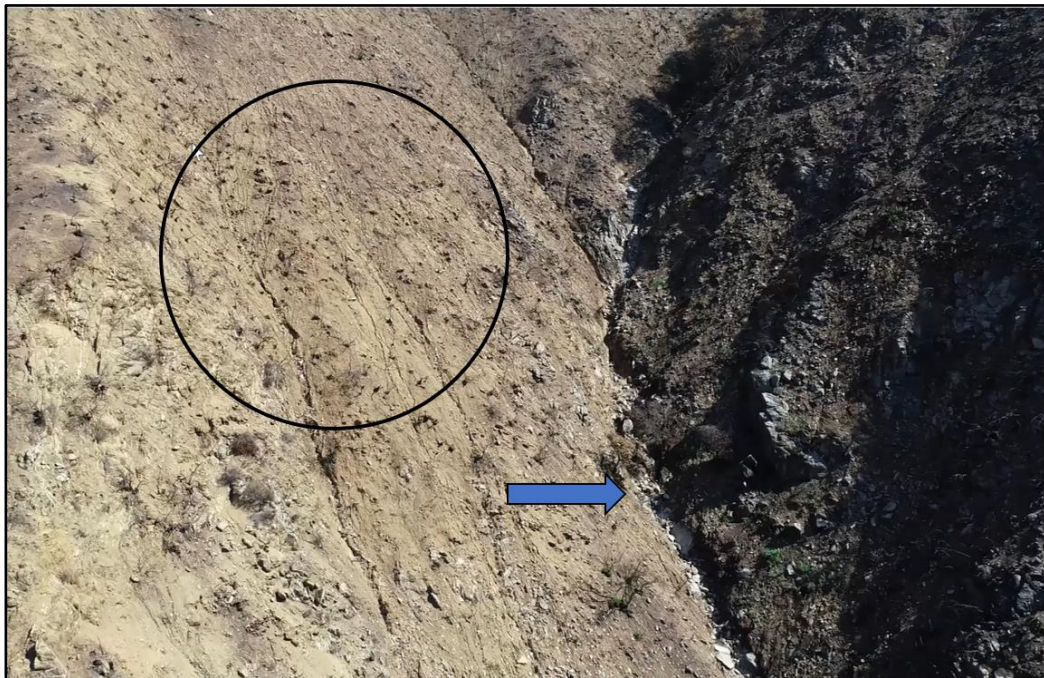
*Figure 23. Circle indicates Rilling and Gullying. The arrow shows a channel from basin I eroded to bedrock.*
