Publication No. WI-2012-04

The Watershed Institute

Partitioning Sediment Sources at the Hollister Hills State Vehicular Recreation Area

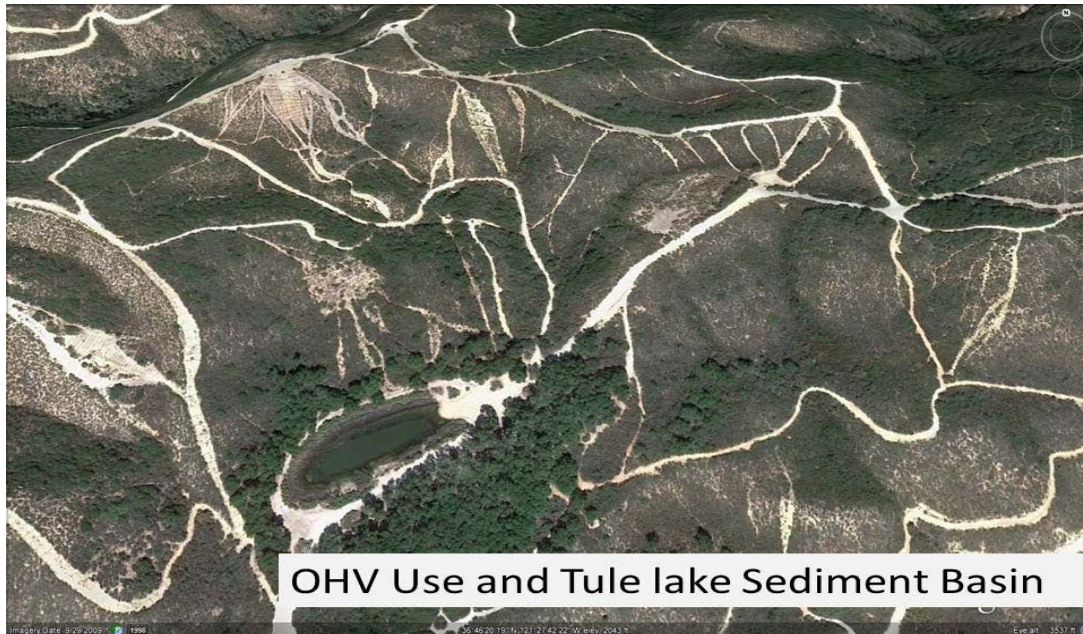
Figure 2. Sediment retention basin catches sediment generated from natural background sources and OHV roads.

We address the erosion impact of OHV use by analyzing the relationship between the total length of OHV trails in a watershed and the amount of sediment removed from sediment basins at the mouths of the watersheds. Specifically we attempted to quantify exactly how much of the trapped sediment produced in Hollister Hills is due strictly to OHV use. Figure 2 shows an example of a sediment basin catching sediment eroded from the watershed that drains into it.

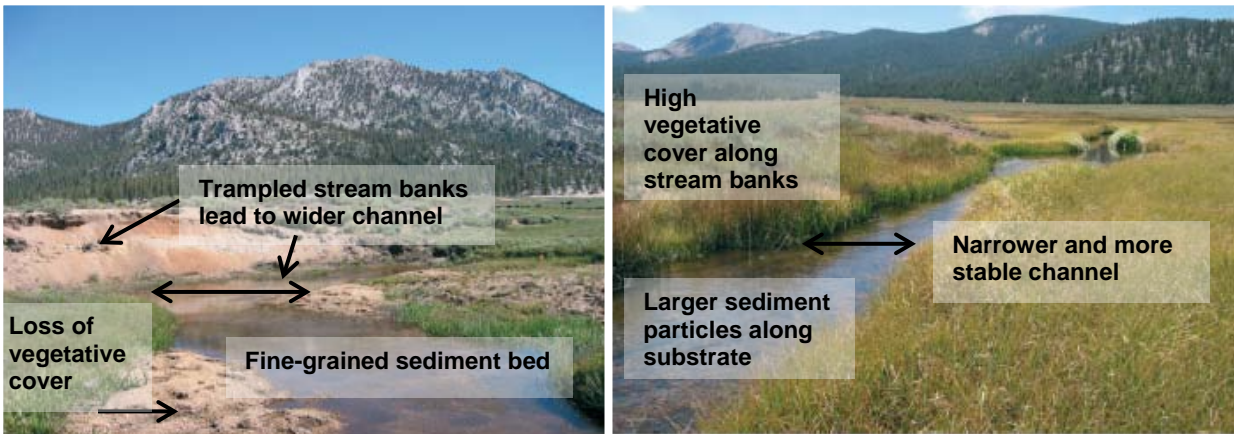
Figure 3. Cattle grazing impacts (left) along a stream in the Sierra Nevada include decreases in vegetative cover, increased erosion and fine-grained sediment input, and channel widening. The ungrazed portion of the stream (right) maintains riparian vegetative cover, narrower channels, and therefore greater channel stability (Herbst et al. 2012).

Numerous studies have shown that cattle grazing near riparian zones can lead to myriad problems (Figure 3; McDowell and Magillian 1997). Grazing of riparian zones can remove up to 80% of the vegetation which can reduce stream bank resistance to erosion (Trimble and Mendel 1995). Trampling alongside and across streams flattens and erodes stream banks which leads to broader stream channel widths (McDowell and Magillian 1997). Stream banks impacted by cattle are quickly eroded and contribute higher inputs of excess sediment through natural stream process (Trimble and Mendel 1995). Furthermore, cattle trampling will directly loosen and dump sediment into streams (Bengetyfield). Sediment yields generated from cattle grazing consists of higher suspended, fine-grained sediment that can make the water muddy (Herbst et al. 2012). The EPA recognized long ago that a major outcome of cattle activity near streams is the input of excess suspended sediment which is classified as a water pollutant (Meehan and Platts 1978). Watersheds with cattle grazing can experience higher suspended sediment yields. For instance, cattle grazing within a watershed in Colorado, US experienced 30% higher sediment yields than a nearby watershed without cattle (Trimble and Mendel 1995). In a tributary in Montana, sediment yields increased from 3 tons/day to 15 tons/day during the grazing period (Bengetyfield). Riparian cattle grazing in the Bird Creek watershed is a potential source of excess in-stream sediment (Figure 4).

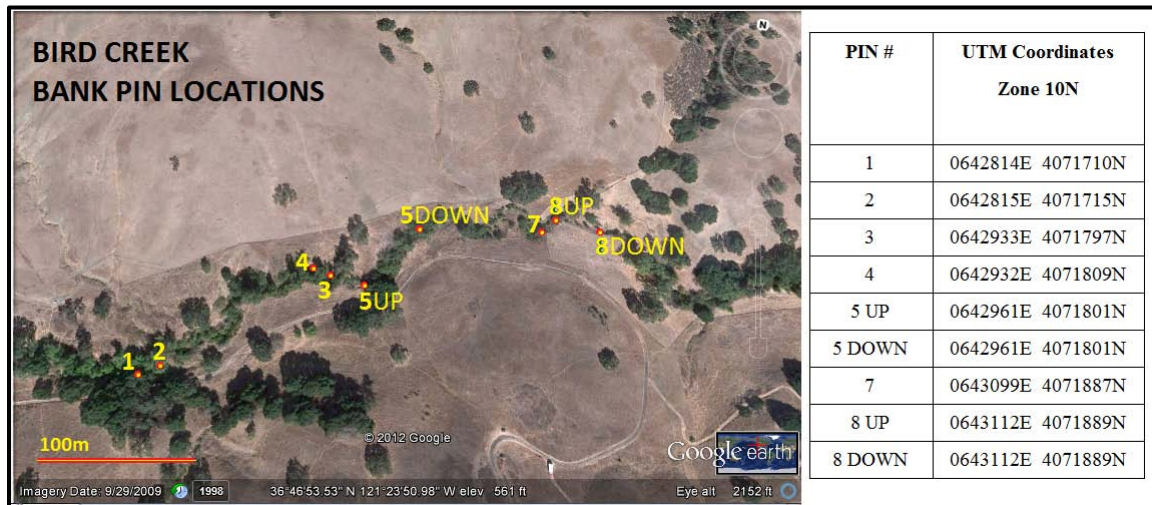
Figure 10. Bird Creek bank pin UTM locations plotted in Google Earth. Image courtesy of Google Earth.

Bird Creek bank pins were installed at 8 locations along Lower Bird Creek in March 2011. Pin sets 5 and 8 have upstream and downstream sets (Figure 10). Each bank pin set consists of 2 to 3 rebar stakes inserted into the channel bank as illustrated in Figure 11. Pin exposure along Bird Creek has been recorded for spring 2011, fall 2011 and spring 2012. Measurements of pin exposure were taken in millimeters. Total mass of stream bank erosion was calculated using the average pin exposure, stream length measured using Google Earth, and the average bank height was calculated from bank measurements taken during the spring 2011 recording.

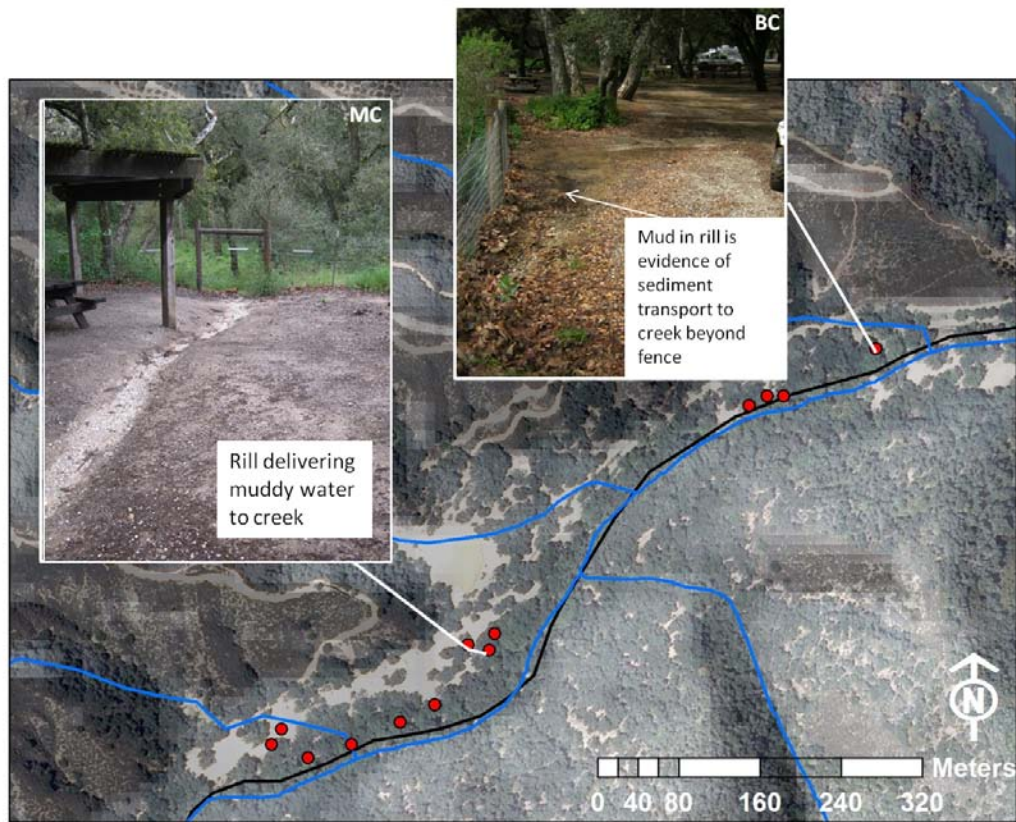
Figure 15. Rill channel pathways at Madrone Camp (MC) & Bee Camp (BC)

Following the overview, an examination of each individual site revealed distinct rills that lead across each campground directly into Bird Creek. In particular, the Madrone and Bee campgrounds featured frequently disturbed landscapes with rolling terrain, heavy vehicular traffic, and deeply incised channels, which appear to be significant sediment contributors connected to the watershed (Figure 15).

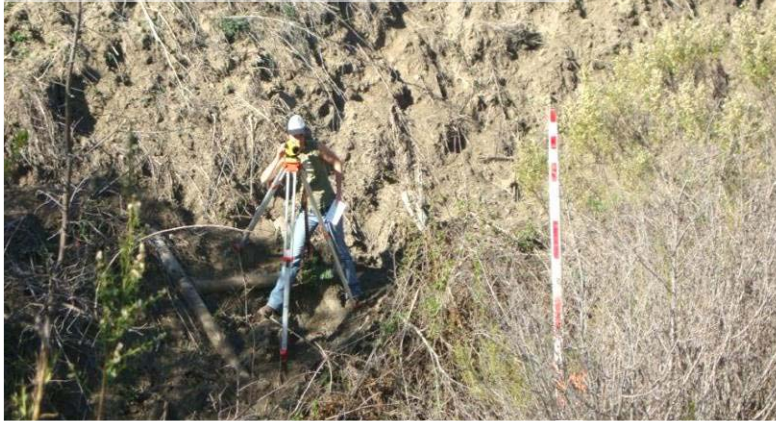
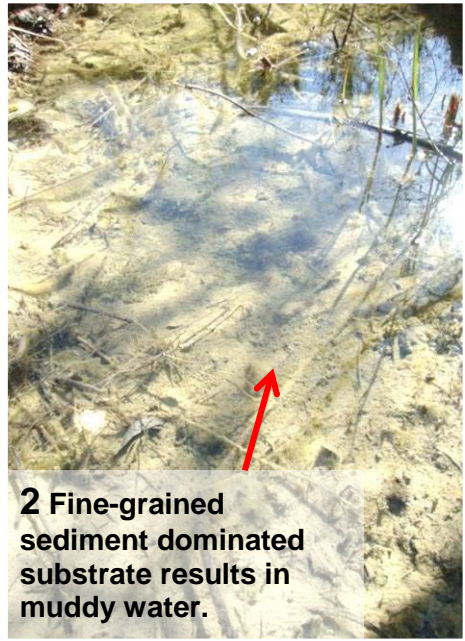
1 Cattle movement around stream banks erode sediment, leading to the upland retreat of banks. This will eventually lead to a wider stream channel cross section.

Photo #	Position	Comments
Photo 1	Left Bank (C)	Dressed back banks with extensive hoof shear
Photo 2	Channel (C – D)	Excessive siltation, likely cattle-caused
Photo 3	Channel (G)	Trampled and denuded banks
Photo 4	Channel (H)	Sheared banks and mud filled channel

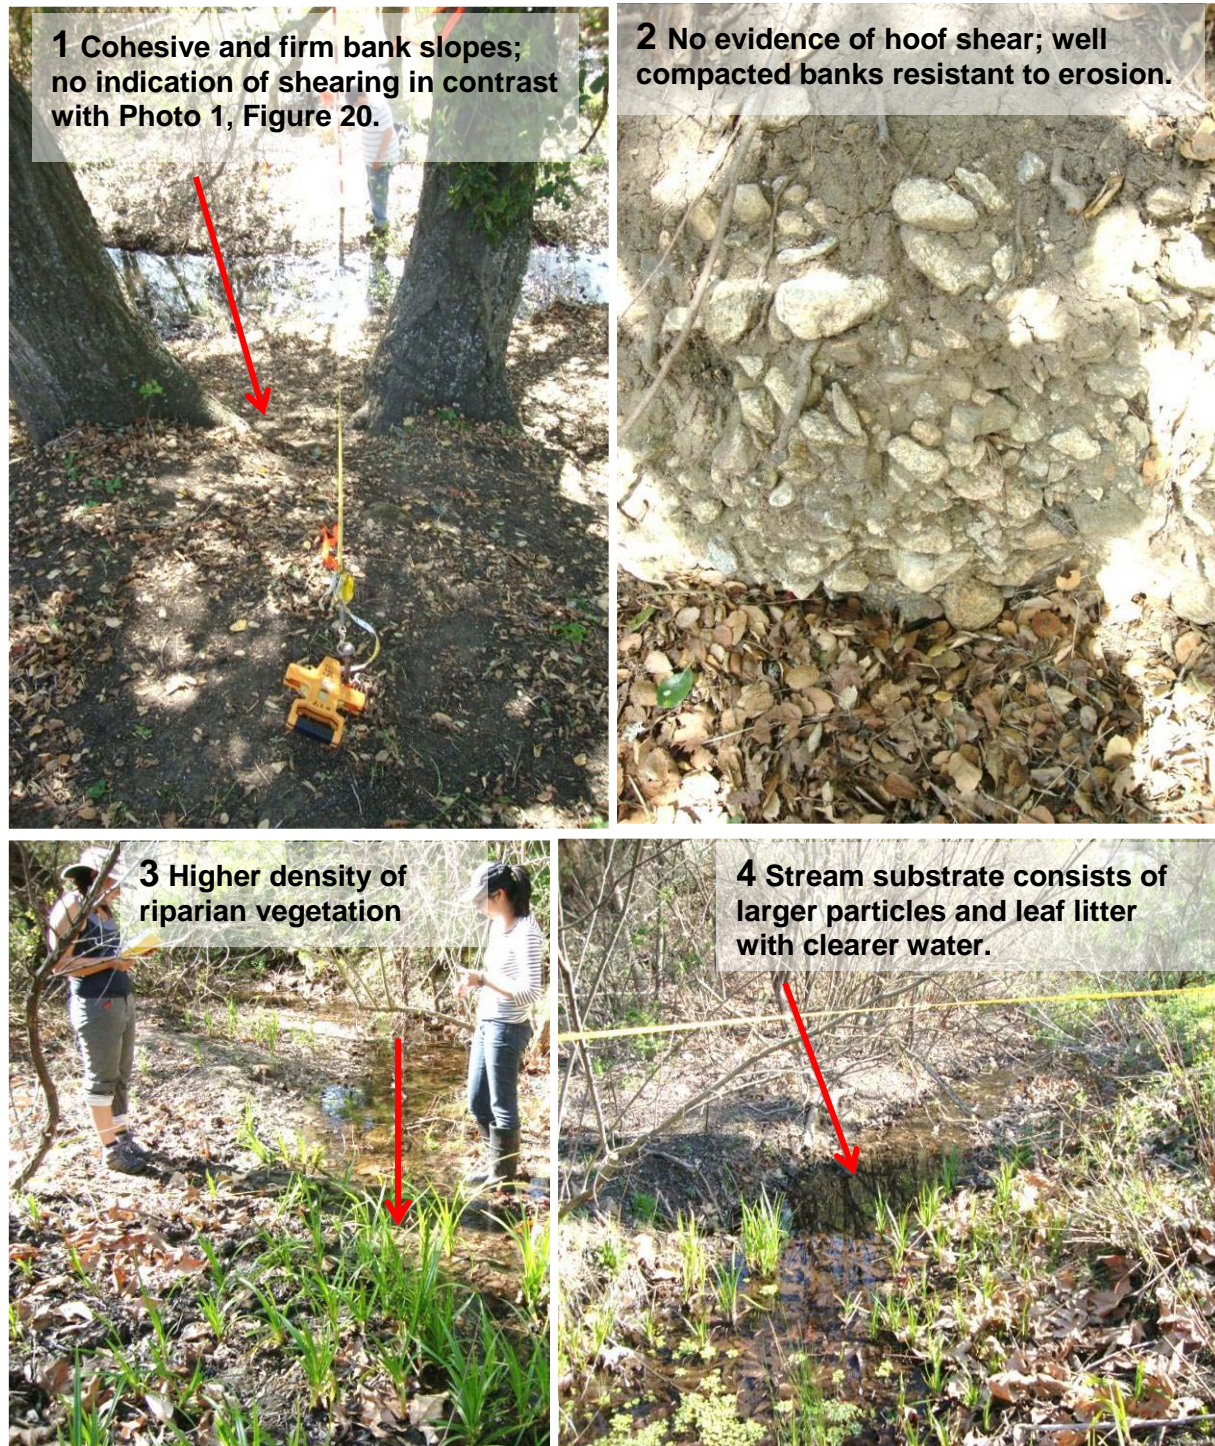
Figure 22. Refer to Table 4 for further photo comments.

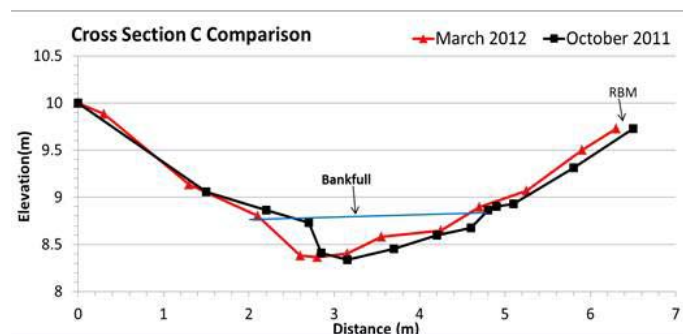
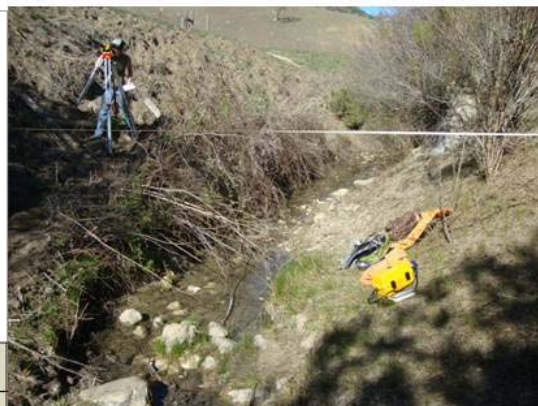
Bankfull Geometry						
Survey	Width (m)	Dbkf (m)	WP (m)	Wfp (m)	E.R.	Area (m ²)
October 2011	2	0.2	2.3	8.8	4.4	0.5
March 2012	2.7	0.2	2.9	8.8	3.2	0.6

Figure Above Right: Bird Creek Cross Section C during March 2012 survey. This picture was taken looking downstream

Figure 24. March 2012 survey shows degradation on the left bank and aggradation on the right bank. The right bench-marks of these surveys do not line up signifying horizontal error between surveys.

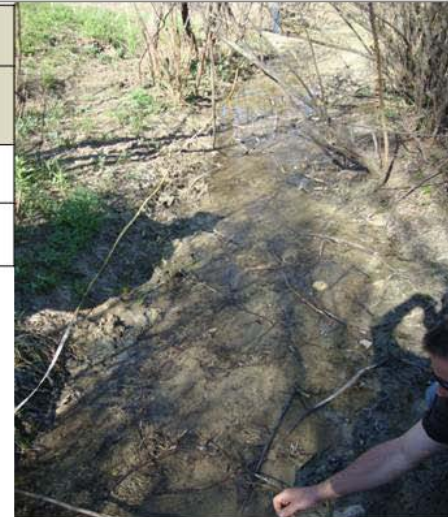
Bird Creek Cross Section E

Bankfull Geometry						
survey	Width (m)	Dbkf (m)	WP (m)	Wfp (m)	E.R.	Area (m ²)
October 2011	2.8	0.3	3.1	12.3	5	0.9
January 2012	2.8	0.4	2.5	14	5.6	0.9

Figure Right: Bird Creek cross section E during March 2012 Survey. Note access to floodplain.

Figure 26. The right benchmarks of both surveys line up precisely suggesting that between survey error is minimal. Aggradation of the left bank and an eroded and shifted right bank can be seen. The entrenchment ratios are high above 2.2. As the graph and photo above show, this section of Bird Creek has an accessible floodplain.

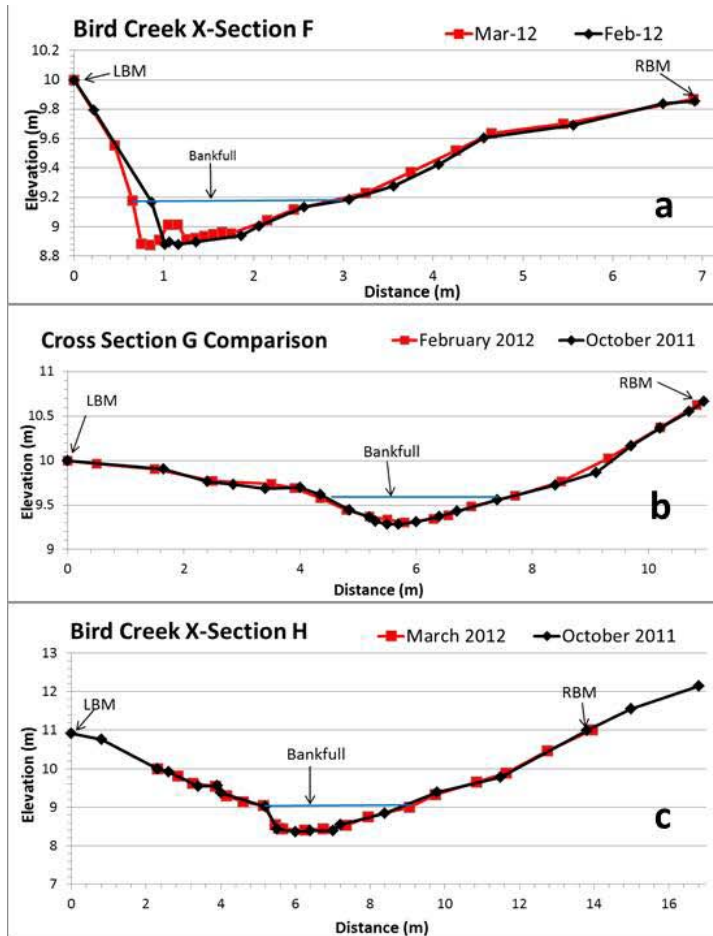
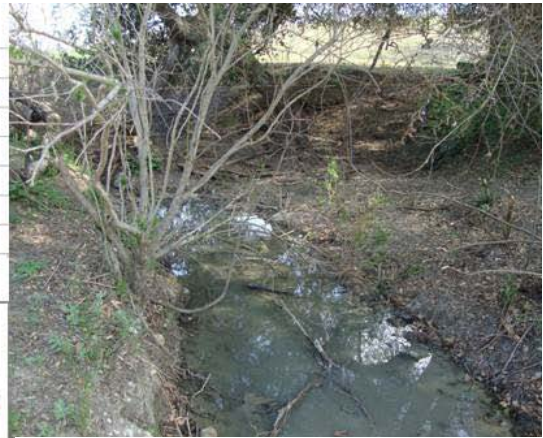
Figure Above: Cross section H in March 2012.

Figure 27. Lower Bird Creek Cross sections that had minimal change or survey error. The degradation seen in cross section F is possible error because the compared time periods are February and March of the same year (2012). Cross sections H and G had well aligned right benchmarks and do not show large changes between surveys.

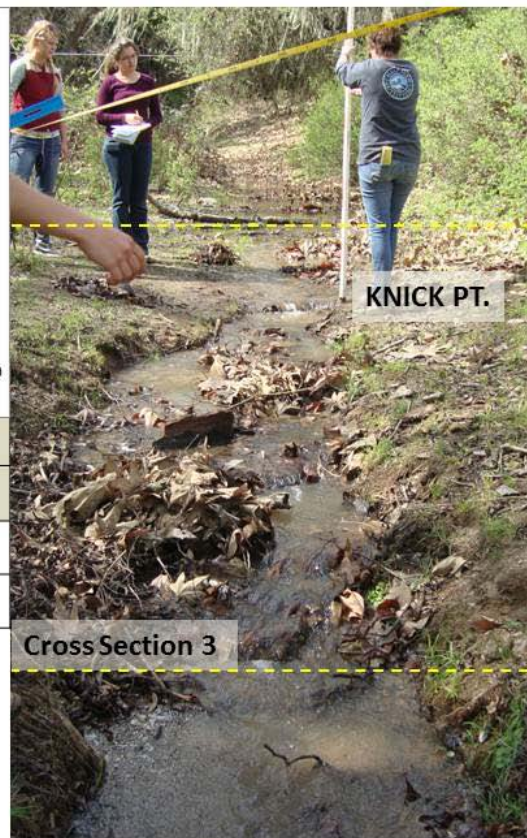
Walnut Cross Section 3

Figure Above: Cross section comparison between the February 2012 and August 2011 surveys.

Figure Right: March 2012 view looking upstream at cross sections 3, and Knick Point.

Figure 31. In Walnut creek cross section 3 there was some vertical error. Overall there was no significant change from August 2011 to February 2012.

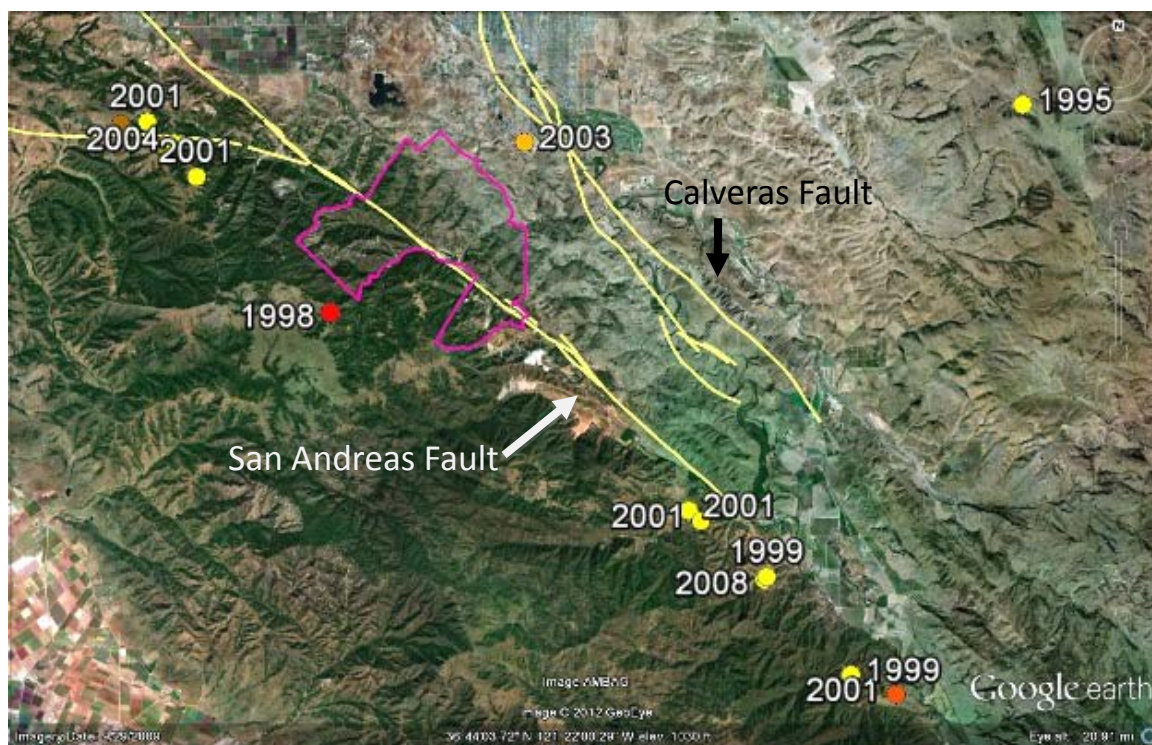
Figure 33. Earthquakes within 20 km of Hollister Hills SVRA between 1992 and 2012 with a magnitude of 4.0 or greater.

In the past 20 years there were 15 earthquakes with a magnitude of ≥ 4.0 within 20km of the Colluvial Creek landslide system (Figure 33), and there were five 10-year 24-hour rainfall events. Major earthquake(s) and storm(s) co-occurred in 1995, 1998, and 2001 (Table 6). The magnitude 5.0 earthquake located closest to the park (~3km away) occurred in the same year as the 1998 El Niño event. Other years that contained potential landslide triggering conditions were 1995, when there was one ten-year rain event and three earthquakes, and 2001 when there were three ten-year rain events and six earthquakes.

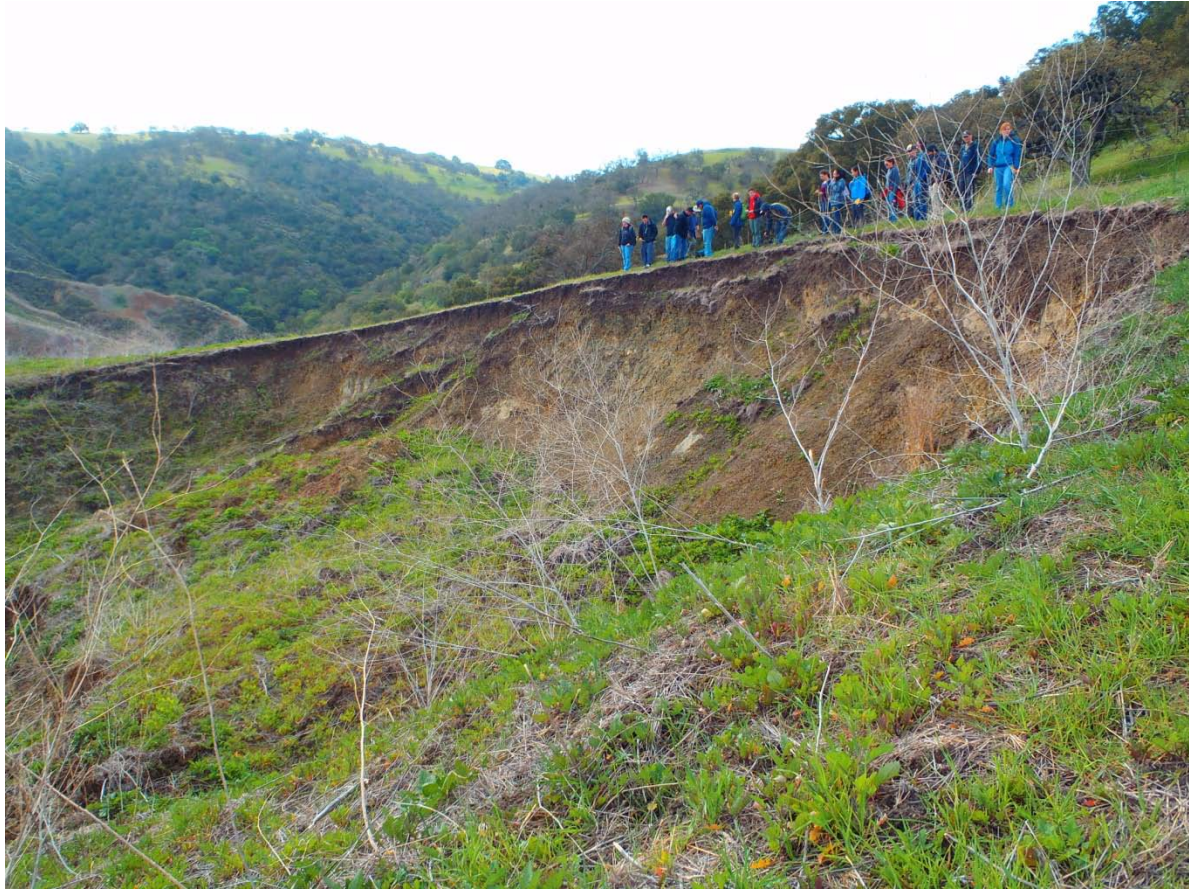
Figure 35. Photo of the landslide located near the Colluvial Creek watershed divide, but outside the Colluvial Creek watershed. Photo date March 12, 2012.

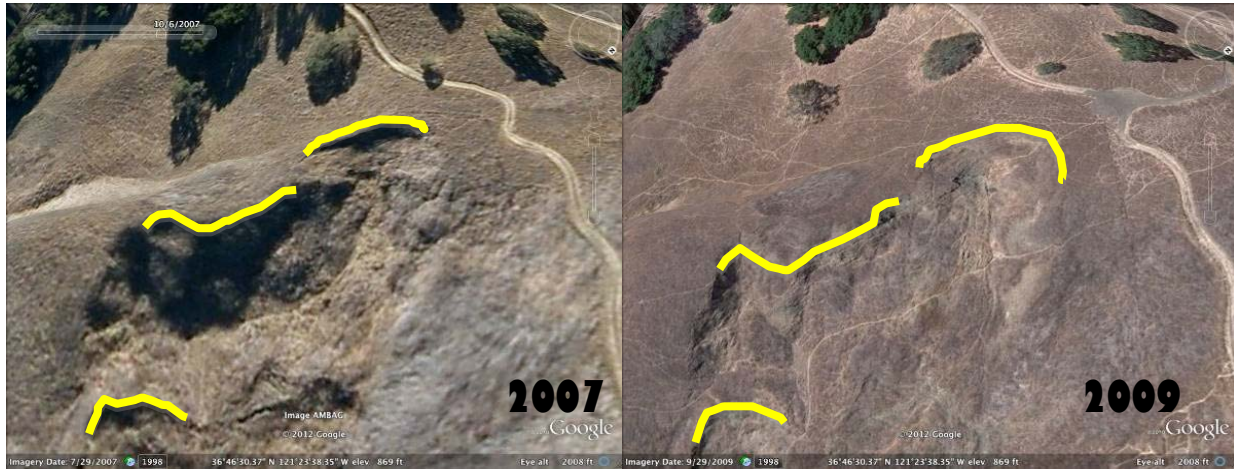
Figure 36. Historical Google Earth imagery of the landslide seen in Figure 35.
