Publication No. WI-2018-07  
30 August 2018  
Revised  
02 April 2019

**The Watershed Institute**

**Carmel River Reroute and  
Dam Removal Fish Passage  
Assessment (Summer2018)**

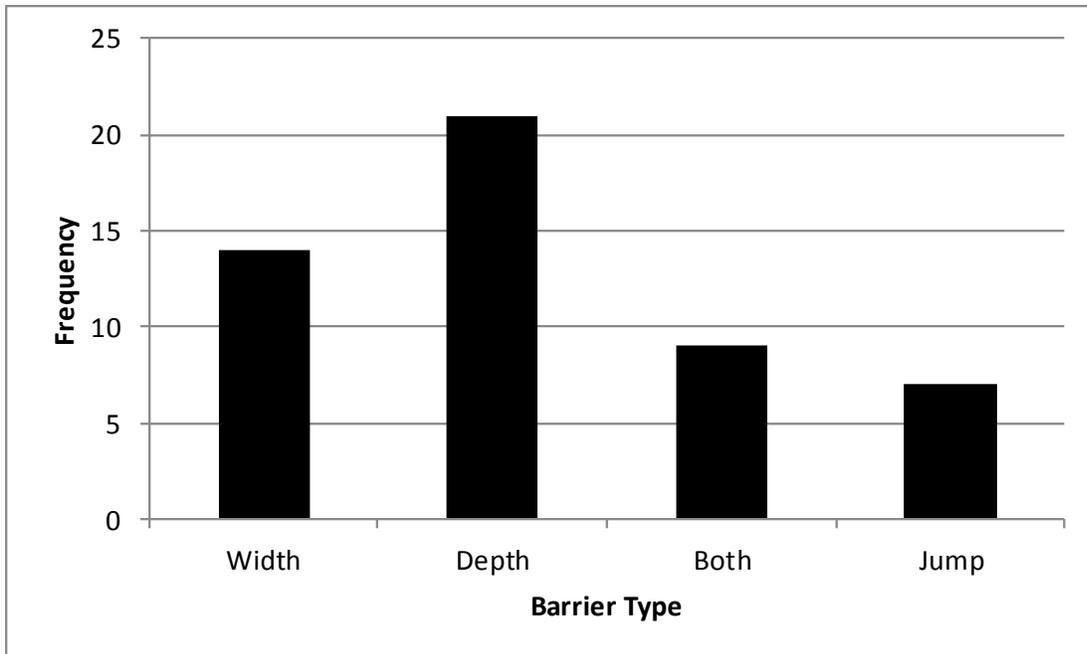
Fifty-one areas failed to meet the passage design criteria at 17 cfs (Fig. 4). While most sites failed only one of the design criteria elements, eleven sites were complex impediments involving up to 28 m of either continuous or very closely spaced problem spots. Shallow depth (whether or not associated with a jump) was the most common problem observed on July 10 at 17 cfs (Fig. 5).

Figure 5. Frequency of type of passage impediment within the CRRDR:

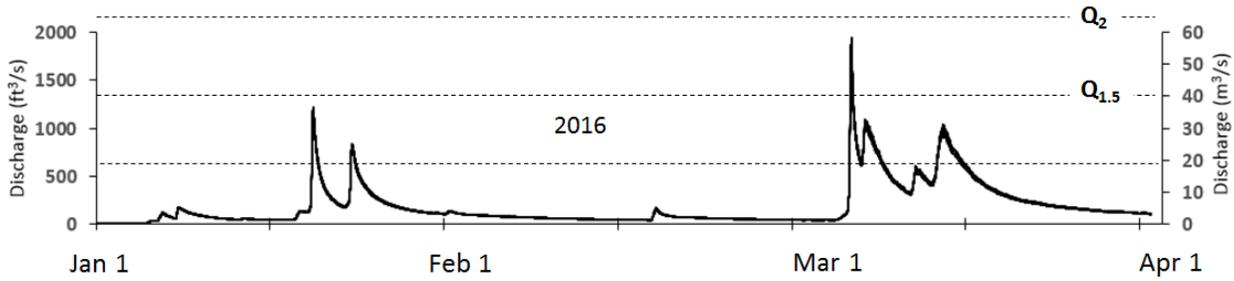
While the CRRDR channel was originally designed to provide adult steelhead and rainbow trout passage at low flow conditions, future studies could instead focus on passage conditions at higher flows, more typical of those encountered by steelhead during the spawning season. Steelhead are winter-run spawners that gain access to the river once the lagoon is breached by high flows or machinery. The water year 2016 hydrograph for Sleepy Hollow provides guidance on typical winter flows (Fig. 25). Water year 2016 had somewhat typical conditions with a few frontal storms providing winter flow and no exceptionally high peaks. The average base flow in 2016 at the Sleepy Hollow gage following the second of the January peaks but before the onset of the first March peak

Figure 25. Sleepy Hollow hydrograph from 2016 water year.

was 59 cfs. We recommend that the year two fish passage assessment be conducted at a flow near 60 cfs. The Carmel River is safely wadable at 60 cfs, so the survey could be conducted at that flow.

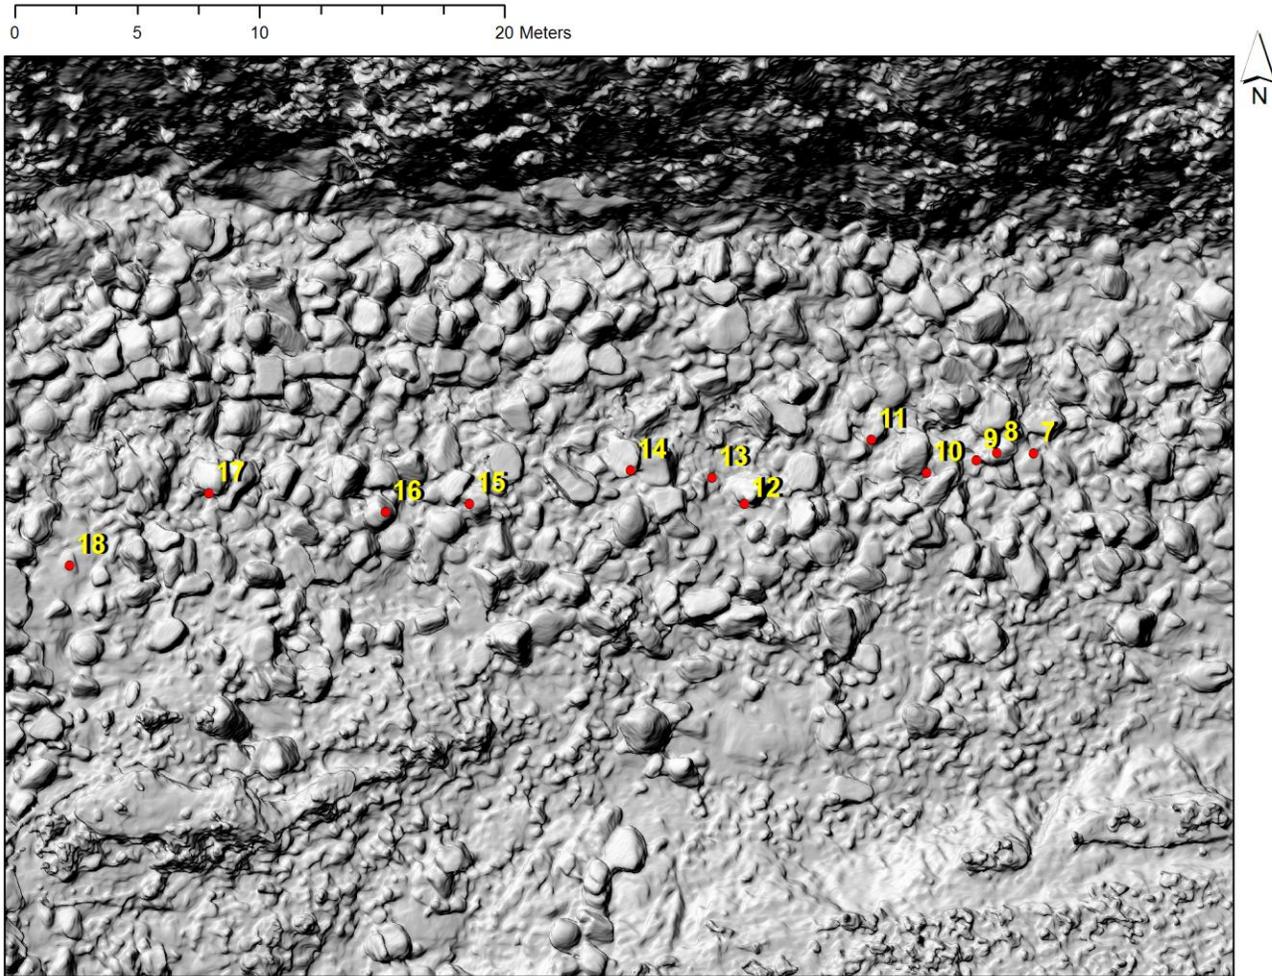
The following descriptions and figures reference the lettered reaches (A–E) of Figure 4. Reach A is characterized by many narrow passages and small jumps (Figs. 3, 6 and 7). The passages are typically less than 3 ft wide, and the jumps typically have shallow launching pools or shallow landing pools (Fig. 8). Appendix B–1 through B–4 show digital models and digital surveys in Reach A.

B-1: Hillshade reveals physical complexity typical of the Reach A boulder field. DSM from 8 mm pixel SfM photogrammetry.

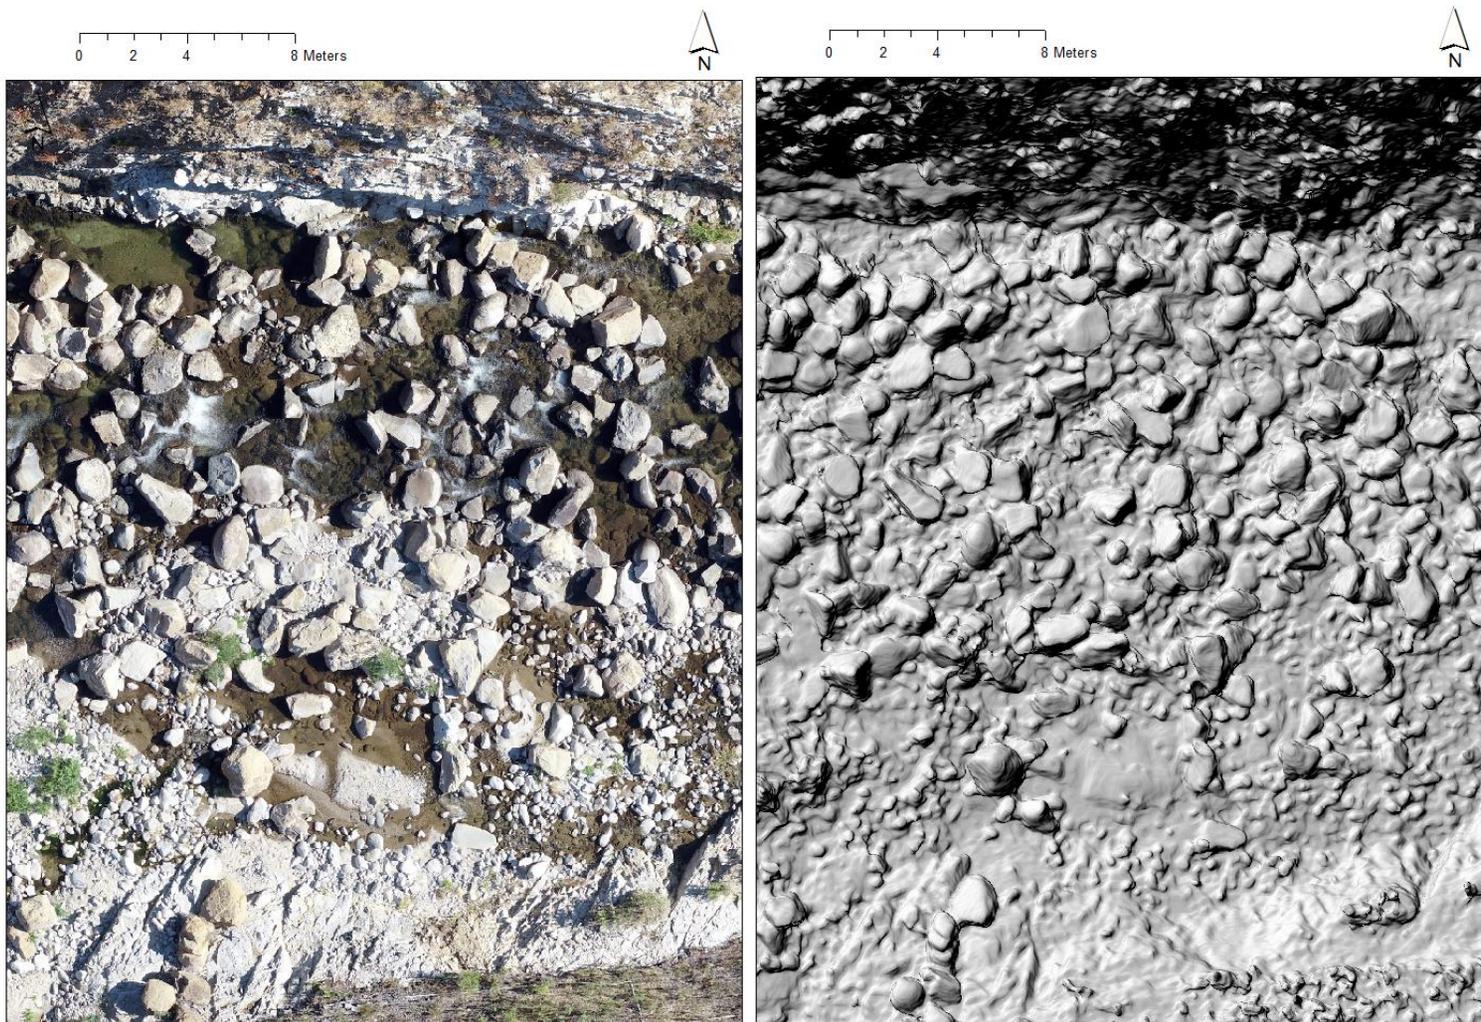
B-2. Left: Orthophoto of portion of Reach A. Right: Hillshade of same location showing the typical physical complexity of the project area. Flow is 15 cfs on 7/15/18
