# First Year Assessment of the Carmel River Reroute and Dam Removal Project

CSUMB Class: GEOL 460 Spring 2016

28 May 2016

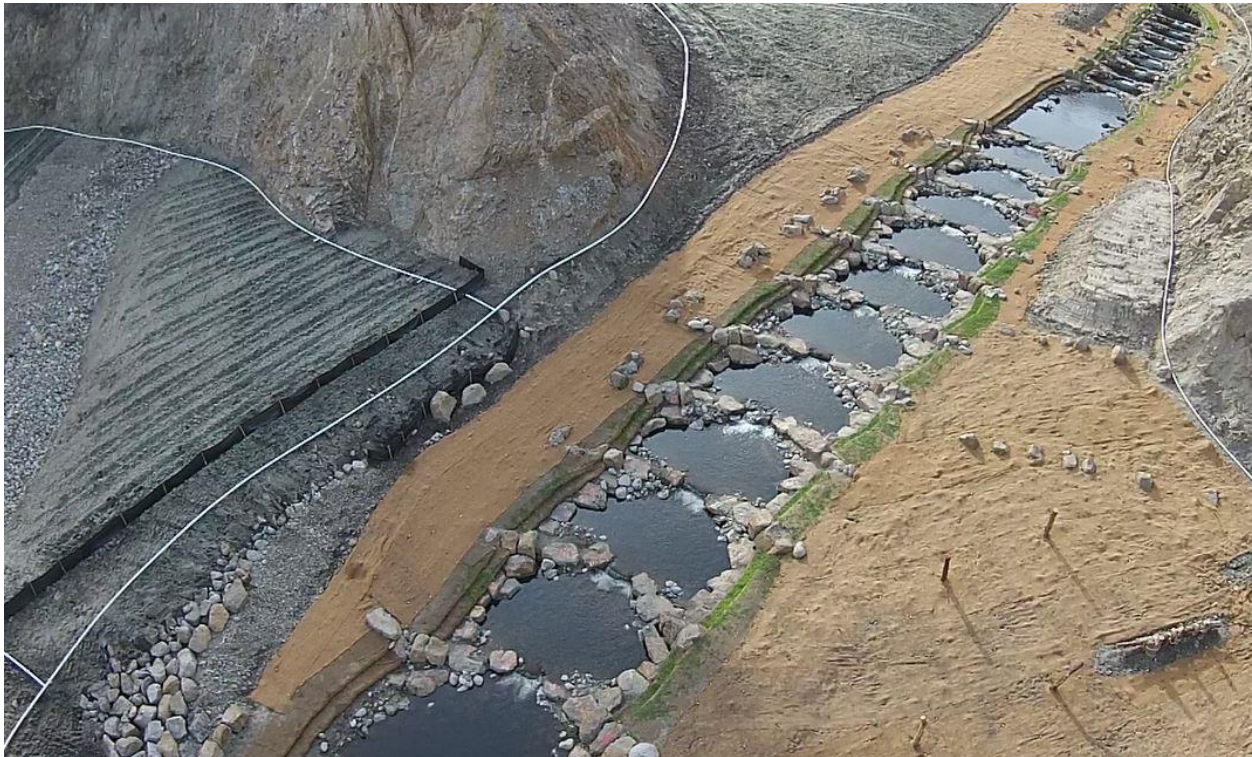
**Figure 5. Representative photo of constructed step-pools in the combined flow reach. Oblique aerial upstream view. Step pool sections A and B are shown, separated by pool 2.**

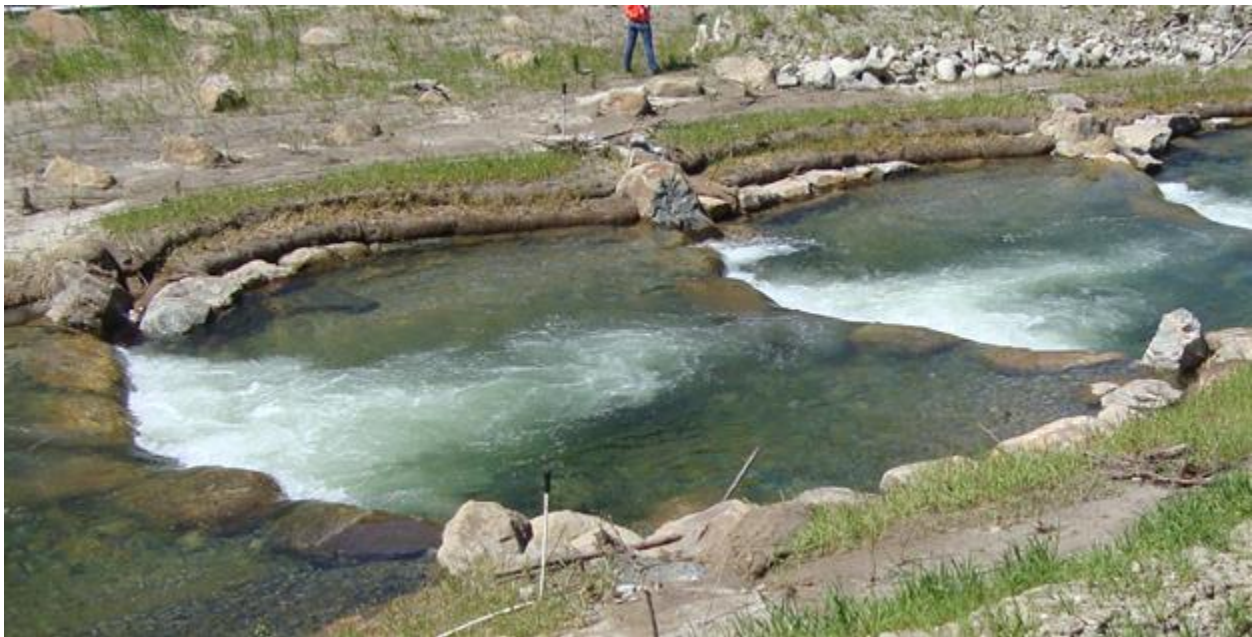
Figure 7. Downstream view of berms in section E. In general, berms were constructed with an arch shape for structural stability and to concentrate the hydraulic stresses toward the middle of the channel. Channel and constructed banks are in excellent condition following one season of flow.

Step-pool section E begins above riffle D and Pool 5 (Fig. 4). Figure 7 is a general post-winter view of section E. At berm E3, water cut through the right side of the step (Fig. 43). The FES on the left bank of step E1 was almost removed from the bank. There were large woody debris deposited on the left floodplain. There were gravelly sand deposits in the corners formed by the berm and bank. No changes were seen were seen in Riffle F (Figs 44 and 45).

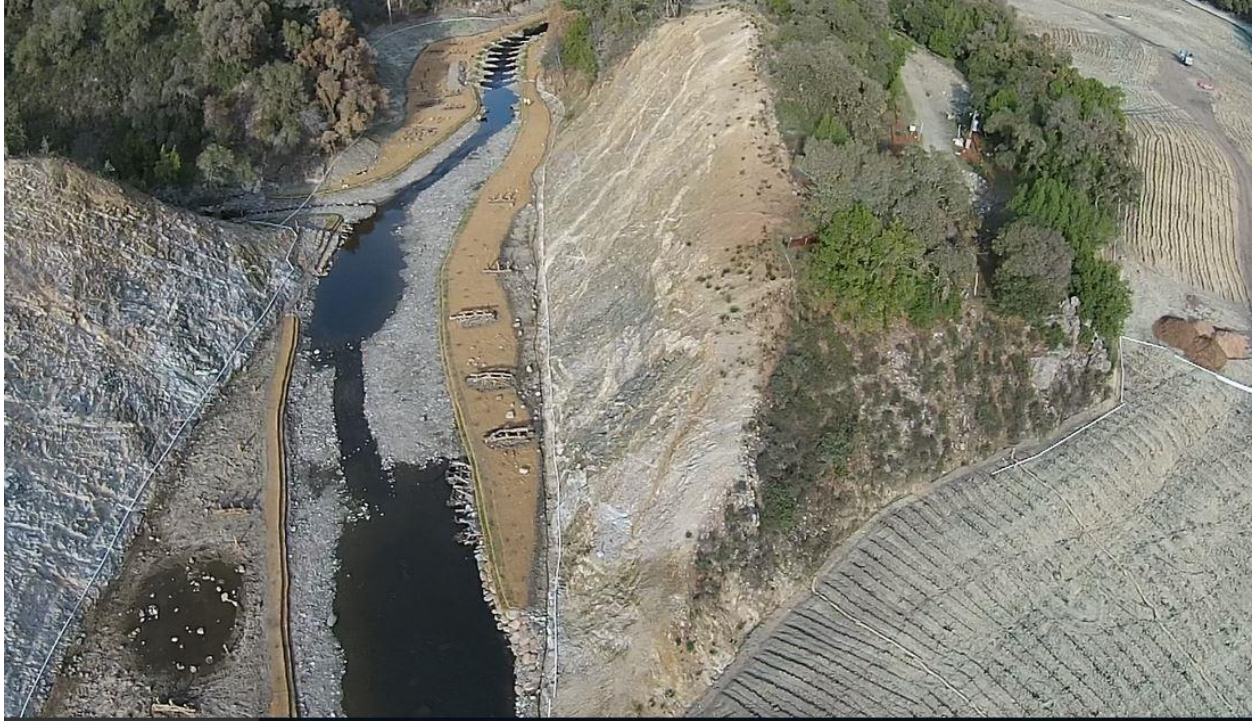
Figure 8. Representative photo of constructed riffles and pools in the reroute reach. Oblique aerial downstream view. Elements shown include pools 9, 10, and 11, and riffles I and J. Section H step-pools are in far background, downstream of resting pool 9.

Between pools 9 and 12 (Fig. 4) the pilot channel (Fig. 8) matured into a series of three riffles separated by two point bars with pools (Figs 52–55). In this reach the FES remained in excellent condition. The pilot channel constructed in riffle I migrated to the left bank in response to side-attached bar or point-bar growth near the mouth of San Clemente Creek (Fig. 52). This section also had large woody debris on the point bar (Figs. 54 and 55).

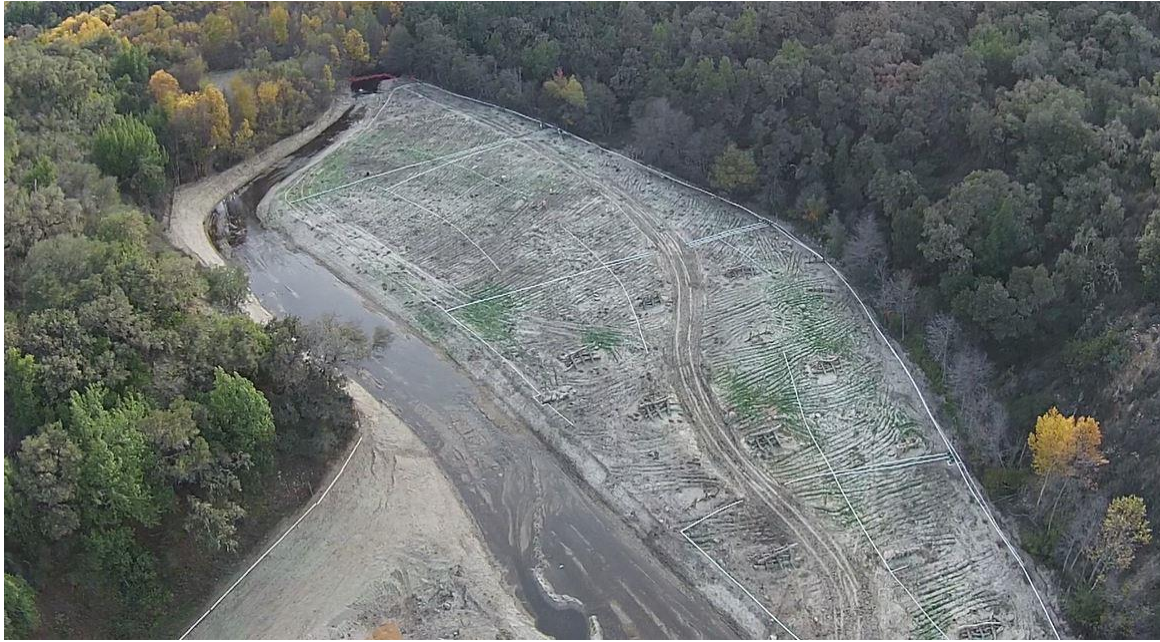
While the combined flow reach and reroute reach were both constructed using active restoration techniques that create strong physical boundaries for the bankfull channel, the Upper Carmel River Reach was constructed with a pilot channel through poorly consolidated floodplain materials (Fig. 9).

**Figure 9. Oblique aerial view upstream of Upper Carmel River Reach. Broad pilot channel was constructed within floodplain deposits. Large woody debris structures were installed on the floodplain.**

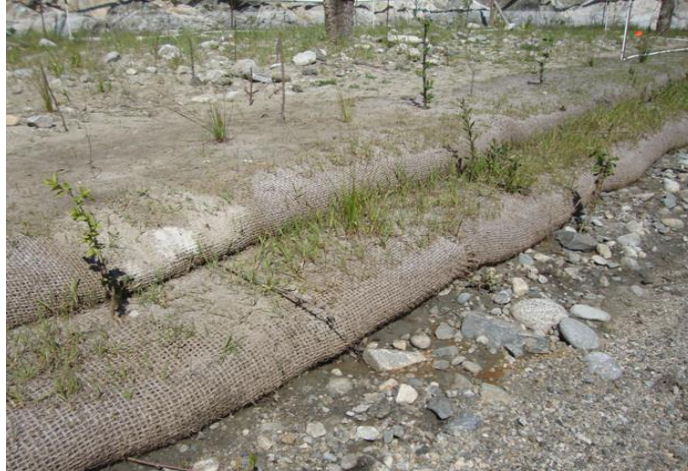
**Figure 11. FES upstream from San Clemente Creek after the winter runoff showing healthy riparian plantings and a veneer of fine sediment from the first overbank flows.**

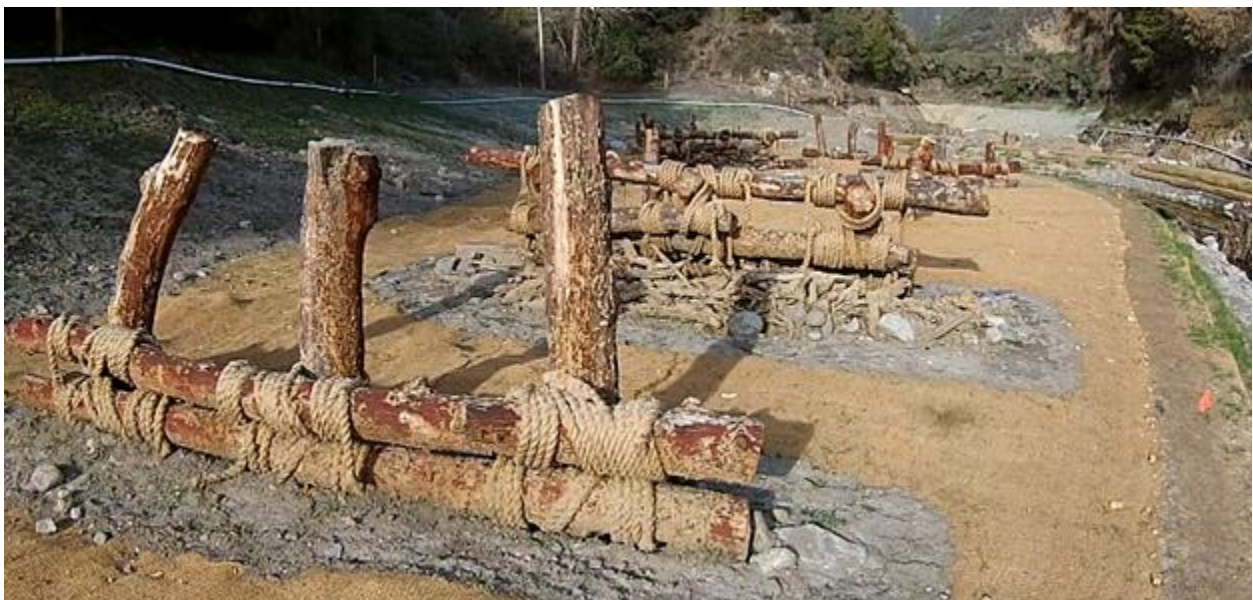
**Figure 12. LWD installation on left floodplain downstream from San Clemente Creek. Fiber matting was used to protect unvegetated floodplain soil from erosion until flood deposits and pioneer vegetation do the job.**

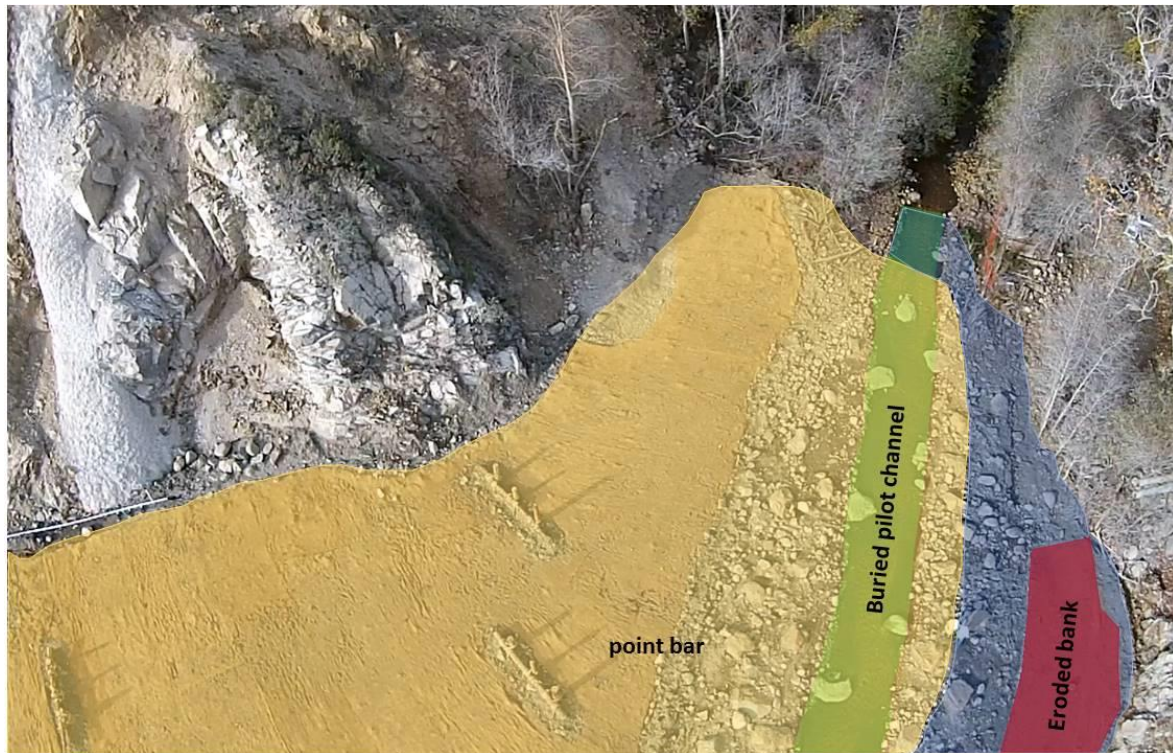
At the downstream terminus of the constructed channel, below Pool 1, the entire floodplain and much of the previous channel is now covered in a thick layer of gravel (Figs. 25 and 26). The main channel has migrated from its original position by eroding the right bank and now runs along the old dam abutment and bedrock on the right side of the channel.

Figure 25. Oblique downstream aerial view at the end of the reroute project where the dam once was.

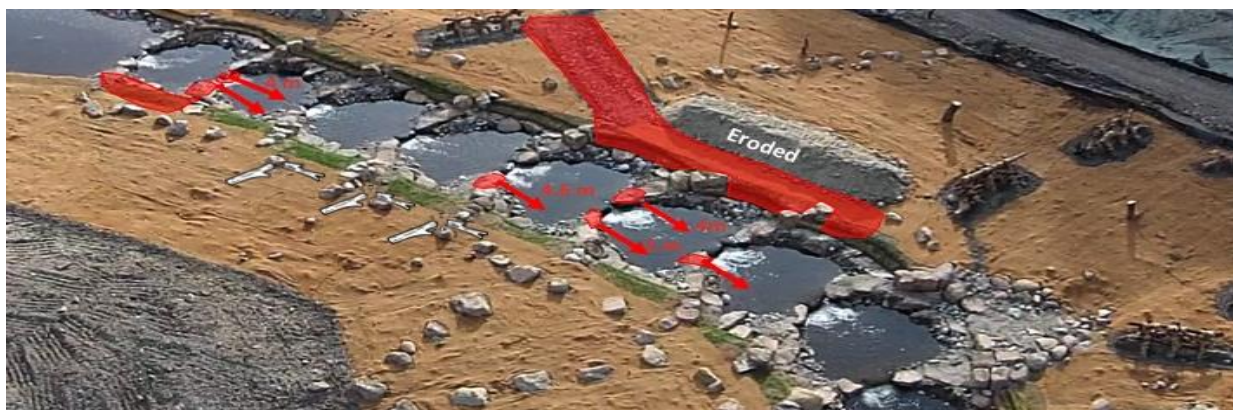
We saw the most structural adjustment in step pool Section C. The left notch boulder in berm C1 was dislodged and moved downstream 4 meters and the left key boulder was moved downstream 6 meters (Fig. 32). The left notch boulder in berm C2 was transported downstream approximately 4.5 meters. In berm C3, the left notch and left key boulders were dislodged and moved downstream approximately 4.2 and 2.5 meters, respectively. There was bank failure from berm C1 to berm C3 and the upper bank sediment pile had been eroded (Fig. 32). The right notch boulder was dislodged from berm C5, but we were unable to relocate the boulder (Fig. 33). In berm C6, the right and left notch boulders moved 2 and 4 meters, respectively. The right key boulder in berm C7 moved downstream about 4.6 meters. In berm C10, the right key and notch boulders both moved downstream approximately 4 meters. There was a lateral failure present between berms C11 and C10 where the right bank and FES were deeply eroded and removed (Fig. 34). There was a deep scour hole along the right edge of the upstream side of C11, potentially indicating piping beneath or alongside the structure (red hatch area in Fig 35; Fig. 36). We also found a significant amount of erosion present on the floodplain of section C where the designed wetlands were supposed to drain back into the river (Figs. 35 and 37), causing a large amount of bank failure from C5 to C7 (Fig. 34). The large upper bank sediment pile along this reach has been eroded (Fig. 33). Large woody debris was present on the right floodplain from berms C9 to C7.

Figure 33. An upstream view of the upper half of Section C showing berms C3–C11.

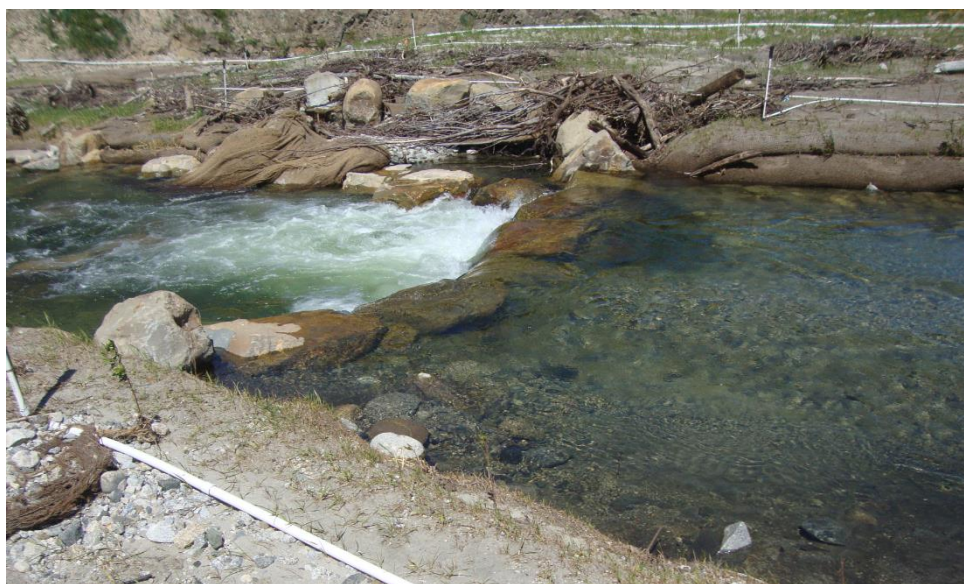
Figure 36. View of C11 from left bank. Note compromised FES on right bank downstream of berm C11. Also visible is the scoured area immediately upstream from the right edge of the berm.

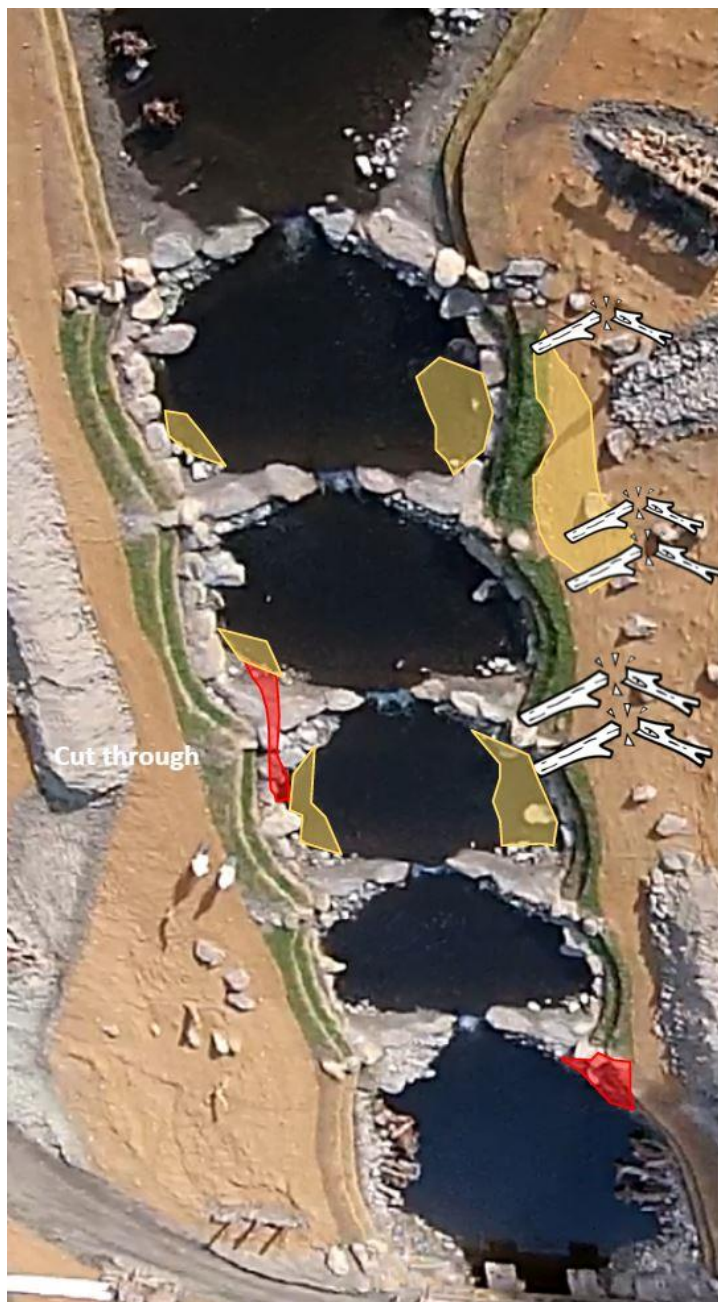
Figure 2. Oblique aerial upstream view of berms E1–E5.

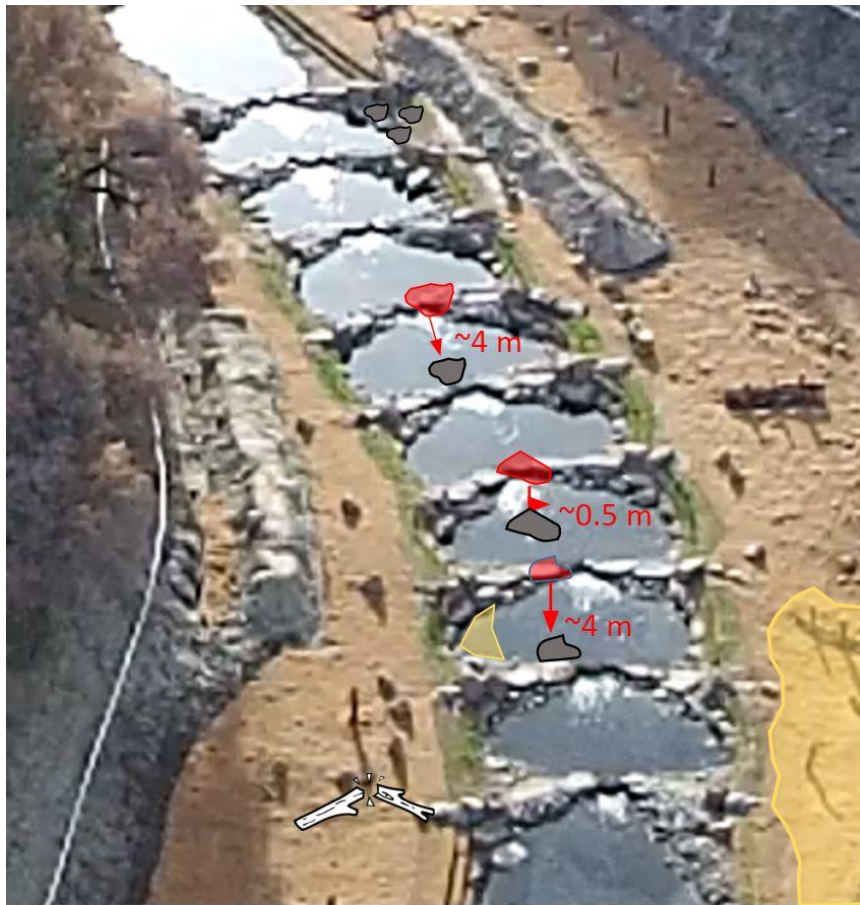
The right notch boulder of berm H3 moved downstream approximately 4 meters (Figs. 48 and 49). The right notch boulder of berm H4 moved downstream about 0.5 meters. The left notch boulder of berm H6 moved downstream approximately 4 meters. Sandy gravel deposits were filling in the sides of the pools against the upstream side of key and notch CNBs from H1 – H3. Pool 9 had large amounts of woody debris (Figs. 50 and 51).

Figure 48. Oblique aerial upstream view of berms H1-H9.

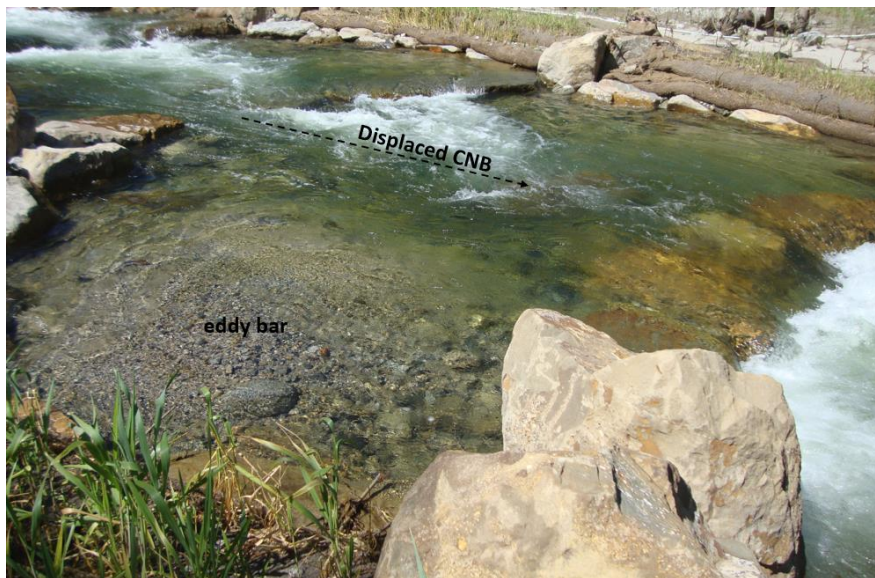
Figure 49. Upstream view of H3. Displaced CNB is visible in channel. This pool is an example showing moderate pool-filling gravel on the right side of the channel. FES in background is performing as designed.

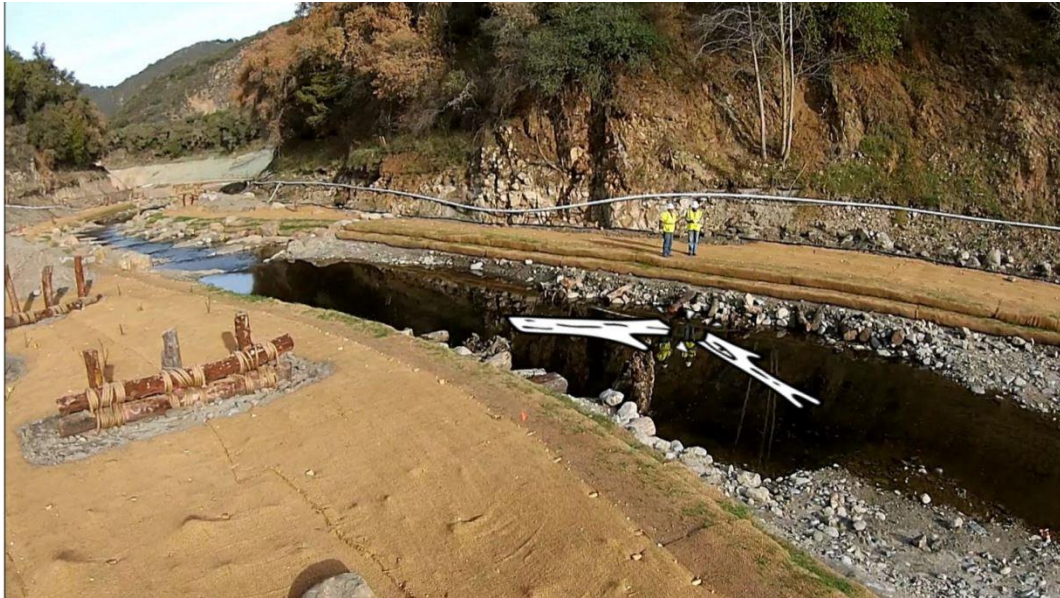
Figure 50. Post-construction downstream view of Pool 9 indicating position of transported LWD structure (see Fig. 51)

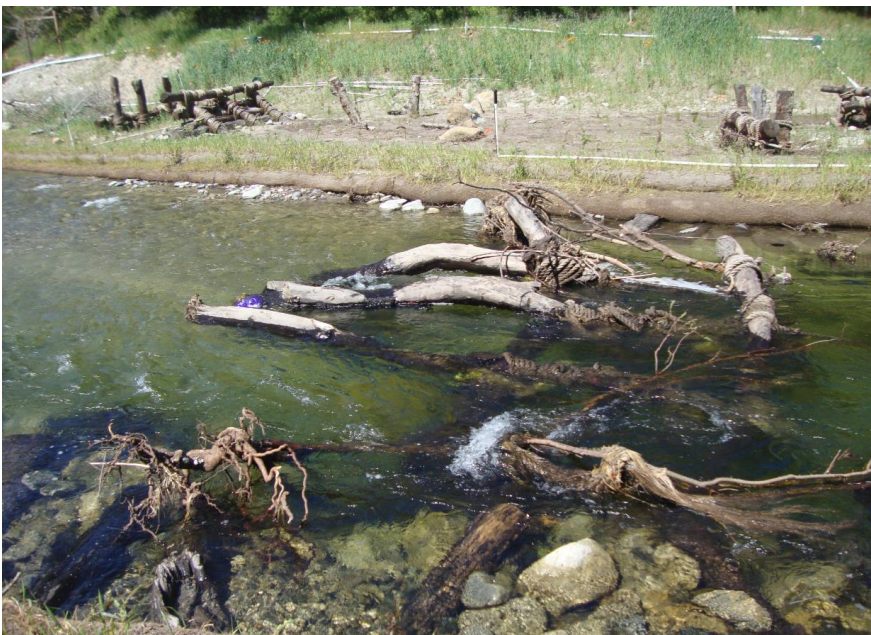
Figure 51 . View from right bank at upstream end of pool 9. Transported LWD structure was lodged at head of pool 9. Note intact FES and new riparian herbaceous growth on left bank.

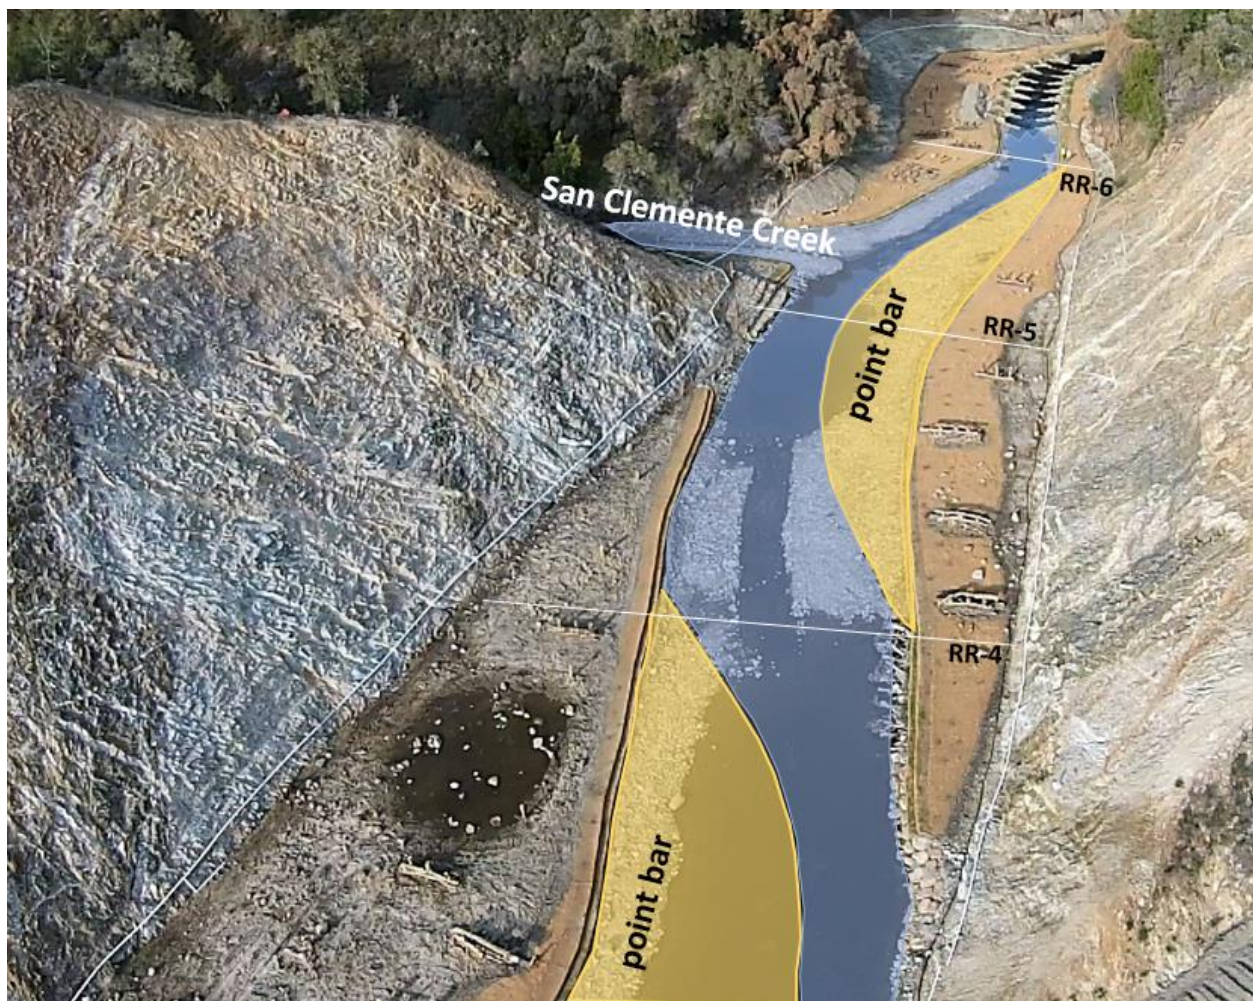
Figure 52. Oblique aerial downstream view of Riffle I, Pool 10, Riffle J, and Pool 11. Pool 9 and berm section H are visible in the distance.

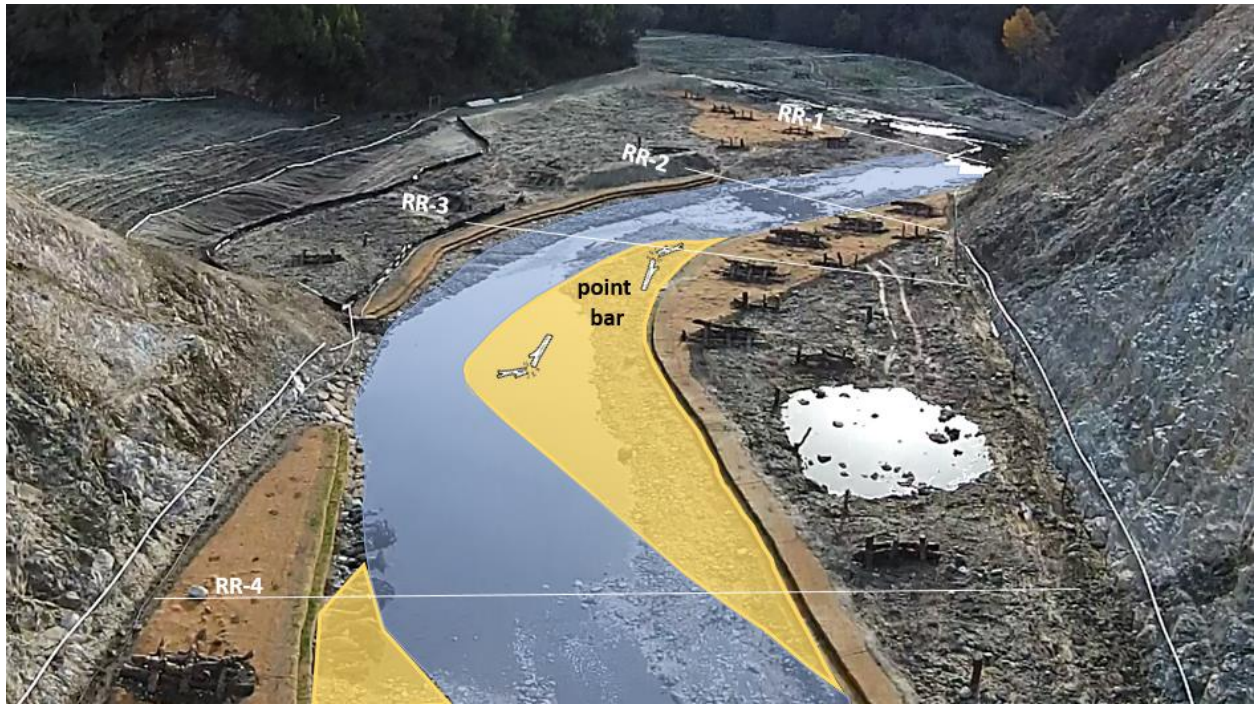
Figure 55. Oblique aerial upstream view of Pool 11 and Riffle K.

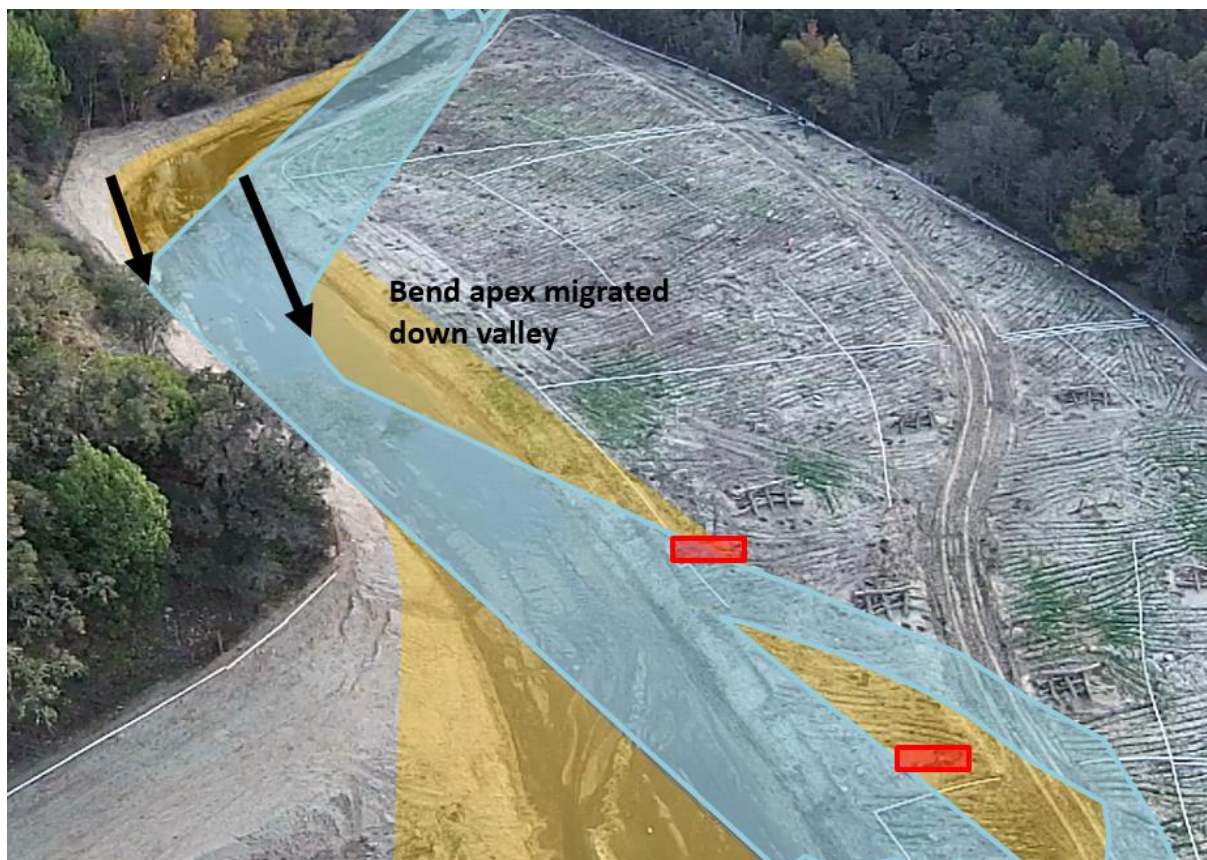
Approximate scaling of the Figure 60 oblique aerial photo, and observation that the eroded floodplain bank was approximately 1.5 to 2 m thick (Fig. 61) indicates that roughly 0.4 acre-ft of gravel was added to the bedload of the river through channel adjustment at the upstream end of the project. That sediment volume is approximately 3% of the estimated 15.2 acre-ft/yr average load (Tetra Tech 2015). Several large wood structures were either missing or structurally compromised (Figs 56–59).

Figure 60. Oblique aerial upstream view of farthest upstream section of the unconfined upper Carmel reach.

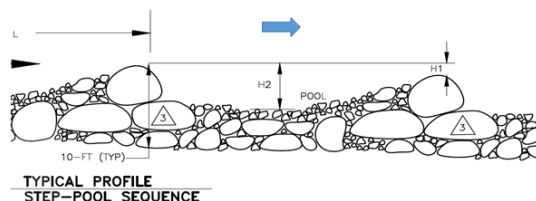
The CNBs were modeled for stability assuming they were spheres that initially moved by rotating forward over a 0.3 ft high fulcrum (Tetra Tech 2015). The presence of a fulcrum, imposed by downstream footer rocks, was not present in design drawings (Fig. 64), but may have been present in some of the berms (Fig 65). Therefore some CNB motion may have been from sliding rather than tipping.

Figure 645. Longitudinal profile of typical step-pool. Design drawing of berms (from Tetra Tech 2015). Blue arrow indicates water flow direction.

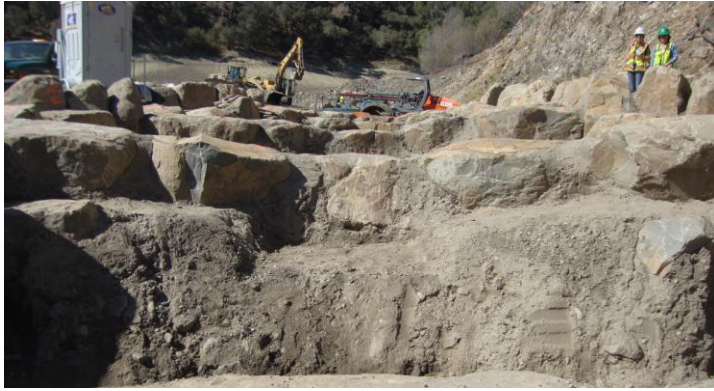
The CNBs are actually blunt rectangular solids rather than spheres (Fig. 65), and thus have different drag coefficients. Drag coefficient is inversely proportional to  $\tau_c^*$ , and will therefore influence the probability of motion. The typical drag coefficient for a sphere ranges from 0.2 to 0.47, whereas it is 1.07 for a rectangular solid (e.g., White 1976). The considerably higher drag on a blunt object compared to a sphere could lead to an underestimate of CNB mobility during modeling. However, Tetra Tech (2015) assumed a drag coefficient of 1.2, a very conservative value for either a sphere or blunt rectangle.

**Figure 656. Berms during construction.**

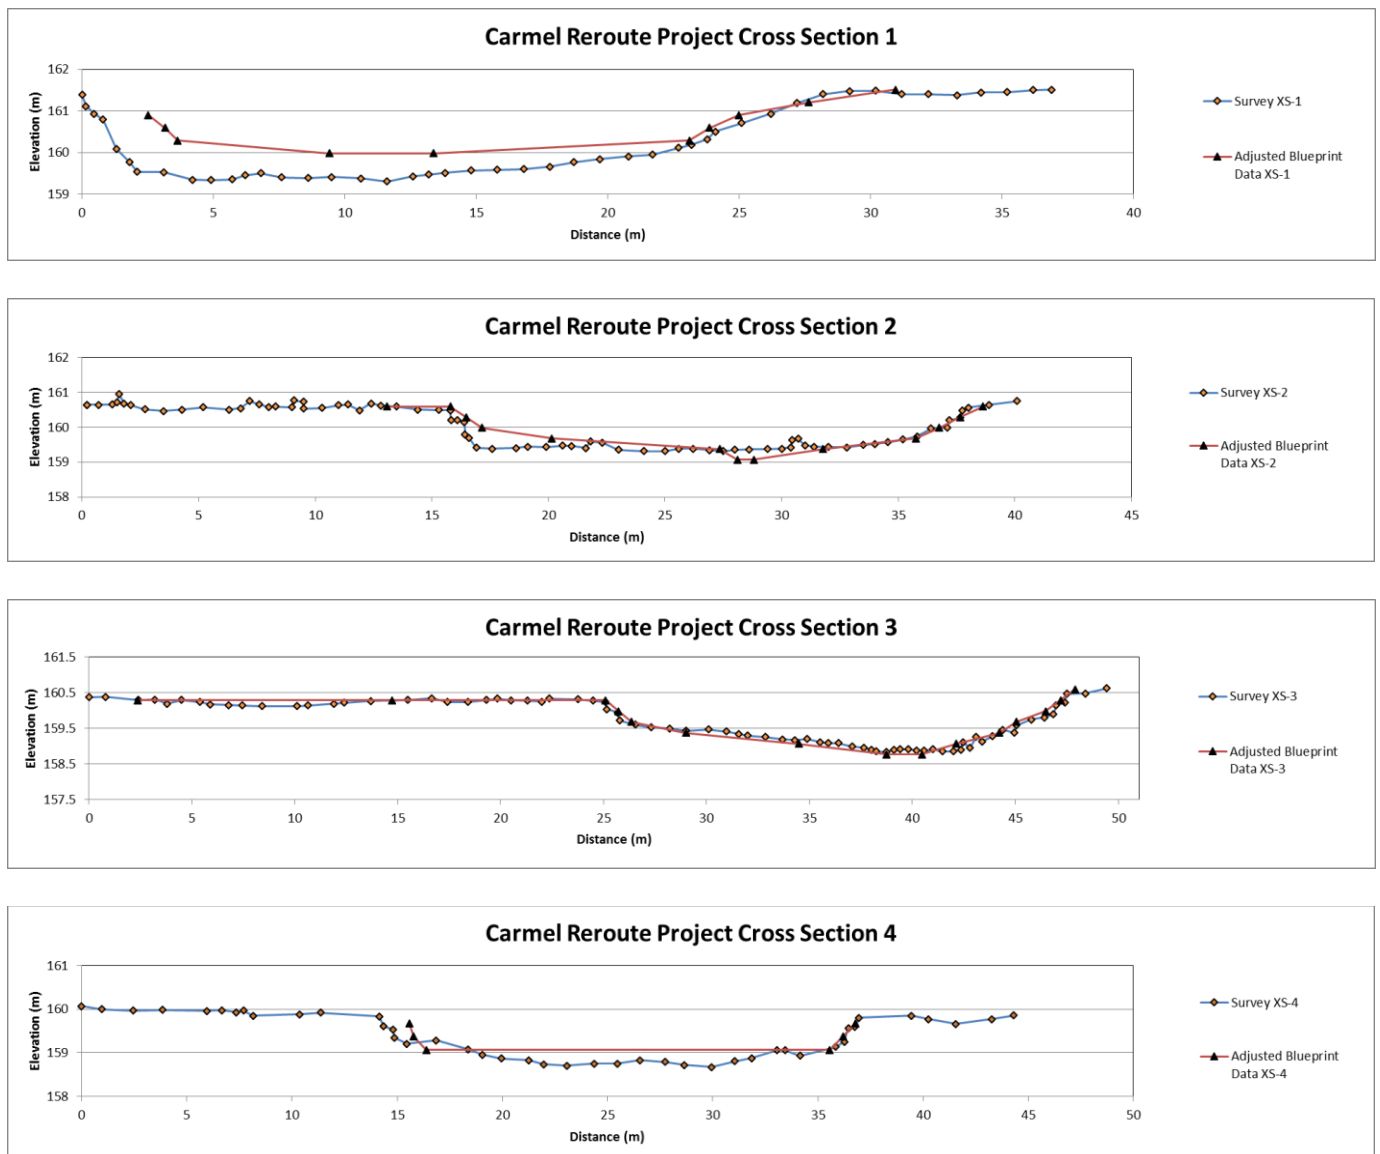
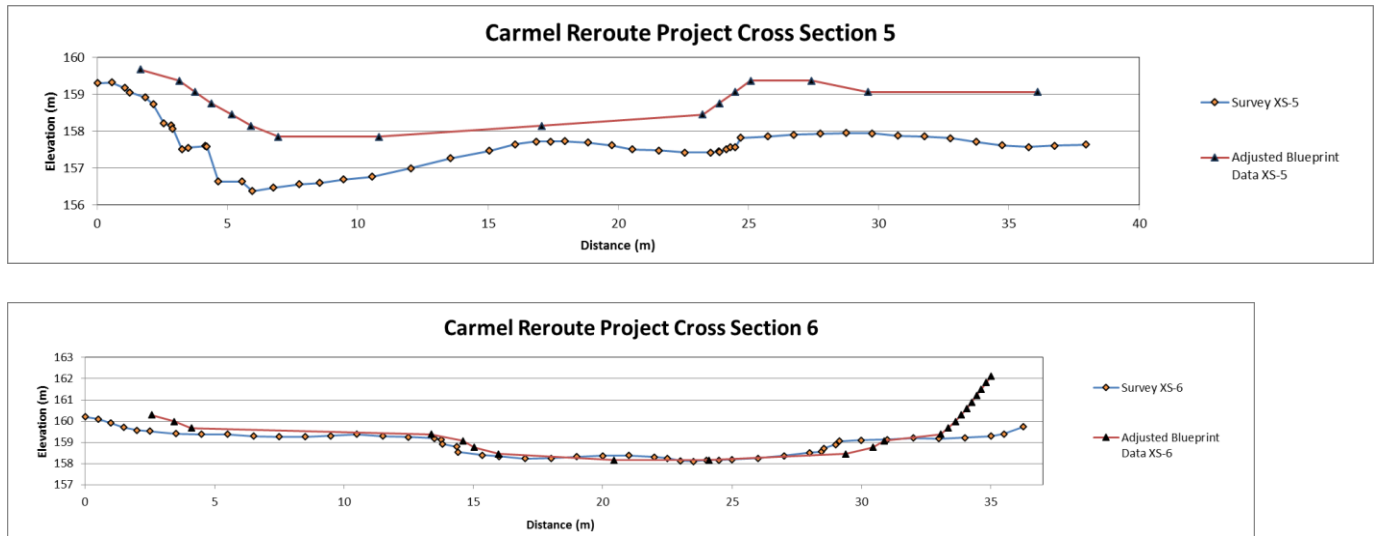
Figure 68. Six cross sections surveyed in the “reroute” reach of the CRRDR project (Fig. 20).

Figure 68 shows that the geometry of the reroute cross sections compared very well with the original constructed channels (assumed to be represented by blueprints) after one runoff season. Cross section 5 has an unresolved error erroneously showing a gross misalignment with blueprint data. Cross section 1 shows the erosion related to expanding the radius of curvature of near pool 12 (Fig. 56). Other minor differences between blueprints and cross sections probably indicate variability between the construction drawings and as built geometry.

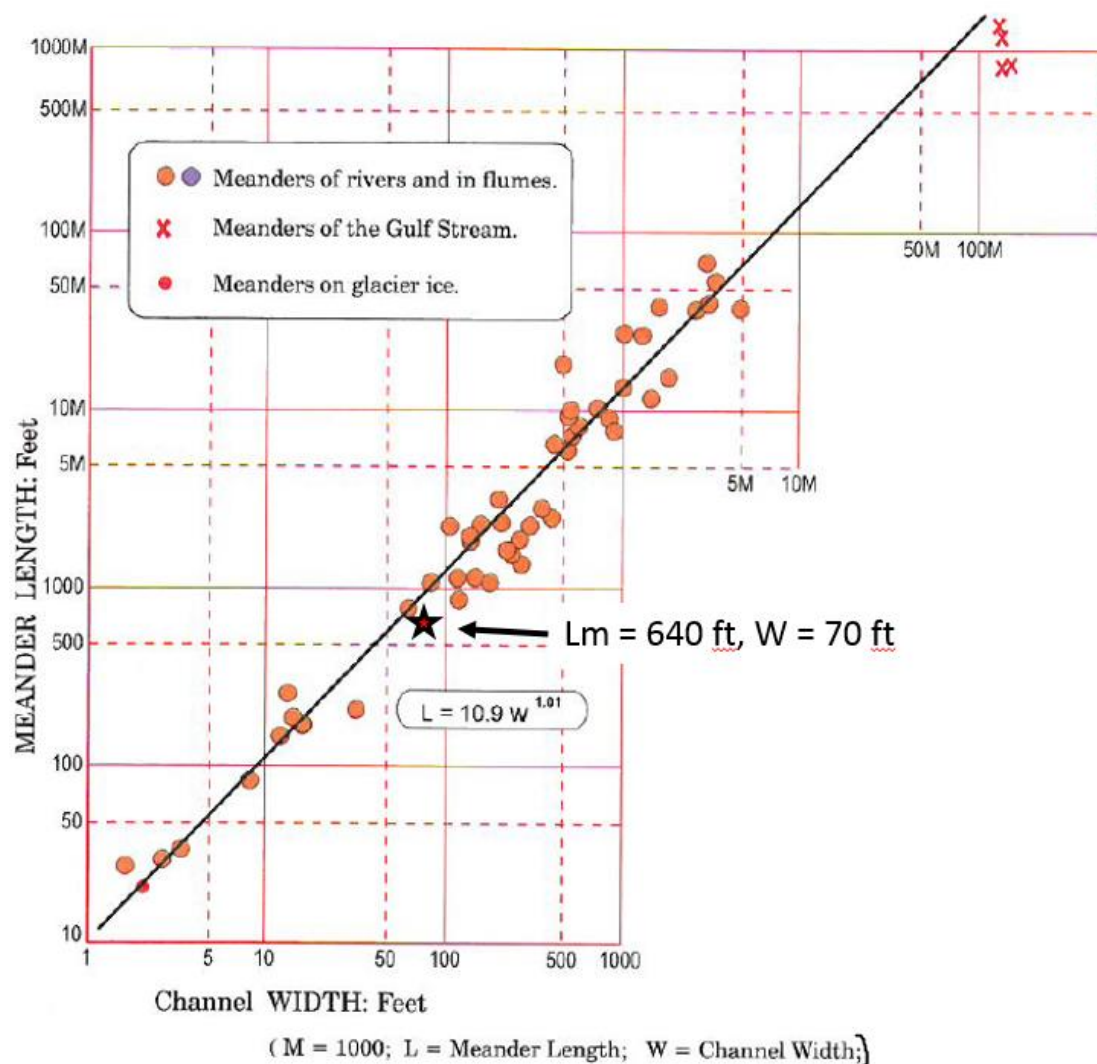
To further assess the reroute section we compared the geomorphology of the surveyed cross sections to general reference rivers plotted by Leopold et al. (1964; Fig 14). Measurements from the design blueprints indicate that the meander length of the reroute reach is approximately 640 ft (Fig. 78). The surveyed riffle cross section widths in that reach averaged 73 ft and the blueprint channel widths averaged 66 ft (Table 8). The surveyed and blueprint values compare well with other general natural rivers of the world (Fig. 79).

Figure 79. Relationship between meander length and channel width from Granite Construction blueprints graphed on published natural stream relationship graph. (Graph modified from: Rosgen, 1996; Original relationship from Leopold et al. (1964))

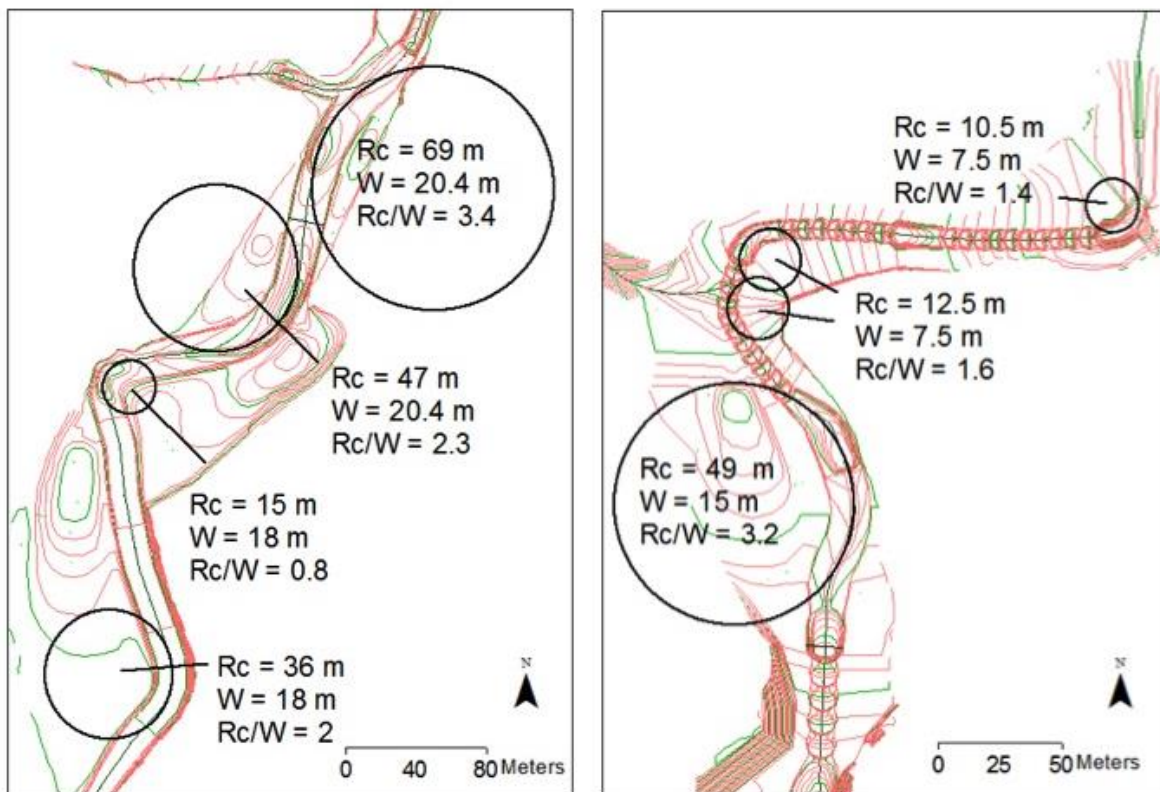
We examined the  $R_c/W_{bkf}$  ratios of the bends in the project and found the highest ratio to be 3.4 and the lowest ratio to be 0.8 (Fig. 80; Table 13). We found that the curves with reasonably high  $R_c/W_{bkf}$  ratios experienced less change than those with small ratios, as predicted from Figure 81. In some

areas, the pattern design of the channel was controlled and restricted by existing valley conditions, but some of the bends were in areas that did not seem to have any placement constraints (Table 13).

Figure 80.  $R_c/W_{bkr}$  ratios of Carmel River Reroute Project. Left map includes the upper Carmel reach (bottom), pool 12, and the reroute reach. Right map includes Riffle D, pool 4, berm sections A through C and pool 1 (top of map). Table 13 summarizes the data.

Location	$R_c/W_{bkf}$	NBS rating from Rosgen Table	Consequence	Context
Downstream of Pool 1	1.4	Extreme	Right bank completely eroded	Pattern controlled by existing valley conditions
Pool 3 and Section C	1.6	Very High	Large lateral failure around step pools	Pattern controlled by existing valley conditions
Pool 4 and Riffle D	3.2	Very Low	None	No constraints
Upstream of Section H – Pool 9, Riffle I, and Pool 10	3.4	Very Low	None	No constraints
Pool 11 and Riffle K	2.3	Low	None	No constraints
Pool 12 and Upper Carmel Reach	0.8	Extreme	Significant erosion of left bank	River had to follow bedrock wall on Pool 12
Upper Carmel Reach – beginning of constructed	2	High	Apex of bend moved tens of meters	No constraints

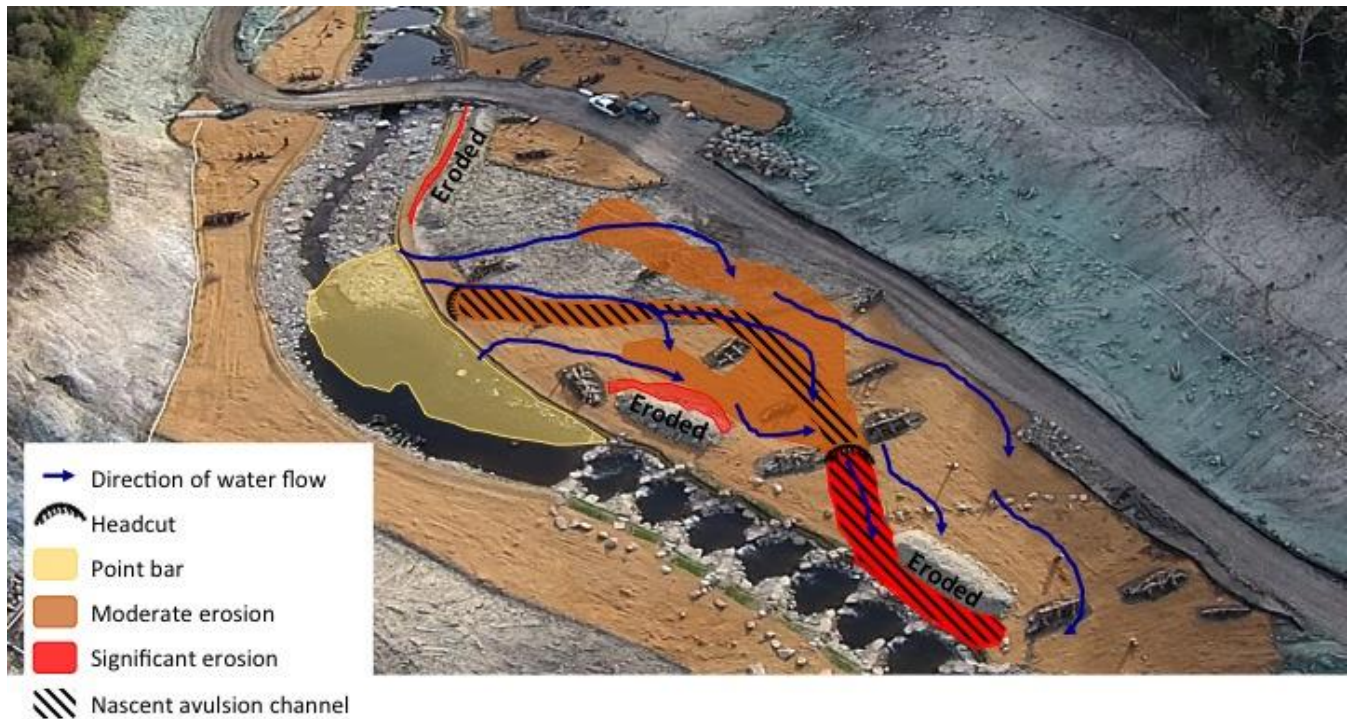
The left floodplain by pool 4 and section C was significantly altered by deposition and local erosion (Fig. 83). During a high flow event, a nascent avulsion channel formed on the floodplain. If that channel were to grow and carry the main flow during low flow conditions, then almost all of the step-pools in section C would be bypassed. In the upper part of section B, the left bank was eroded to the bedrock, causing the water to partially bypass the step-pool design in both low and high flows (Figs. 30 and 31). This lateral failure could lead to the destabilization of a subset of the berms in Section B. However, the bend is adjacent to a bedrock wall, so future adjustment might be limited, and fish passage is not jeopardized at this time. The main impact in section A is that the most downstream berm (A1) is missing (figs 27 and 28). Berm A1 set the local base level for the project as a whole. The incremental effect of CNB or berm loss is to have a taller step on the next berm upstream, making fish passage incrementally more challenging, however, the step at A2 did not appear to be significantly higher than others in the section.

Figure 83. Detailed map of left floodplain adjacent to pool 4 and section C. Floodwater flow paths were determined from debris alignment on tree stems.
