Report No. WI-2005-02 21st January 2005

The Watershed Institute

Garrapata Creek Watershed **Steelhead Barrier Assessment**

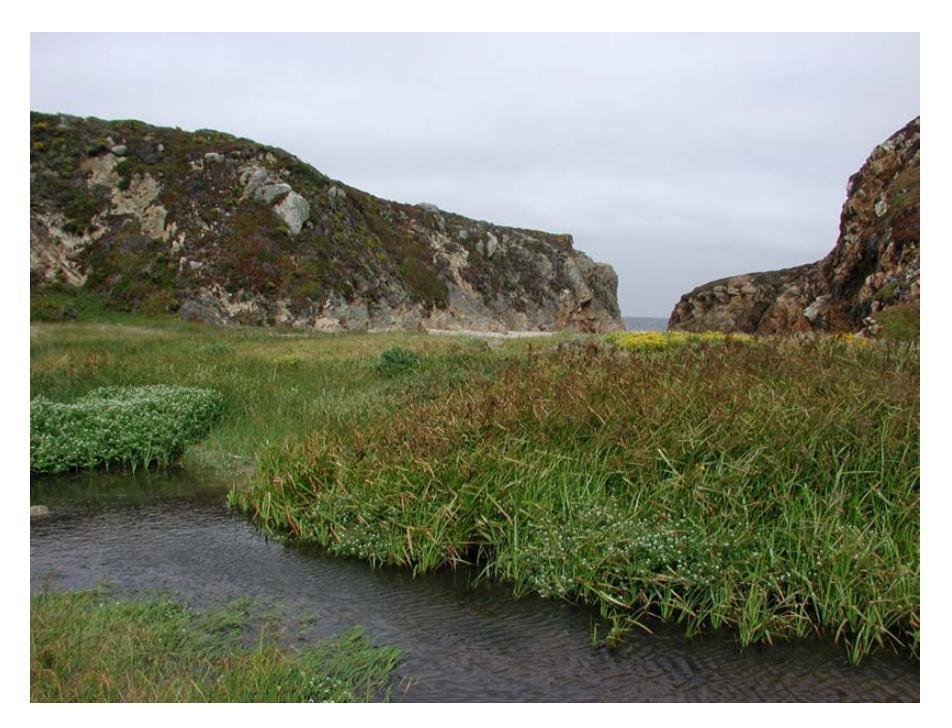
The Garrapata Creek Lagoon was visited on July 1st 2004. At this time, the lagoon was narrow with the deepest embayments along the bedrock bluffs to the north (right bank). From upstream to downstream, there were differences in water quality and habitat type within the lagoon. Furthest upstream, a transition zone existed where the Garrapata Creek stream habitat, fed into a broad backwater habitat that was well vegetated with emergent vegetation (Fig. 4.2). Some fish were observed here, however the species was not identified. Water depths averaged approximately 0.25 m.

Figure 4.2 The eastern half of the Garrapata Creek Lagoon. This area was the transition zone between stream habitat and lagoon habitat. The main embayment of the lagoon is against the bluffs in the upper right corner of the photo. Photo: Joel Casagrande, 1 July 2004.

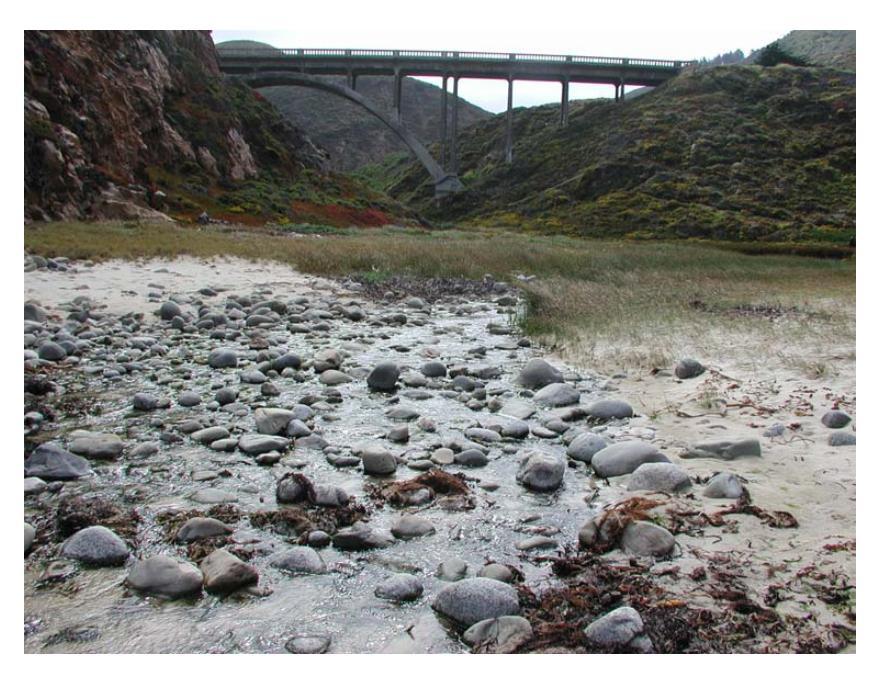
Further downstream, a broad riffle of coarse substrate connected the upper vegetated areas into the eastern of two main embayments of the lagoon (termed here as eastern and western embayments) (Fig. 4.3). Threespine stickleback (*Gasterostreus aculeatus*) were observed at the downstream base of this riffle. At this point emergent vegetation was minimal to none. The eastern embayment (Fig. 4.4) was shallow, 0.3 m on average, with a deeper scoured channel (~0.5 m depth) along the northern bluffs.

Figure 4.3 The broad riffle shown here (looking upstream) separated the eastern backwater areas (upstream) to the main lagoon embayments (downstream). Note the kelp accumulations in the foreground indicating the upstream extent of wave action. Photo: Joel Casagrande, 1 July 2004.

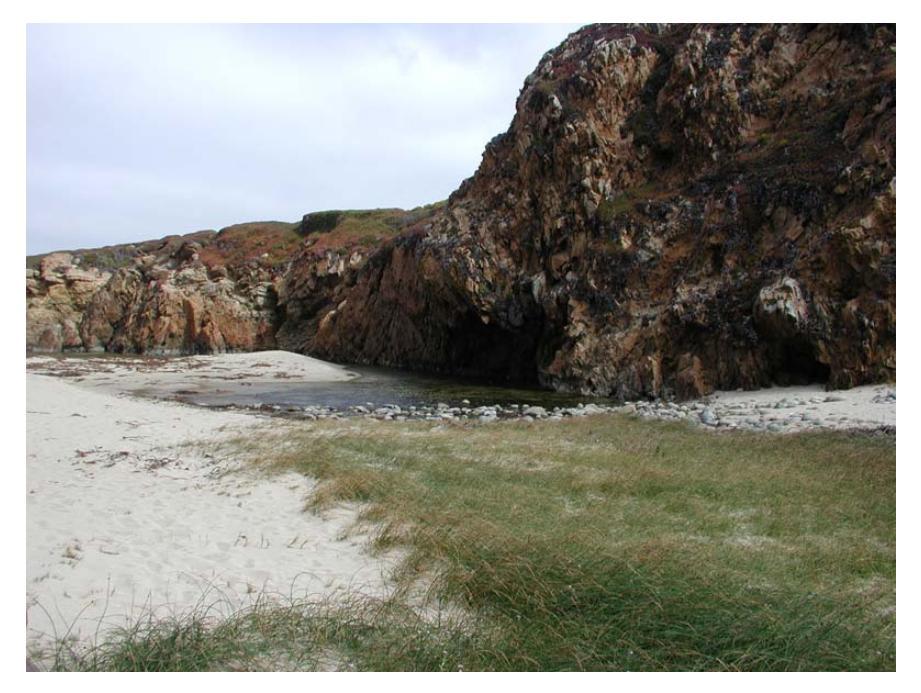
Figure 4.4 A view of the eastern of the two main embayments shown at the base of the bedrock bluffs at the center of the photo. Photo: Joel Casagrande, 1 July 2004.

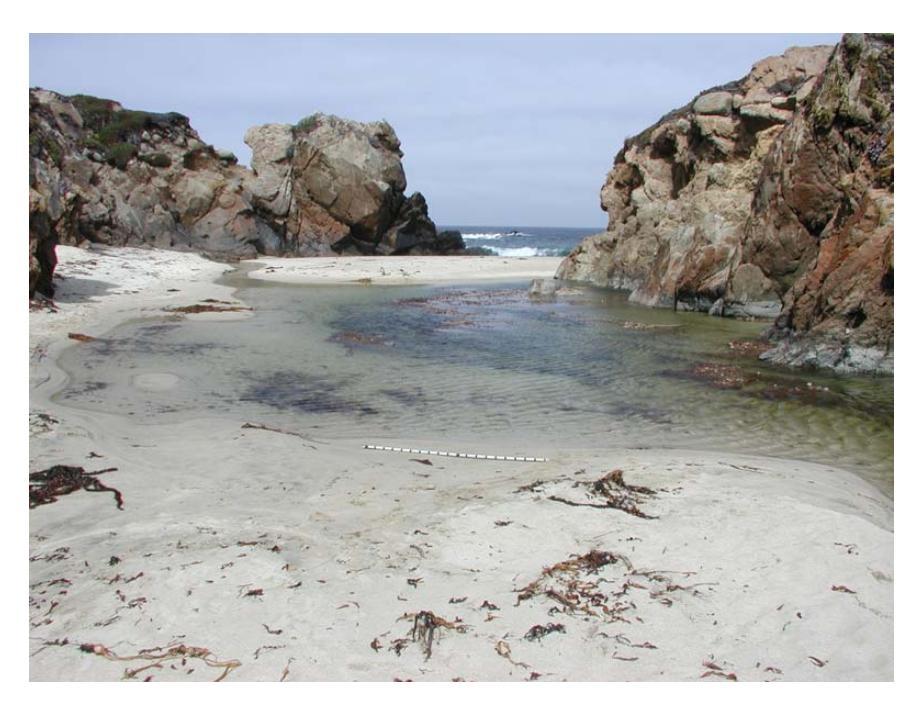
The western embayment was located against the sand bar and the northern bluffs. The sandbar was opened along the left bank, although minimally (Fig. 4.5). Water depths were deepest in the western embayment with a maximum depth measured of 1.45 m near the center-right bank portion of the pool.

Figure 4.5 The western main embayment of the Garrapata Creek Lagoon. Note the sandbar is open along the left side. Photo: Joel Casagrande, 1 July 2004.

The use of the lagoon for rearing and smolting by juvenile steelhead is unknown. Studies should be conducted to determine its suitability and potential for steelhead production. Data that should be included in such studies are: seasonal fish sampling (seine) for size and age distributions, seasonal water quality data (specifically salinity, dissolved oxygen, and temperature), seasonal changes in oceanic inputs, and seasonal availability of macroinvertebrate species.

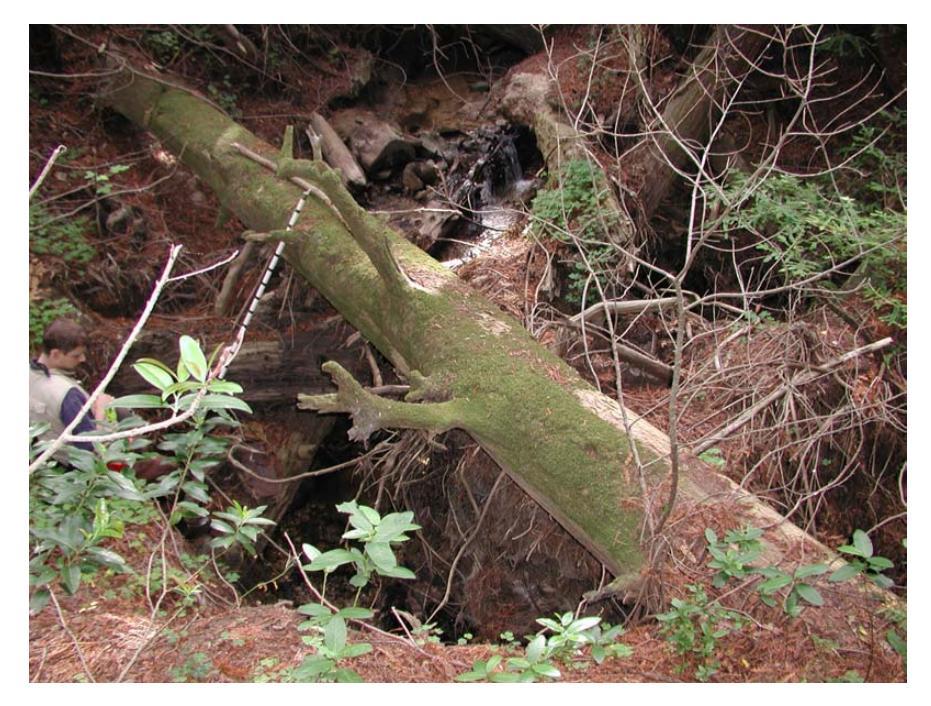
Structure jb02 is a logjam located approximately 427 m (1400 ft) upstream of the confluence with Garrapata Creek or 198 m (650 ft) upstream of structure jb01. The logjam has a double jump that drains towards the right bank side. The first jump is approximately 0.75 m tall and the second jump is 0.25 m tall (Fig. 6.3). At current flow rates the streamflow is spilling/percolating through the tangled debris below the second step. At higher streamflow there is a larger secondary route along the right bank and it is likely water spills over the entire structure at the highest flow levels. A shallow scour pool has formed at the base of the structure that is 0.25 m deep. Significant accumulations of sediment occur both upstream and downstream of the structure.

Figure 6.3 Structure jb02. View is from the right bank – downstream is to the right. The small waterfall shown (at top) here is the second jump. Photo: Ryan Lockwood, 3 June 2004.

Remove or cut larger logs that are forming jumps along the right bank side. Leave the remainder of the structure in place as habitat complex habitat including the larger moss covered log shown in the foreground of Figure 6.3.

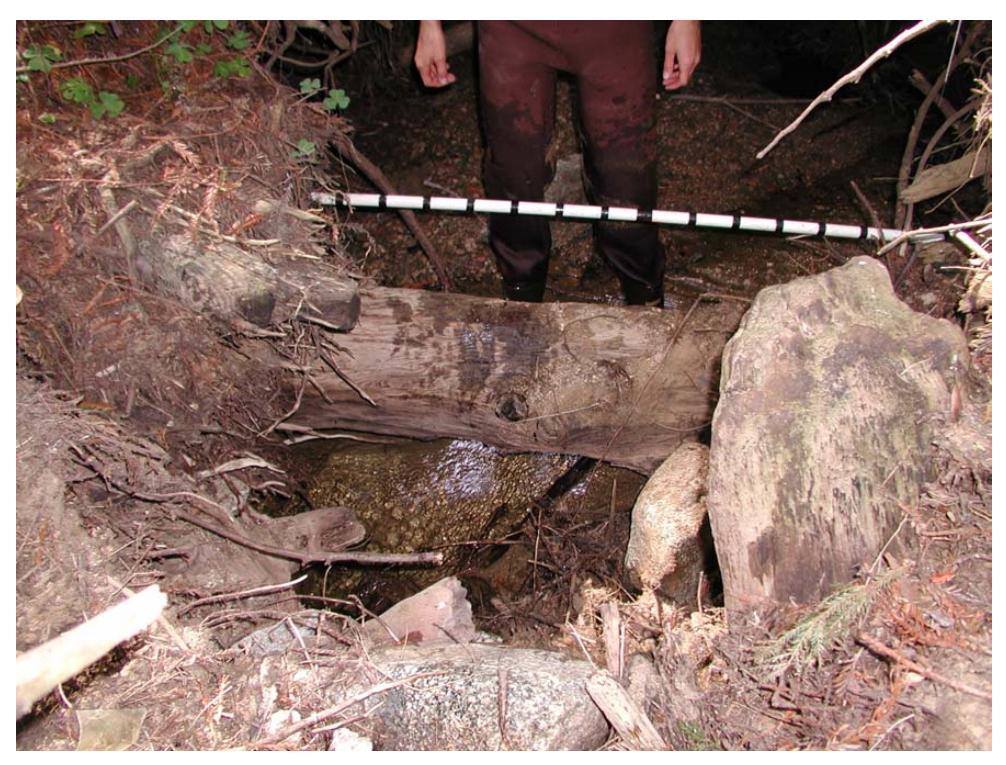
Structure jb03 is log/debris jam located approximately 447 m (1466 ft) upstream of the Garrapata Creek confluence, or 20 m (66 ft) upstream of structure jb02. The jam was created by several key logs that span the entire width of the channel, which have accumulated small woody debris and sediment (Fig. 6.4). The height of the structure is 1.1 m above the surface of the water downstream and there was no jumping pool present at the downstream edge.

Figure 6.4 Structure jb03 looking downstream. Photo: Joel Casagrande 3 June 2004

Cut pieces of key logs through the center and remove. Adjust positions of larger boulders and other woody material to reduce the height of the structure by allowing for transportation of accumulated sediments. Some small and medium sized woody debris removed. The hole between the log and the boulder at the bottom of Figure 6.4 was created after removal of debris. Figure 6.4 was taken after removal of material. More material to be removed.

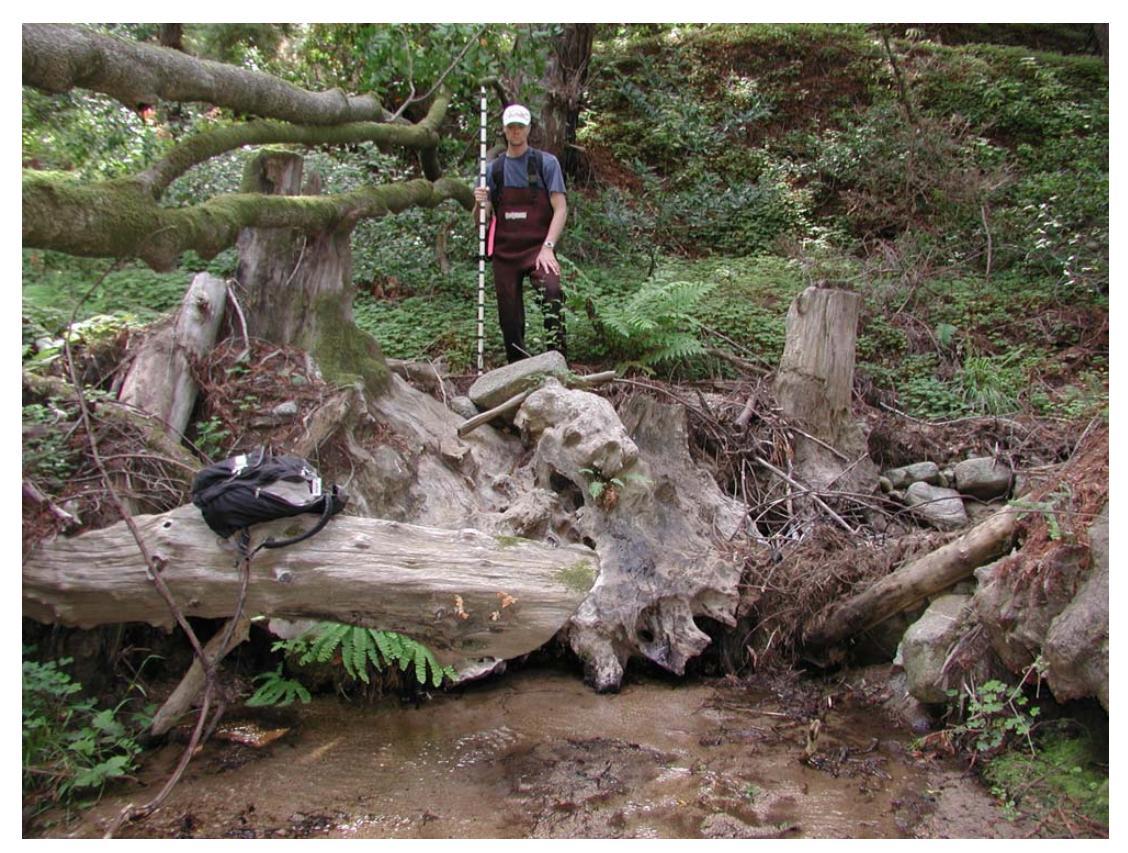
Structure jb04 is a natural feature created by existing rootwads that have trapped sediments and small woody debris forming a two step sequence along the left bank (Fig. 6.5). It is located approximately 524 m (1718 ft) upstream of the Garrapata Creek confluence or approximately 76 m (250 ft) upstream of jb03. The first step is approximately 0.5 m tall while the second is 1.0 m. No pool occurs at the base of the structure, which is covered with sand deposits.

Figure 6.5 Structure jb04 looking upstream. Photo: Joel Casagrande 3 June 2004.

Remove small and medium woody debris along the left bank route. Decrease second jump by adjusting/removing accumulated debris and sediment. Leave large rootwad shown in center as habitat feature (See Fig. 6.5).

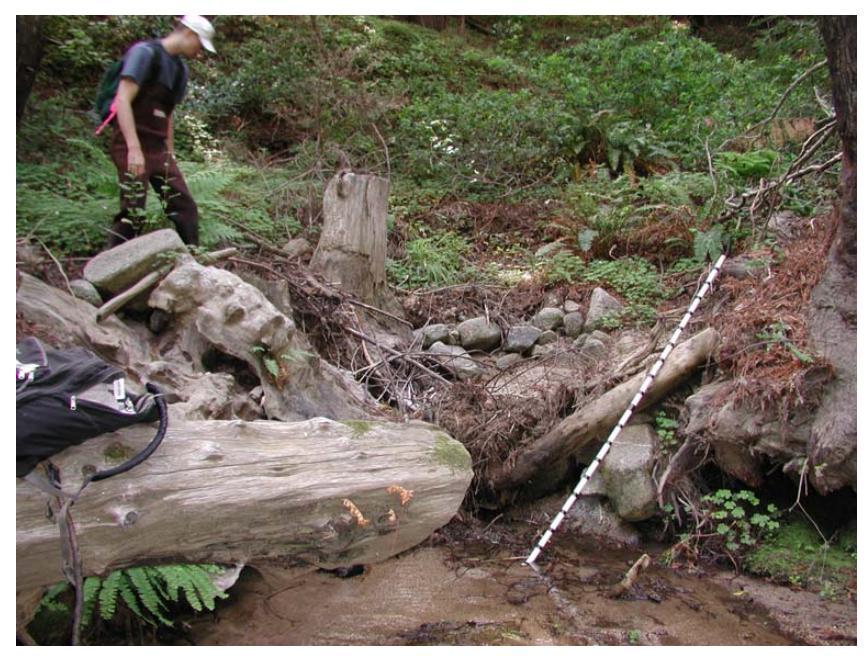
Figure 6.6 Structure jb04 looking at the left bank route. Photo: Joel Casagrande 3 June 2004.

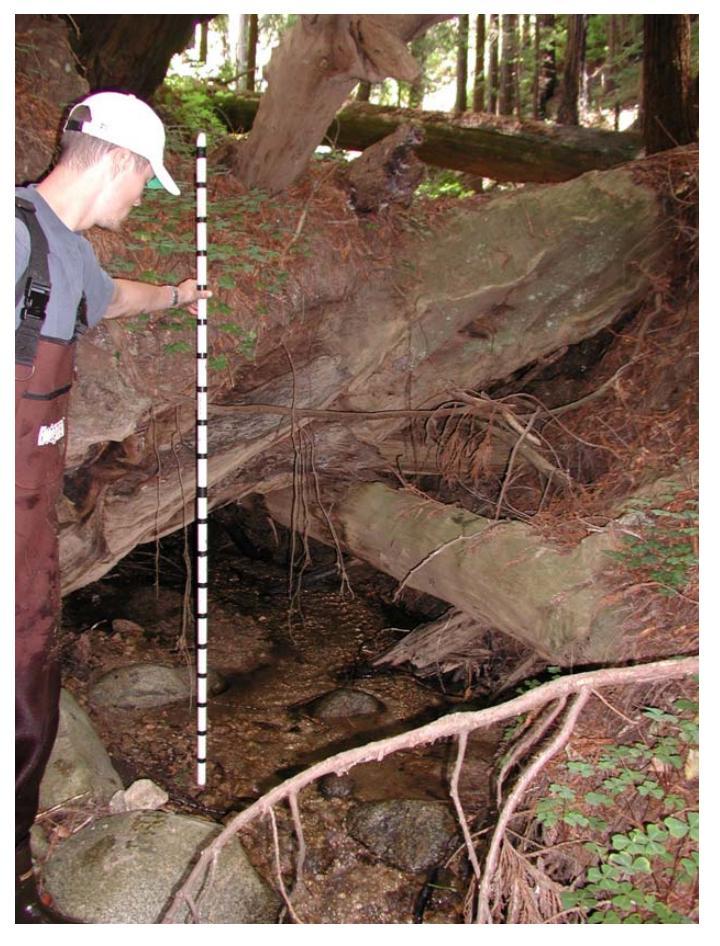
Structure jb07 is large logjam consisting of several large redwood logs in addition to a significant amount of stored sediment that extends approximately 5 m upstream (Figs 6.10 & 6.11). This logjam is located approximately 745 m (2444 ft) upstream of the Garrapata Creek confluence, or 104 m (340 ft) upstream of structure jb06 (Table 6.1). The height of the structure is 2.0 m above the downstream water surface.

Due to limited upstream habitat and accessibility to fish, improvements of this structure would not result in a considerable increase in spawning and rearing habitat. Efforts should be spent downstream and in other streams in the watershed.

Figure 6.10 Structure jb07 looking upstream. Photo: Joel Casagrande 3 June 2004.

No recommendations for improvement.

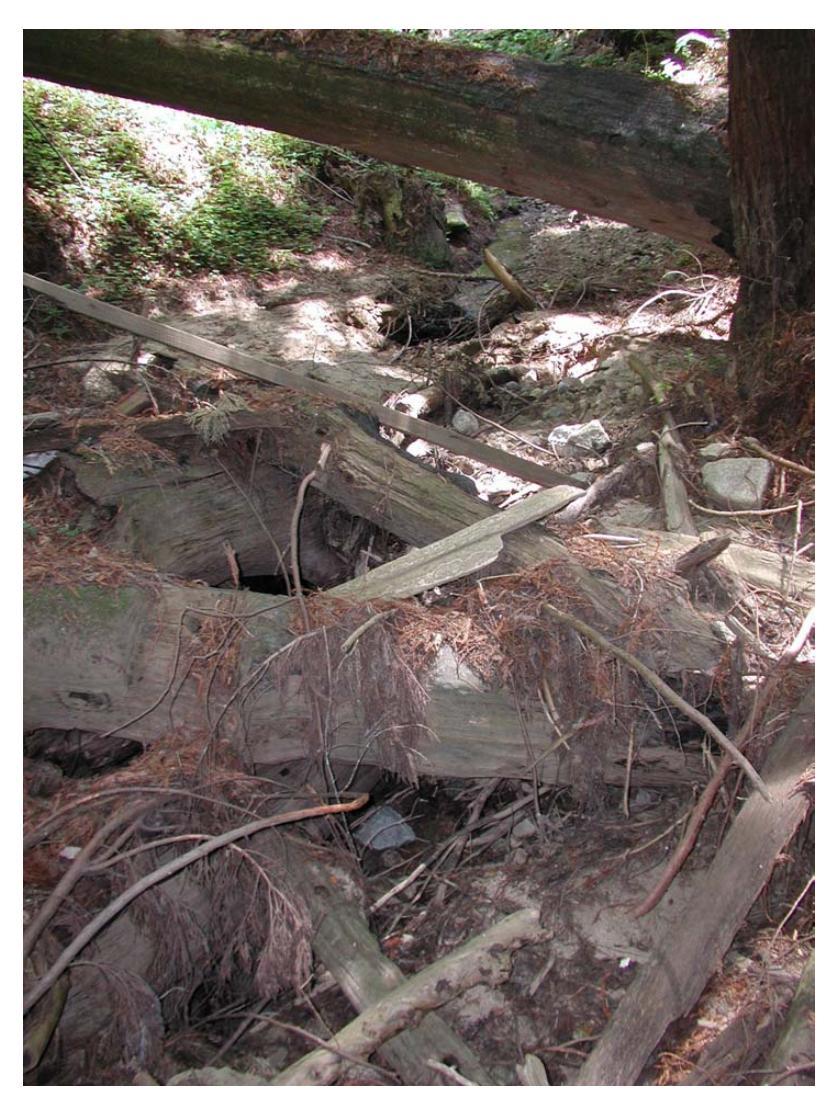
Figure 6.11 Structure jb07 looking at the upstream half of the accumulation. Photo: Joel Casagrande 3 June 2004.

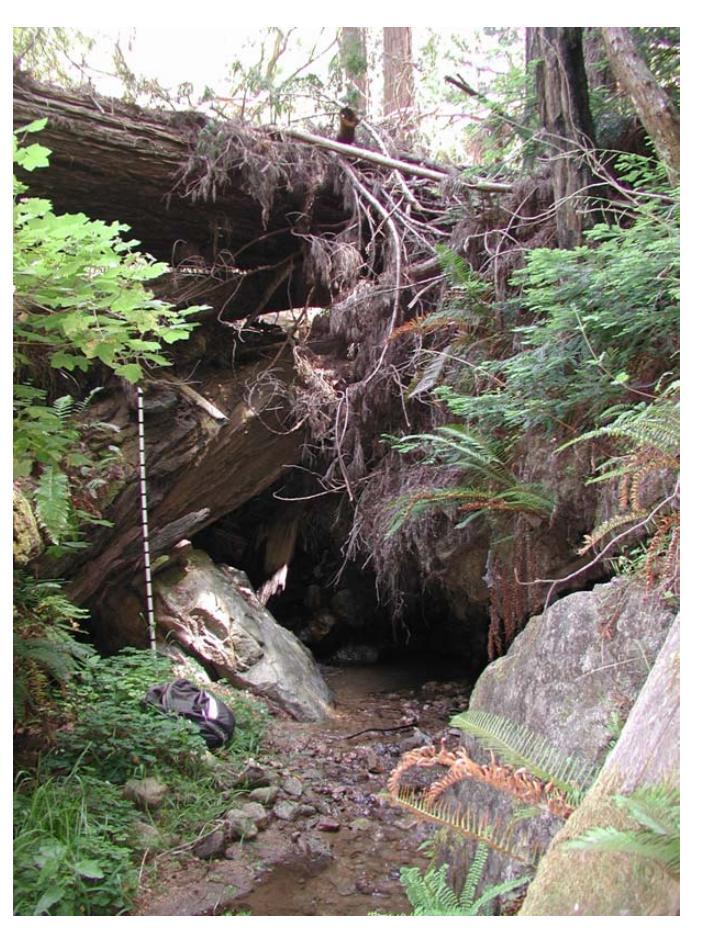
Figure 6.12 Structure jb08. Photo: Joel Casagrande 3 June 2004.

This barrier is the largest non-waterfall structure found in this sub-watershed. It is located 799 m (2620 ft) upstream of structure jb07. Several large redwood logs, resulting from natural recruitment into the channel have accumulated to form a 4 m tall complete barrier (Fig. 6.12). A substantial volume of sediment and debris has accumulated behind the structure to form a significant grade control structure in the channel. The narrow channel conditions at this location are likely prone to having debris jams. During summer conditions streamflow was percolating through the debris and accumulated sediment several meters upstream of the logjam. There was no clear path underneath the structure.

The inaccessibility of this structure and the limited benefit to improvement does not warrant the effort needed to improve this structure. Efforts should be focused downstream of this and/or in other streams in the watershed.

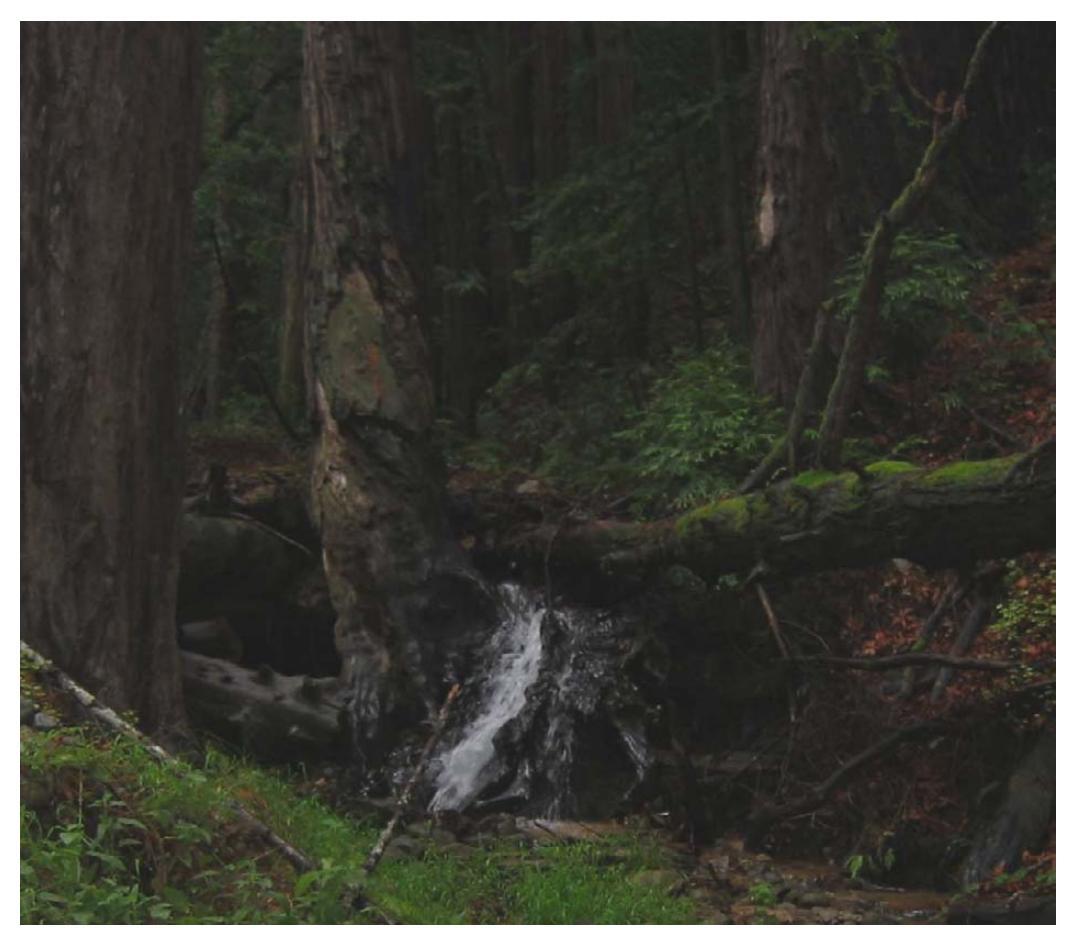
Figure 6.14 Structure jb09 looking upstream during winter streamflow conditions. Photo: Ken Ekelund 24 January 2004.

The inaccessibility of this structure and the limited benefit from improvement does not warrant the effort needed to improve this structure. Efforts should be focused downstream of this and/or in other streams in the watershed.

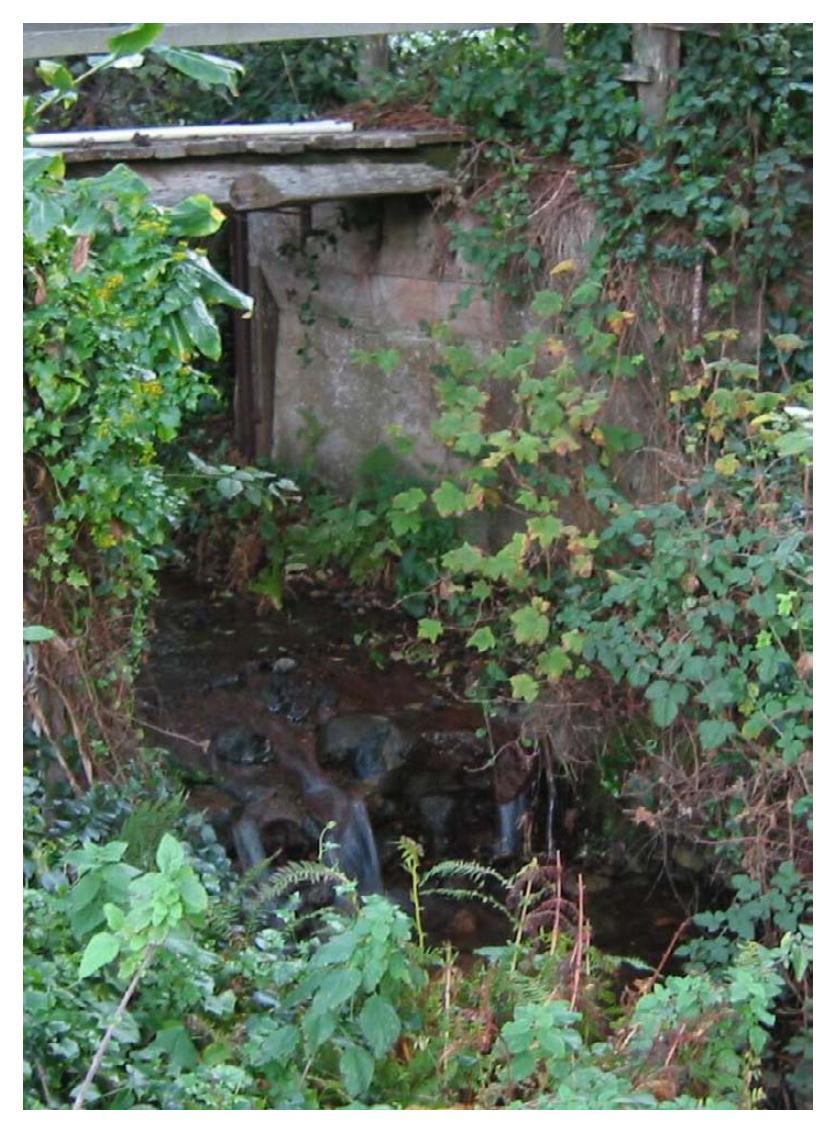
In addition to the logjams on Joshua Creek, a small concrete control structure is present on lower Joshua Creek approximately 137 m (450 ft.) upstream of the confluence with Garrapata Creek (Fig. 6.16). It stands approximately 0.40 m above the downstream water surface and there is no pool at the downstream end. At present, this structure is only a potential barrier for up-migrating adults during periods of low runoff.

Figure 6.16 Concrete control structure on Joshua Creek at the footbridge near the confluence of Garrapata Creek. Photo: Ken Ekelund, December 1, 2004.

The concrete control apron on Joshua Creek could be improved using a sledgehammer to either completely remove or create a lower notch in the center, although this could jeopardize the effectiveness of the road culvert directly upstream. Note: details of this structure are not included in Figure 6.2 or Tables 6.1 & 8.1.

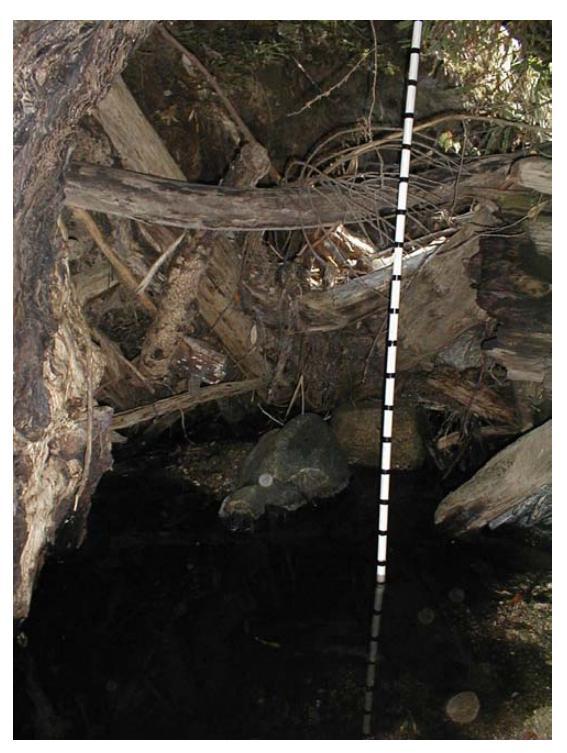
This debris jam is located 88 m (290 feet) upstream of the confluence with Garrapata Creek (Fig. 7.3 & Table 7.1). It is anchored behind narrow banks of the channel due in part to local geologic constraints as well as the presence of large streamside trees (Fig. 7.1). Woody material and minimal sediment accumulation extends upstream for several meters (Fig. 7.2). Materials include several medium to large redwood logs that have fallen into the channel due to bank erosion and through fluvial transport, with additional small woody debris accumulations at the upstream edge. Some small woody debris was removed during the site visit including much of the material shown at center of Figure 7.1.

The height and complexity of this logjam can result in difficult passage during lower streamflow volumes. Future clogging would significantly increase the severity of this structure. The accumulation of fine sediment accumulation is low.

Figure 7.1 Structure b01 in Wildcat Creek. Photo: Joel Casagrande 12 September 2004.

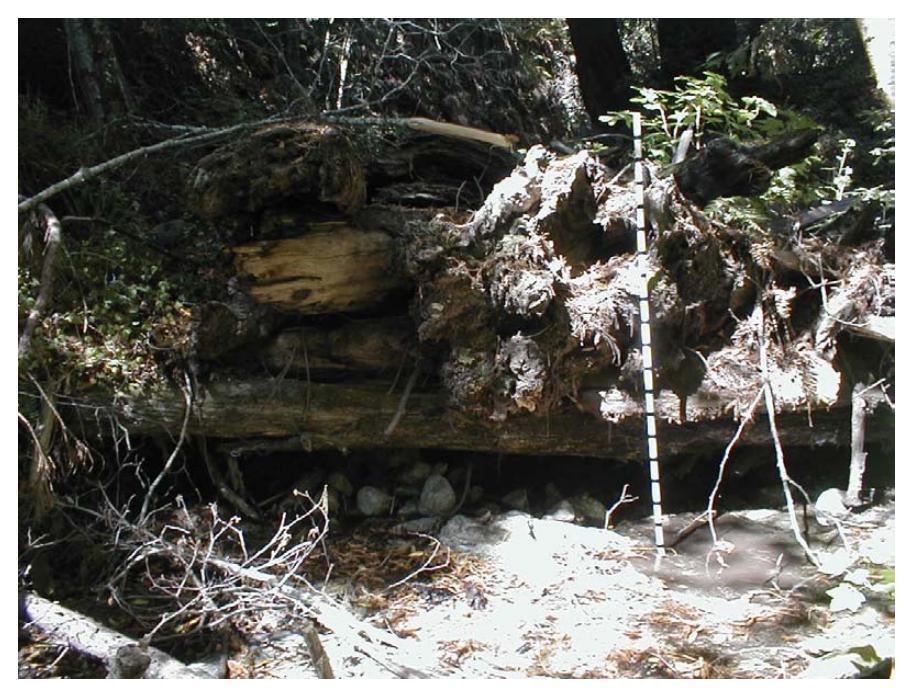
Structure wb02 is located approximately 226 m (740 ft) upstream of the confluence with Garrapata Creek (Table 7.1). This structure is approximately 1.6 m in height at center and right bank (Fig. 7.4), but a shorter, more passable route exists along the left bank (0.5 m from the downstream bed elevation). The woody debris provide complex habitat for juvenile trout, especially during winter. Flow underneath this structure was clogged with woody debris and coarse sediments, suggesting that possible fish passage is best achieved along the left bank. However, it is likely this route is only available at higher flows.

Figure 7.4 Structure b02, a logjam, looking upstream. Photo: Joel Casagrande, 12 September 2004.

A few individuals with hand or chain saws can easily improve this logjam. On the right bank side, SWD should be removed by hand to allow passage under or around the larger logs. On the left bank, passage should be improved by cutting larger logs that are accumulating woody debris and forming several small yet difficult steps, especially during low runoff events.

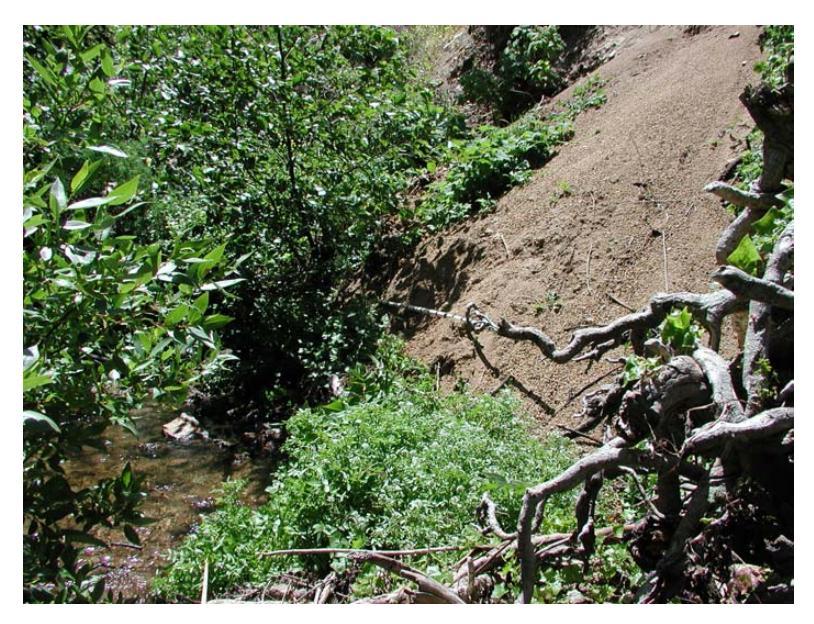
One small landslide was observed in lower Garrapata Creek approximately 1369.5 m (4582 ft) upstream of the Garrapata Creek Lagoon (Figs 9.2 & 9.3). Loose sediment currently ready for transport was quantified by measuring the length (along stream axis), height (up the bank) and estimated depth, or thickness of loose sediments. The volume of exposed loose sediment at this slide was estimated at approximately 39 m³.

Figure 9.3 Emergent vegetation growing along the toe of the slide. Young alders are also shown growing nearby. The stream is shown in the lower left corner. Photo: Joel Casagrande 2 June 2004.
