Publication No. WI-2019-03

18 March 2019

The Watershed Institute

**Landslide, Channel, and Road Culvert  
Sediment sources at Hollister Hills  
State Recreational Vehicle Area  
2018 Report**

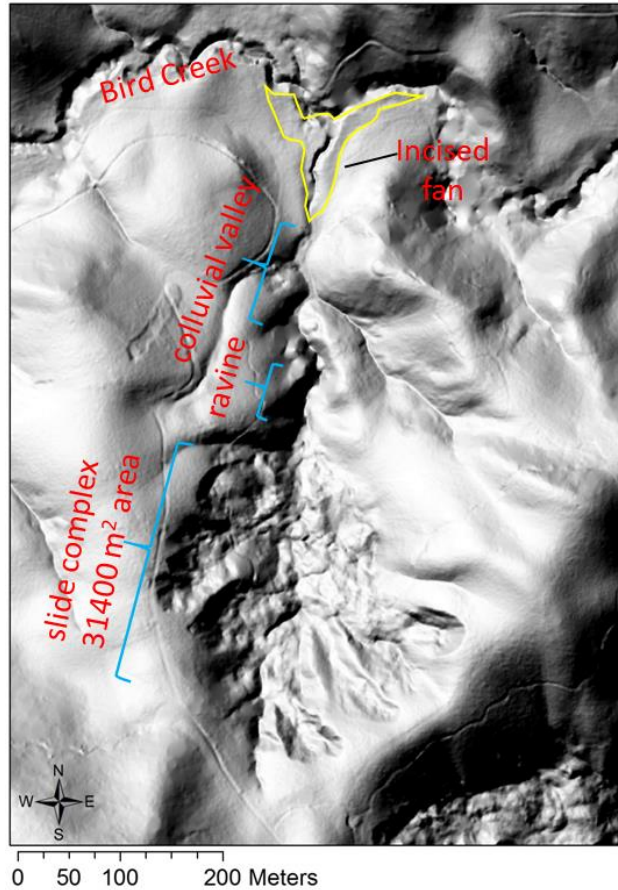
In general, slope failure changes the local gradient of the valley in which it occurs, and gully systems develop that move sediment from the toe of a slide to Bird Creek during periods of heavy rain (Smith et al. 2016). That is the general case in the Colluvial Creek slide system (Fig. 4). In the Hudner Creek slide system (Fig. 5), the slide body intersects a small tributary to Bird Creek (Hudner Creek). The slide body dammed Hudner Creek, which ponded water and forced sediment to aggrade behind the slide body. A gully has cut a ravine through the slide body and is harvesting the trapped wetland sediment.

Figure 4. Key geomorphic elements of the Colluvial Creek landslide system. Background is hillshade from 2011 LiDAR-based DEM (1 m/pixel).

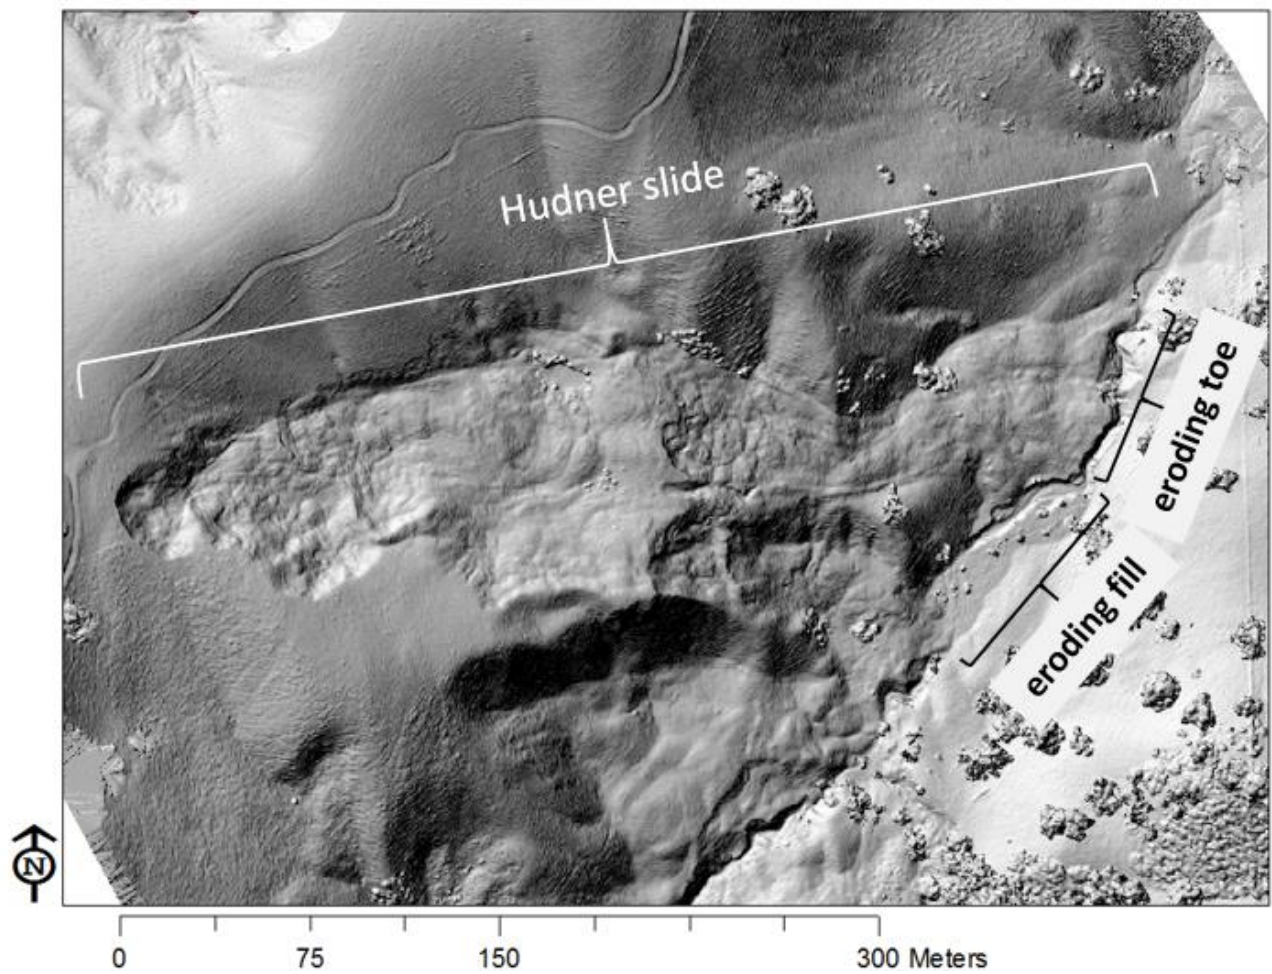
Figure 5. Key geomorphic elements of the Hudner landslide system plotted on hillshade of 4 cm/pixel DSM derived from May 2018 photogrammetry.

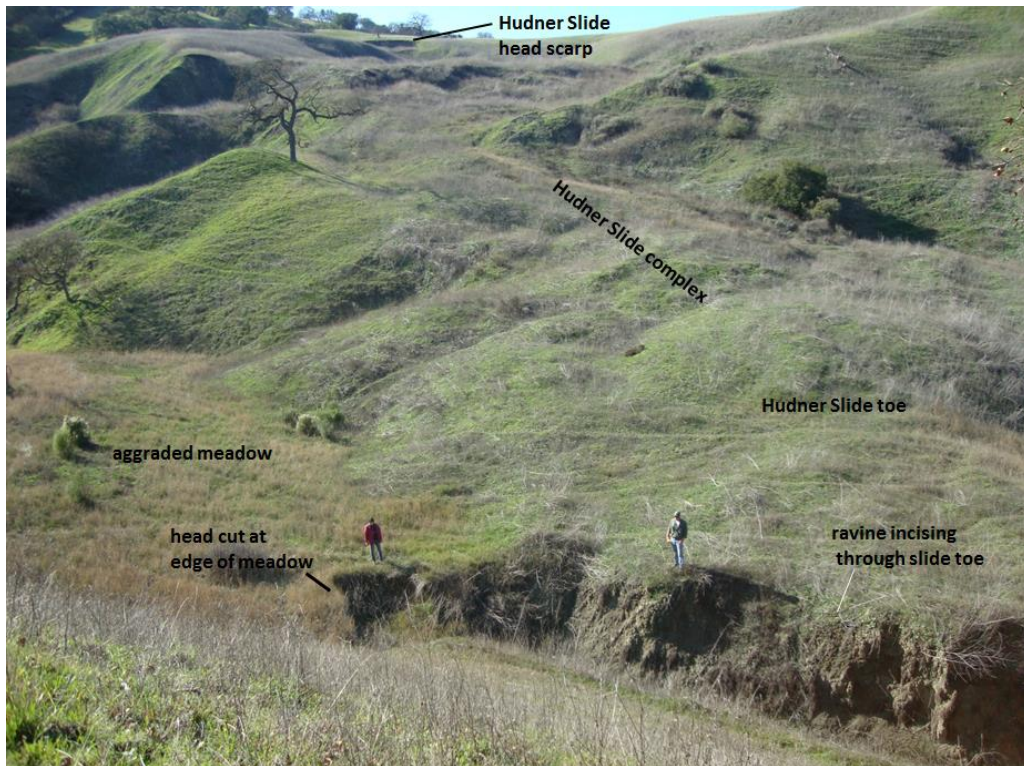
Figure 6. Oblique photo showing field relations between slide elements and valley sediment transport system.

The multiphase sediment transport process active in Hudner Slide includes gullying that liberates slide-related sediment from the slide toe and sediment trapped upstream of the slide toe (Smith et al. 2016; Figs. 6 and 18). Sediment released to Bird Creek through this gully system alone during the winter of 2017 is estimated at approximately 1100 m<sup>3</sup> (1460 yd<sup>3</sup>), based upon 55 m of headward gully growth and a typical cross-sectional area of 20 m<sup>2</sup> (Fig. 19). That volume represents approximately 2950 tonne (2900 ton) assuming an alluvium density of 2590 kg/m<sup>3</sup>, which is the value calculated for sediment deposited in an “alluvial meadow” (Dumikh 2014). The volume and mass reported here are minimum contributions of sediment to Bird Creek from Hudner Creek because there are similar active gully systems located farther up the Hudner Creek valley.

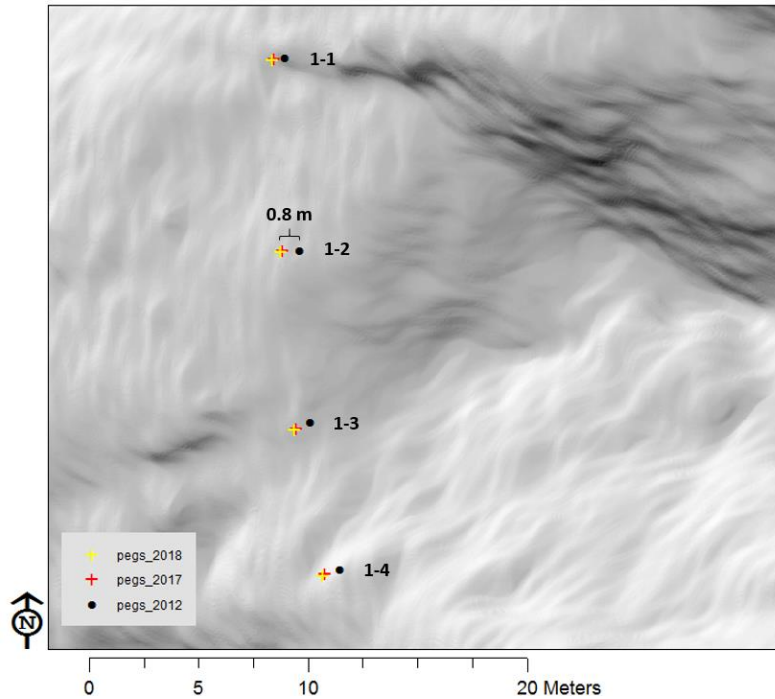
The Colluvial Creek slide complex includes several individual slump features, a colluvial and alluvial system that historically transported sediment to a sediment fan, and a gully that has incised the fan (Fig. 4). Five of the slumps were monitored for motion since January 2012 (Fig. 10, Table 2). Slide 1 shows the typical movement history where only a few centimeters of motion occurred in any given year until the heavy rains of 2017. In 2017 slide 1 moved 50 cm. The slide again slowed during a more typical rain year in 2018 (Fig. 11; Table 2). Slide 3 moved over 5 m in 2017, which was the largest displacement measured in the Colluvial Creek slide system (Fig. 12; Table 2). Like the other slides, slide 3 returned to a few centimeters of movement in 2018 (Fig. 12). The intense rains of 2017 triggered movement on all the slides monitored in the Colluvial Creek system (Fig. 13).

Figure 11. Close view of pegs in head of Colluvial Creek Slide number 1 (Fig. 10 for context). Background is hillshade from 5/2/2018 low altitude photogrammetry.

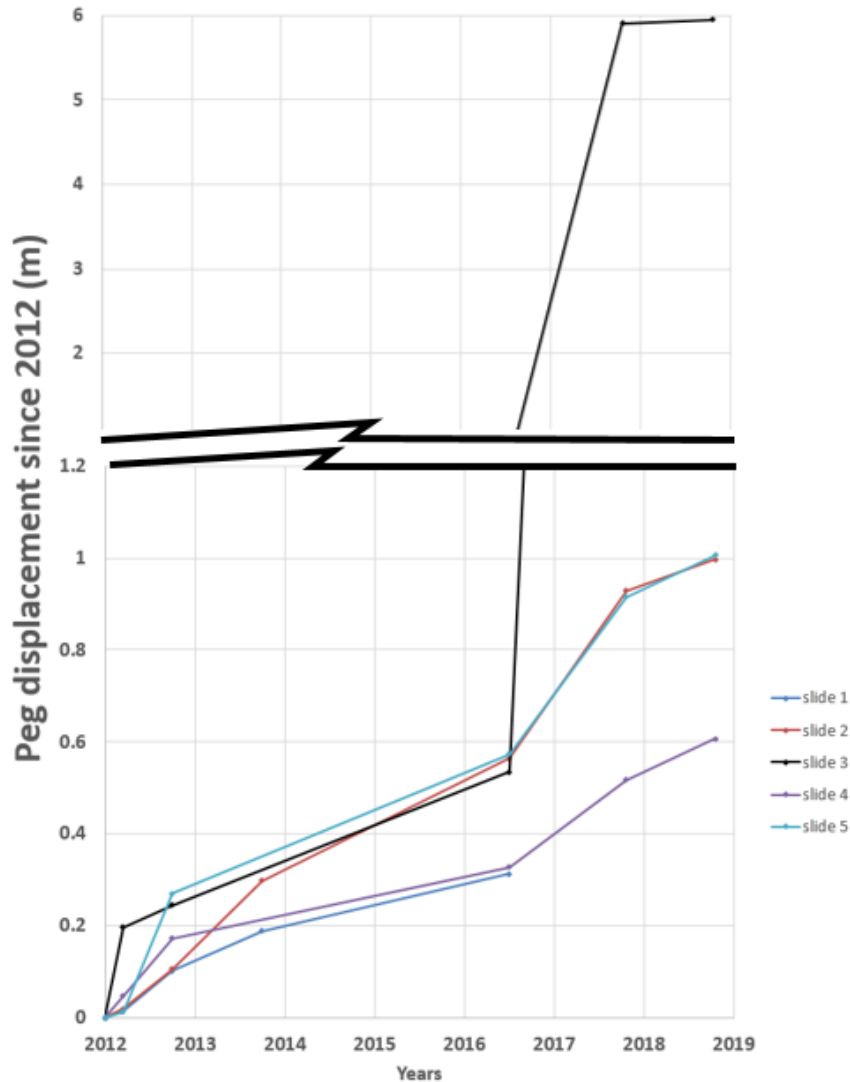
Figure 13. Slide displacement history of Colluvial Creek Slide. Note scale change to accommodate large displacement of Slide 3 in winter 2017.

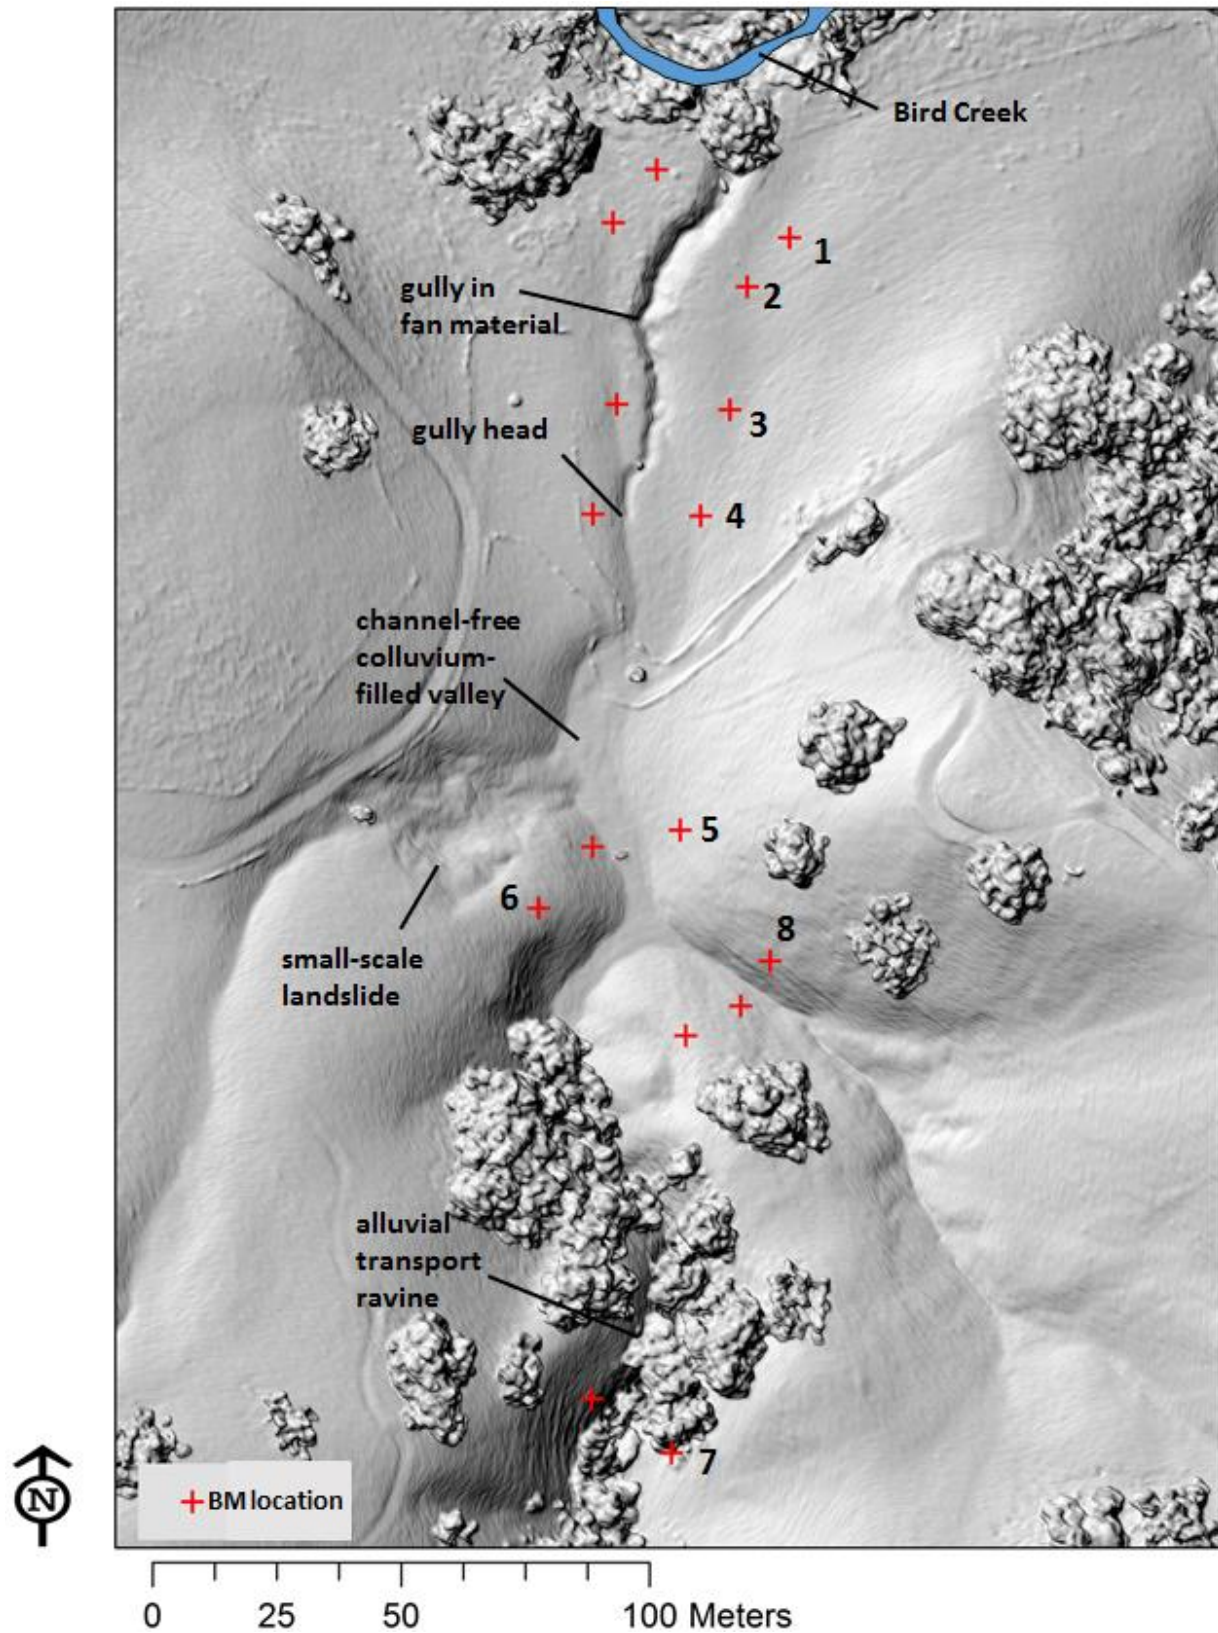
Figure 14. Benchmark locations for Colluvial Creek cross sections shown in Figure 15. Background is hillshade from 5/2/2018 low-attitude photogrammetry.

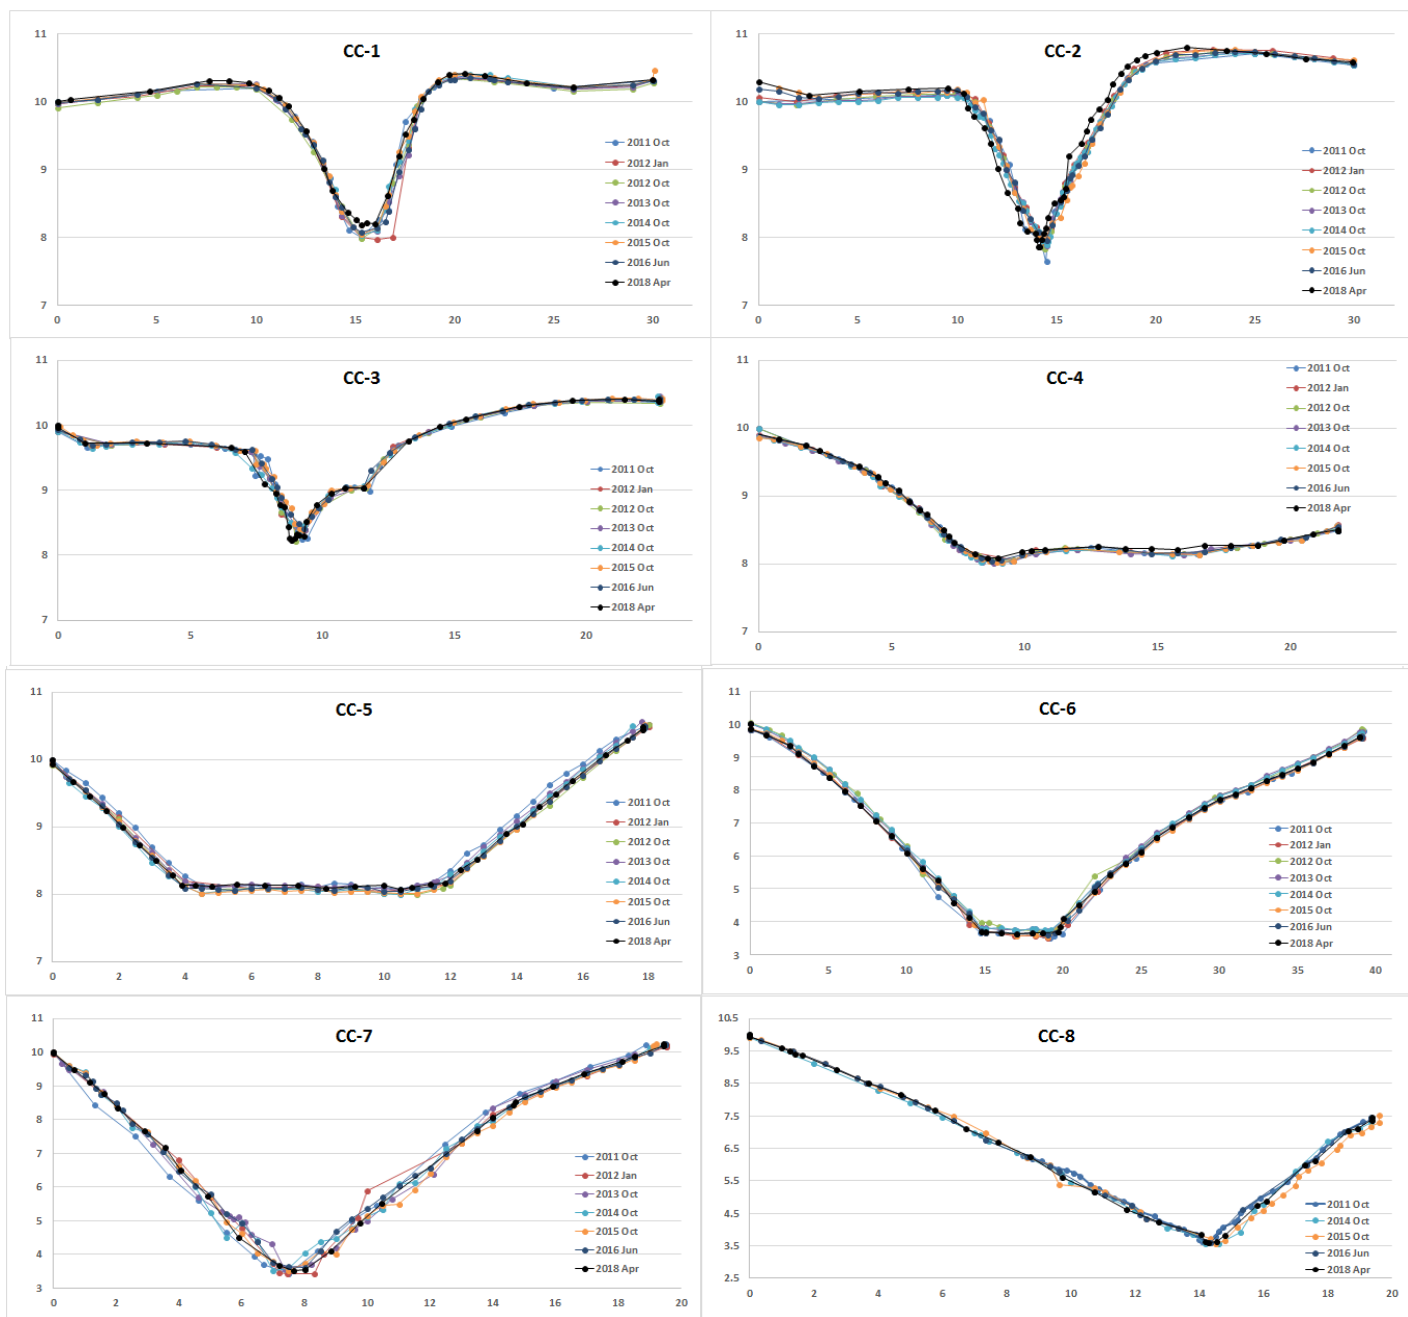
gullies and Bird Creek since 2012 (Fig. 15). Evidence of minor erosion in the gully incising the sediment fan show that the gully occasionally transports water, but geomorphic changes have typically been smaller than between-survey precision on cross sections (Fig. 15). Cross section 4 was positioned only a few centimeters up-valley of the gully head shown in Figure 14 in 2012 but has not captured any topographic incision (Fig. 15). The cross section would have captured active head cutting if the gully had extended just a few centimeters.

Figure 15. Time-series cross sections of Colluvial Creek. Horizontal axes are distance (m) from left benchmark. Vertical axes are elevation in meters relative to 10 m assigned to left benchmark. See Figure 14 for locations.

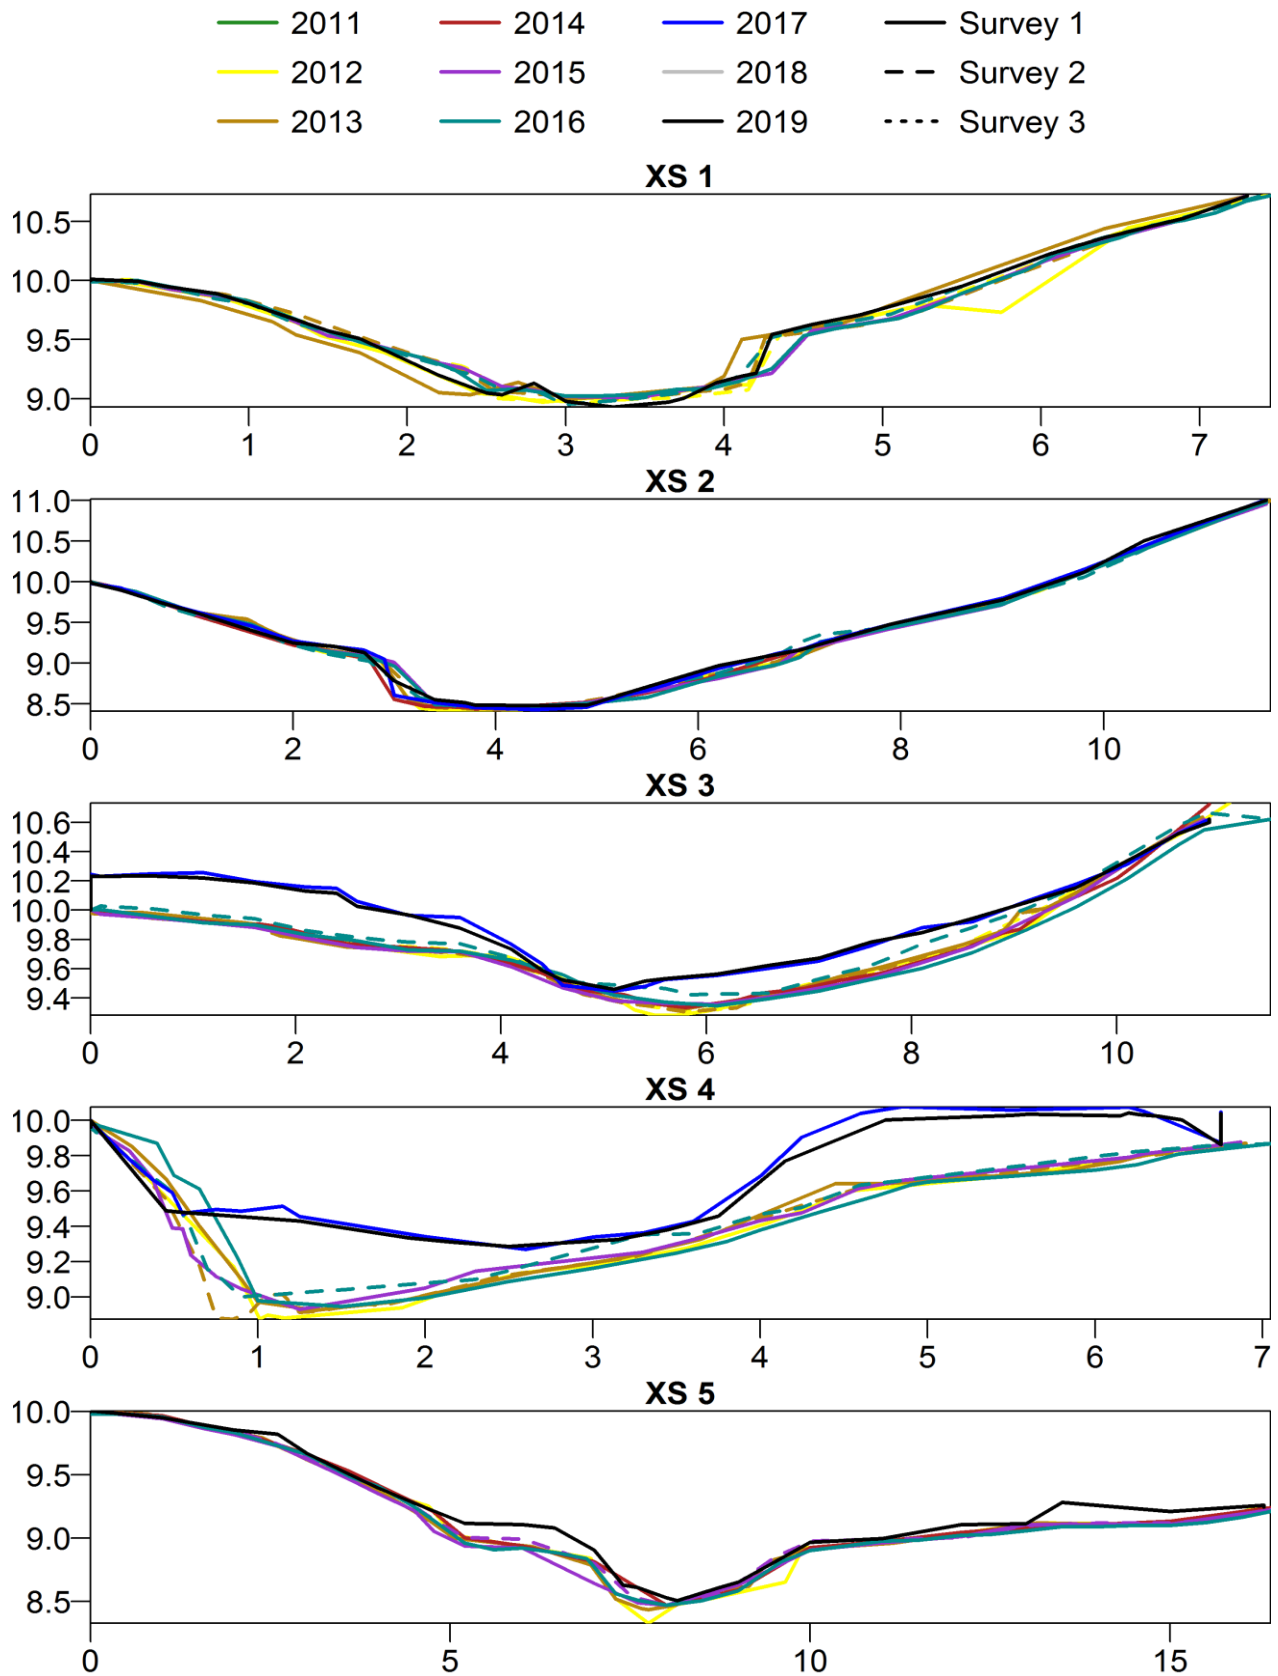
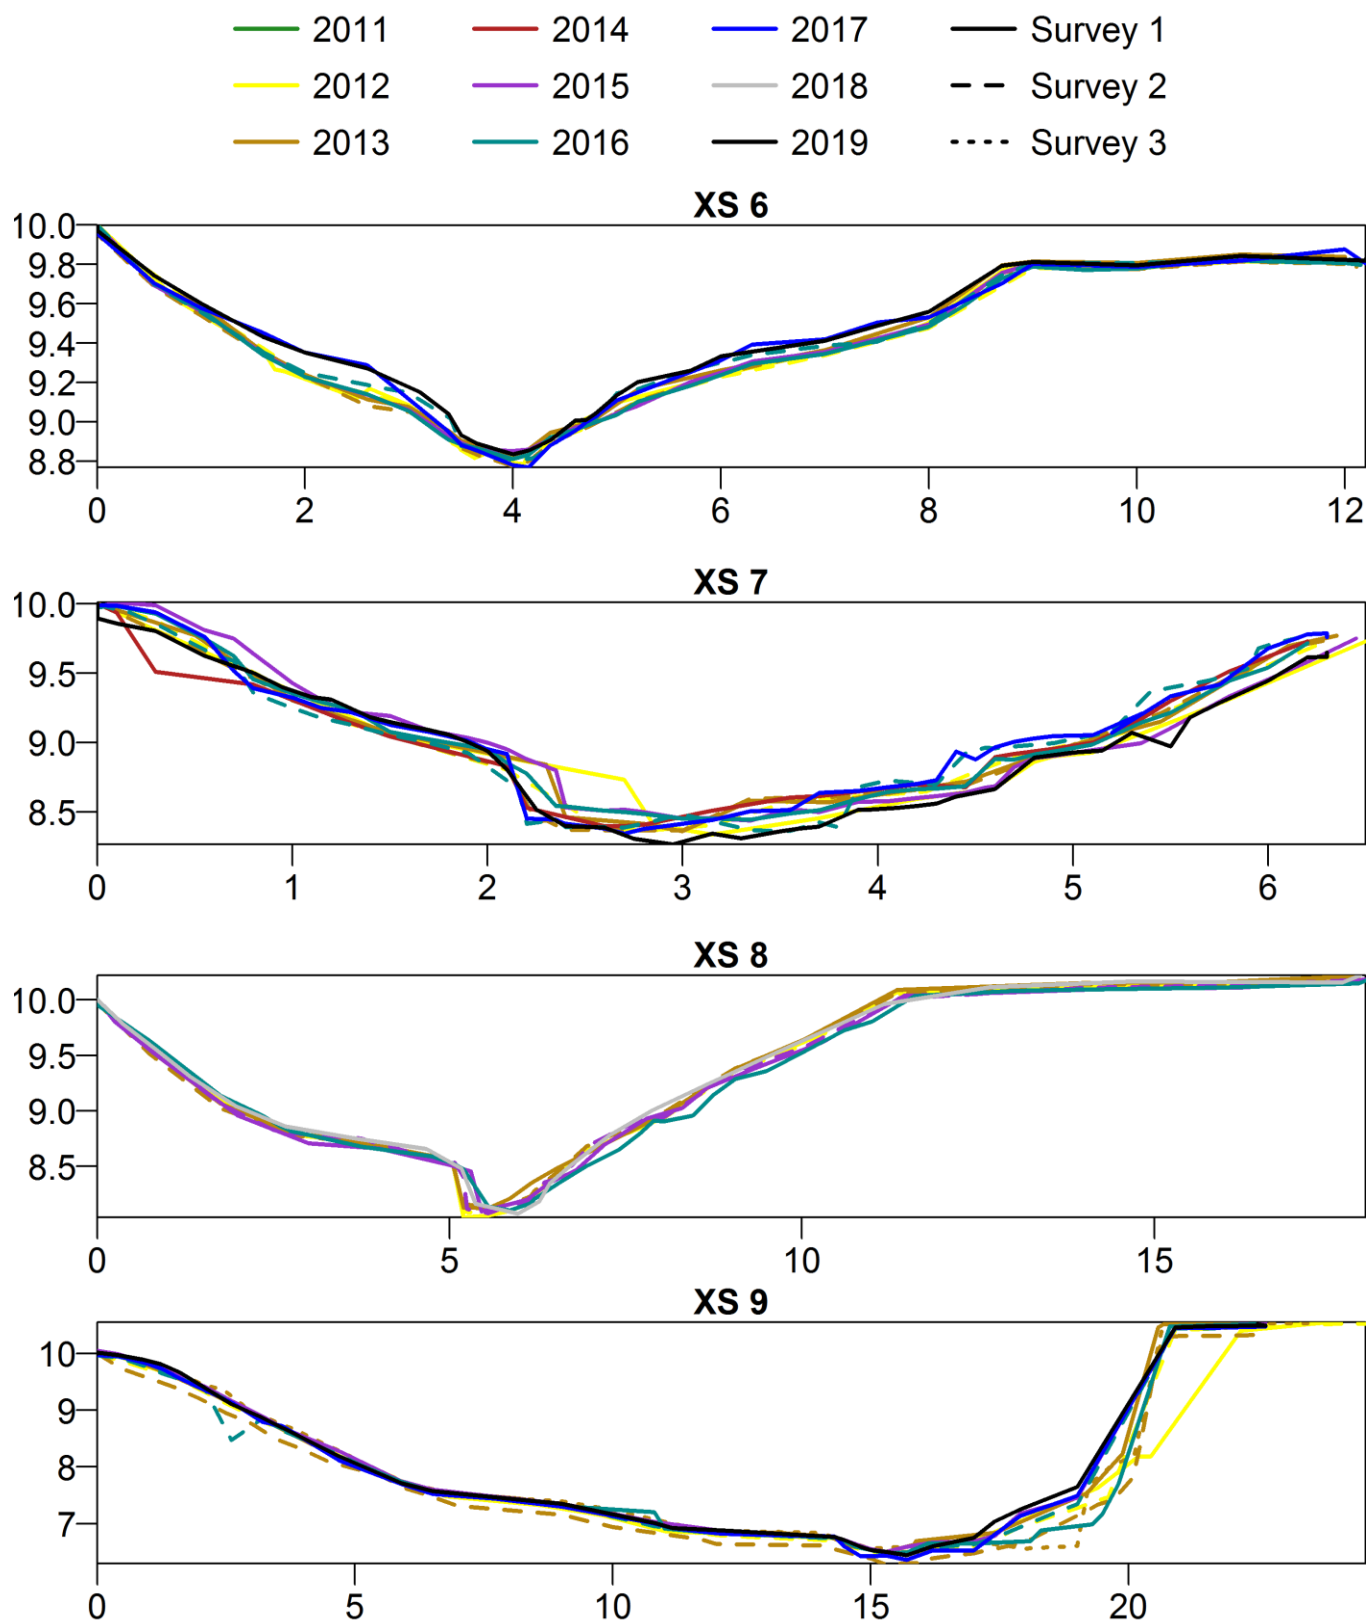
High magnitude storm runoff events generate high shear stress, and sometimes high sediment loads from the watershed, which can impact stream morphology. The extreme rain events of winter 2017 provided such a test of channel stability and function. All transects maintained their pre-2017 geometry except for transects 3, 4, and 5 (Figs. 9  
28

and 21). The reach of river that starts between transects 2 and 3 and ends between 5 and 6 experienced varying amounts of significant aggradation of sand-sized bed material in 2017. We estimate the volume of sand and small gravel stored in the channel to be approximately 320 m<sup>3</sup> (420 yd<sup>3</sup>) by averaging the change in cross sectional areas between adjacent cross sections and multiplying by the distance between cross sections. That volume is the same order of magnitude estimated to have been input directly to the channel in 2017 by a small landslide located just 90 m upstream of transect 1 (Fig. 20). The channel is relatively straight and narrow between the slide and transects 1 and 2. Therefore, interruption of sediment transport is unlikely in this reach. A 90-degree left bend in the Bird Creek channel just after transect 2 apparently slowed the flow enough to trigger a pattern of aggradation in the reach just downstream, measured in transects 3 to 5. The volume of sediment deposited gradually tapered downstream until the 300 m<sup>3</sup> of sand from the slide was exhausted just downstream of transect 5.

Figure 21.: Time-series benchmarked cross sections in Bird Creek in the Hudner area. Dashed lines are used for years with multiple surveys. See Figure 9 for locations.

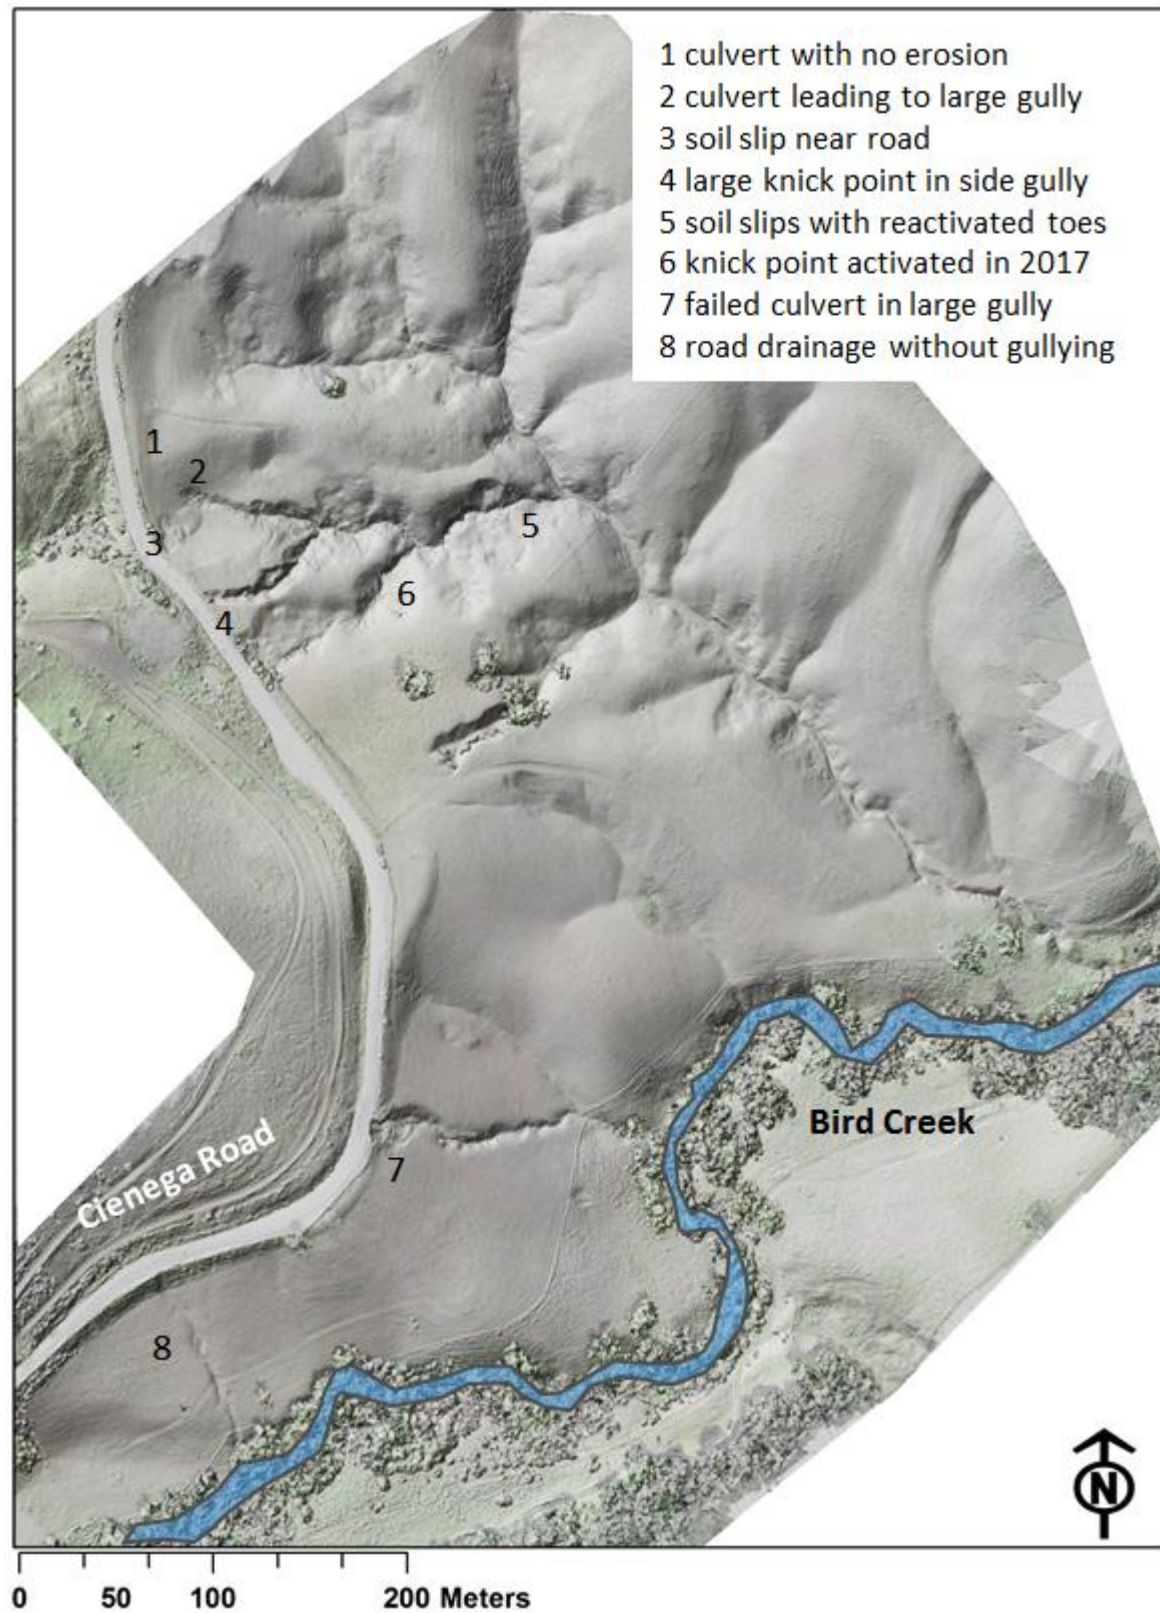
Drainage networks grow from budding of new side channels and headward growth of those new channels through up-slope erosion. This natural process is considered a hazard when the resulting erosional features intersect roads or other infrastructure. These processes are accelerated by intense rainfall or flow modifications that force local high erosion rates, and can be associated with slope failure features. Specific erosion rates and slip rates are not well documented. This report discusses some of the road-related erosional features and geomorphic changes observed along Cienega Road.

Figure 22. Culverts and erosional features along Cienega Road. Image is blended hillshade and orthophoto.
