Report No. WI-2003-07 8<sup>th</sup> April 2003

Steelhead Habitat
Assessment and
Restoration in Upper
Williams Canyon Creek:
Mitteldorf Redwood
Preserve, Monterey
County, California

Dr. Douglas Smith (Ph.D.)
Bob Curry (Ph.D.)
Dennis Jackson (M.S.)
Amy Thistle
Chris Marin

8 April 2003

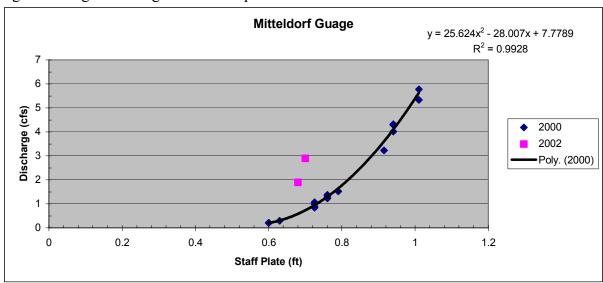
Figure 6: Stage-Discharge Relationship in 2000 and 2002

A stage-discharge relationship was developed to convert stage (ft) recorded by the gage to discharge (ft<sup>3</sup>/s). An index of stream stability is the stability of the stage-discharge relationship through time. An analysis of the change in stage-discharge relationship (Fig. 6) shows between 0.12 ft and 0.20 ft of stage decrease for a constant discharge between Spring 2000 and Spring 2002. This change is due to a change in channel shape during that interval or a change in the gage pool control. The channel could have become slightly wider and/or deeper. The change in stage-discharge relationship is statistically significant (p<0.01), indicating that net erosion may

have occurred at the gage site, approximately 20 m downstream from the lodge stairs between 2000 and 2002. Therefore, during those two years, the water passing by the lodge had more energy than was required to move the sediment supplied from upstream; the excess water energy caused slight enlargement of the local channel. Although the amount of scour was not large, it is significant to note that any "excess" sediment supplied to the channel during that same time, was insufficient to aggrade (partially fill) the channel.

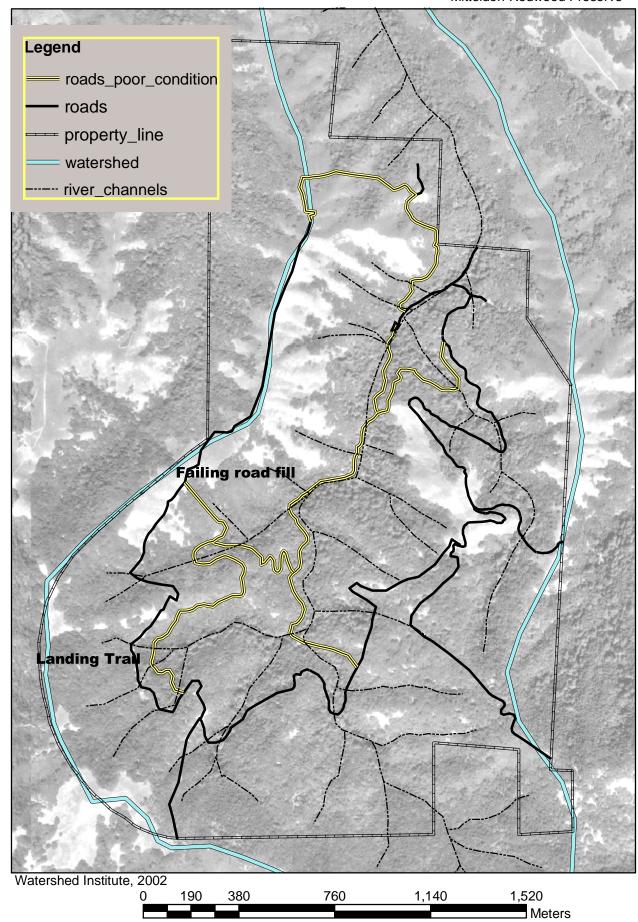
In addition to the individual sediment sources listed in table 8, there is also sediment eroded from the bare road surfaces throughout the watershed. Minor erosional features (rills) are pervasive on the road and trail surfaces in the watershed. We estimate the sediment yield from road surface erosion in the following general way. Annual sediment yield=road width (10 ft) X road length (52800 ft) X erosion rate from rilled roads (0.03 ft/yr) X %roads rilled (50%) X delivery ratio (80%). This amounts to a rough estimate of 6300 ft³/yr or 230 yd³/yr of sediment delivered from the general road surfaces to the creek channel. Reducing the amount, and velocity, of water runoff on the road surfaces, can reduce road rilling. The kinds of solutions that an erosion-control consultant might employ include, road outsloping, water bars,, rolling dips, and open-top box culverts. Professional erosion control consultants should be hired to design and place those kinds of erosion-control measures. Figure 11 shows roads that should be decommissioned.

We recommend decommission unnecessary roads as the best means of reducing road-generated sediment, both from individual sites and general surface erosion. We estimate that 3.7 miles of road with severe erosion sites are not required, and should be decommissioned (Fig. 11). Most of this road system is already abandoned and designated as trail on the BSLT map of the Preserve, so the total mileage of roads to be decommissioned in the future is far less than 3.7 miles. The highest priority roads for decommissioning are where the side-cast road fill is failing. The highest priority for decommissioning is the "Landing Trail," which parallels the "Headwaters Road" (Fig. 11). Another critical site is the road below the "Ladder Trail;" however, heavy equipment currently has no access to that site (Fig. 11). Road decommissioning should be planned with the consultation of experts.
