Publication No. WI-2018-08

The Watershed Institute

School of Natural Sciences
California State University
Monterey Bay

**Current Conditions and
Restoration Scenarios for
the Carmel River and
Riparian Corridor at the
Rancho Cañada Parcel of
Palo Corona Park: Carmel
Valley, CA**

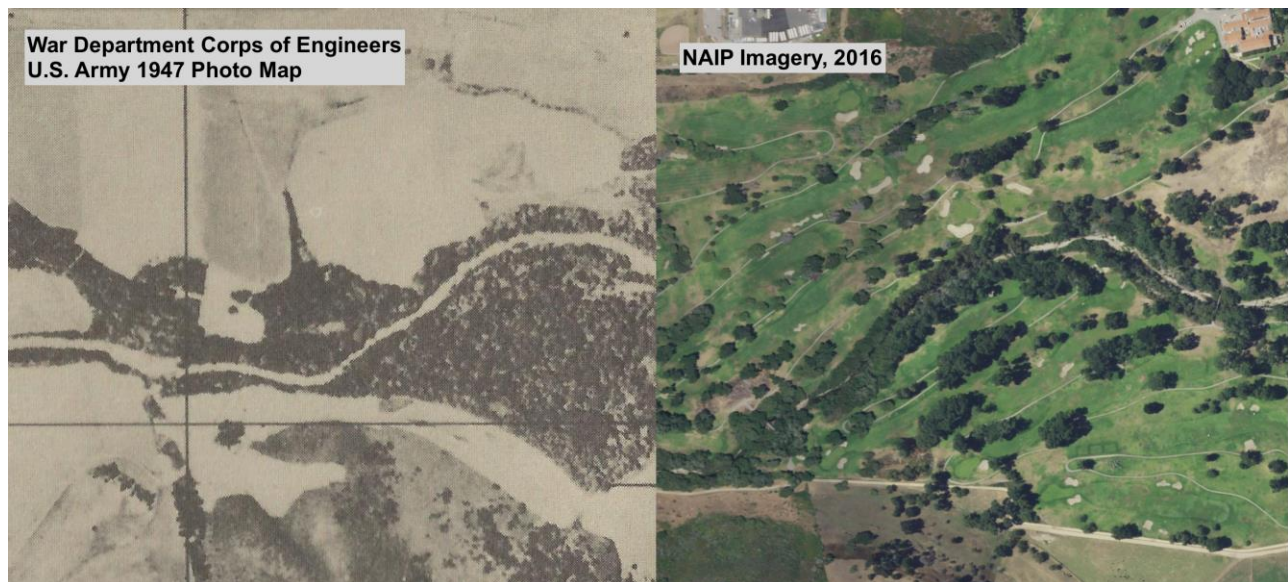
Figure 2. Comparison of forested portion in the south area of the Rancho Cañada Unit from 1947 to 2016. Tree species cannot be determined from the 1947 imagery.

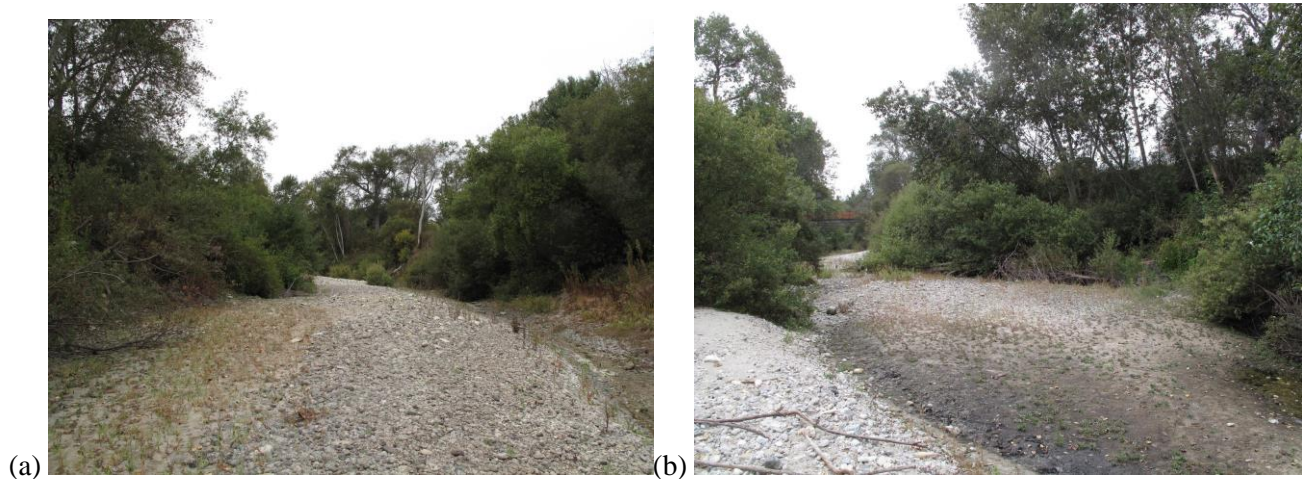
Figure 4. (a) Riffle cross section (b) Pool cross section

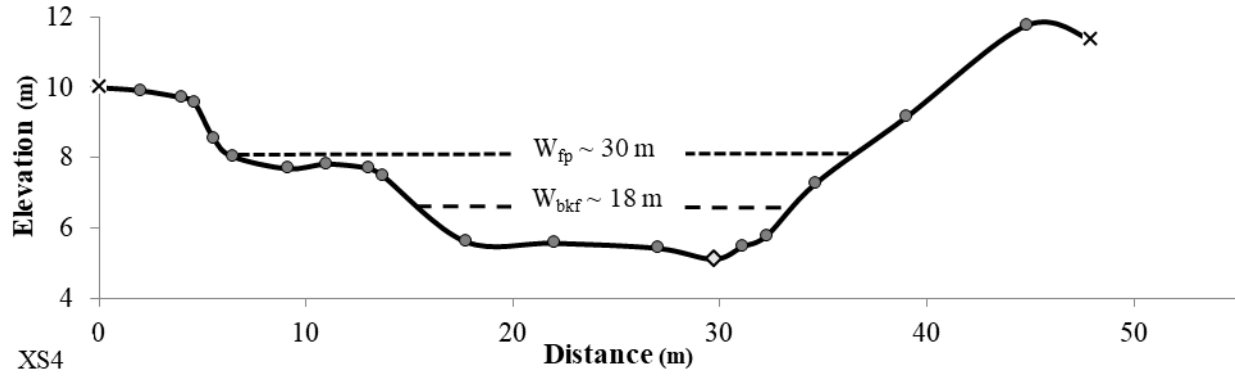
Figure 9. Cross Section 1 current channel dimensions surveyed on September 14th, 2018 measured at established benchmarks (X) from the left to right river back looking downstream with indicated distances for flood-prone width (W_{fp}) and bank full widths (W_{bkf}) calculated from maximum channel depth (D_{max}) determined at the thalweg (\diamond).

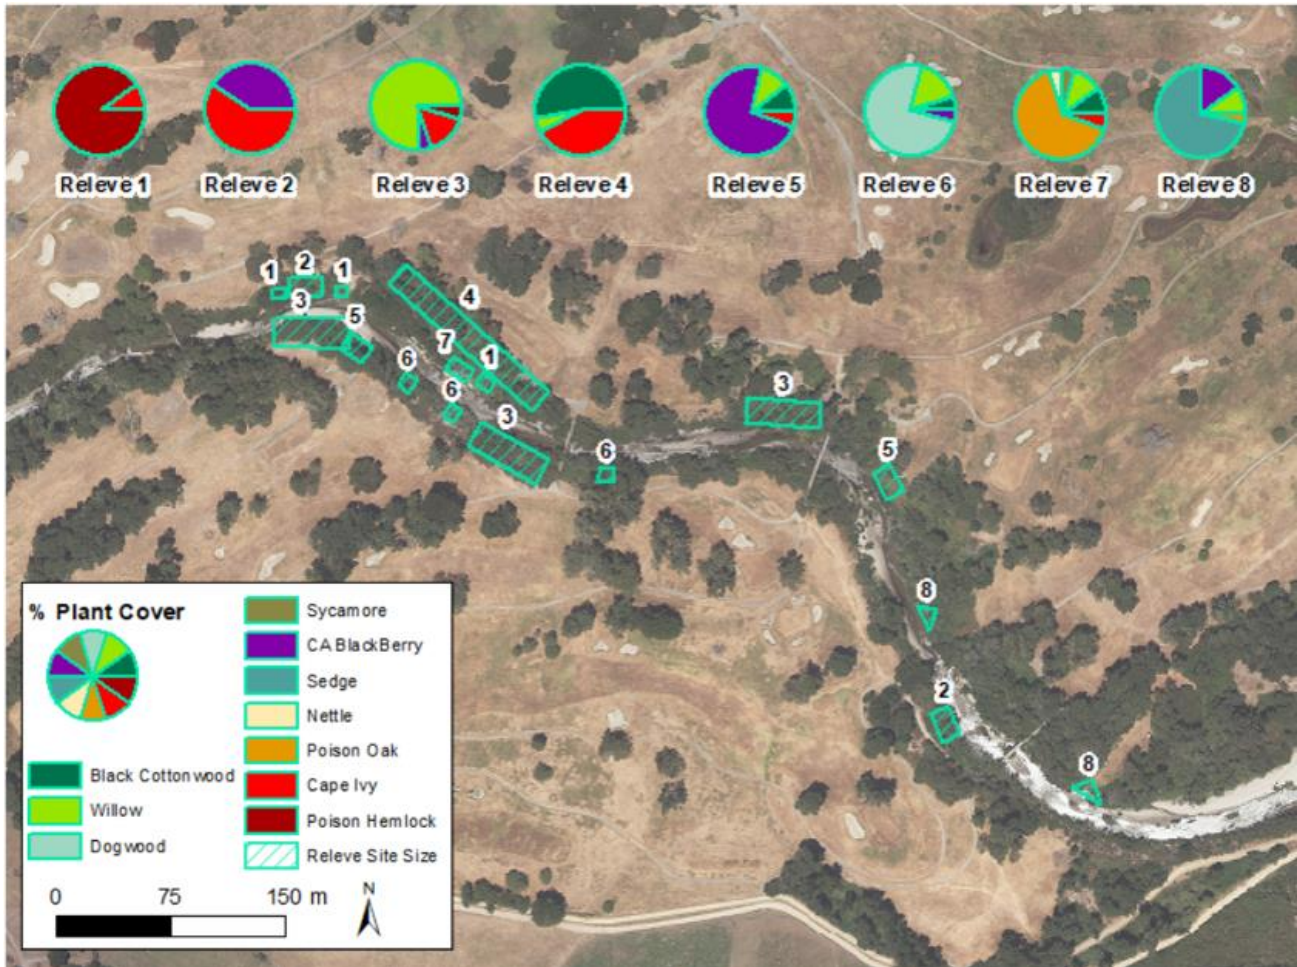
Because the PCRCP was a former golf course, each site was impacted by competition from exotics, erosion, groundwater pumping, altered flood regime, rip-rap, human caused channelization, and grazing. Specifically, relevé site 1 was highly eroded and had a steep bank on the transition zone. Relevé site 2 had a tall and steep transition zone. Details of each site can be found on Table 10 and locations of relevé sites with their respective plant cover percentages can be found in Figure 12.

Figure 12. Visual representation of relevé survey showing plant species greater than 1% cover from each of the relevé sites.
