Report No. WI-2017-05
17 October 2017

The Watershed Institute

2017 Annual Report: Hydrologic Conditions in Baseflow Reaches Pursuant to Conditions 14 and 15, Santa Lucia Preserve, Monterey County, California

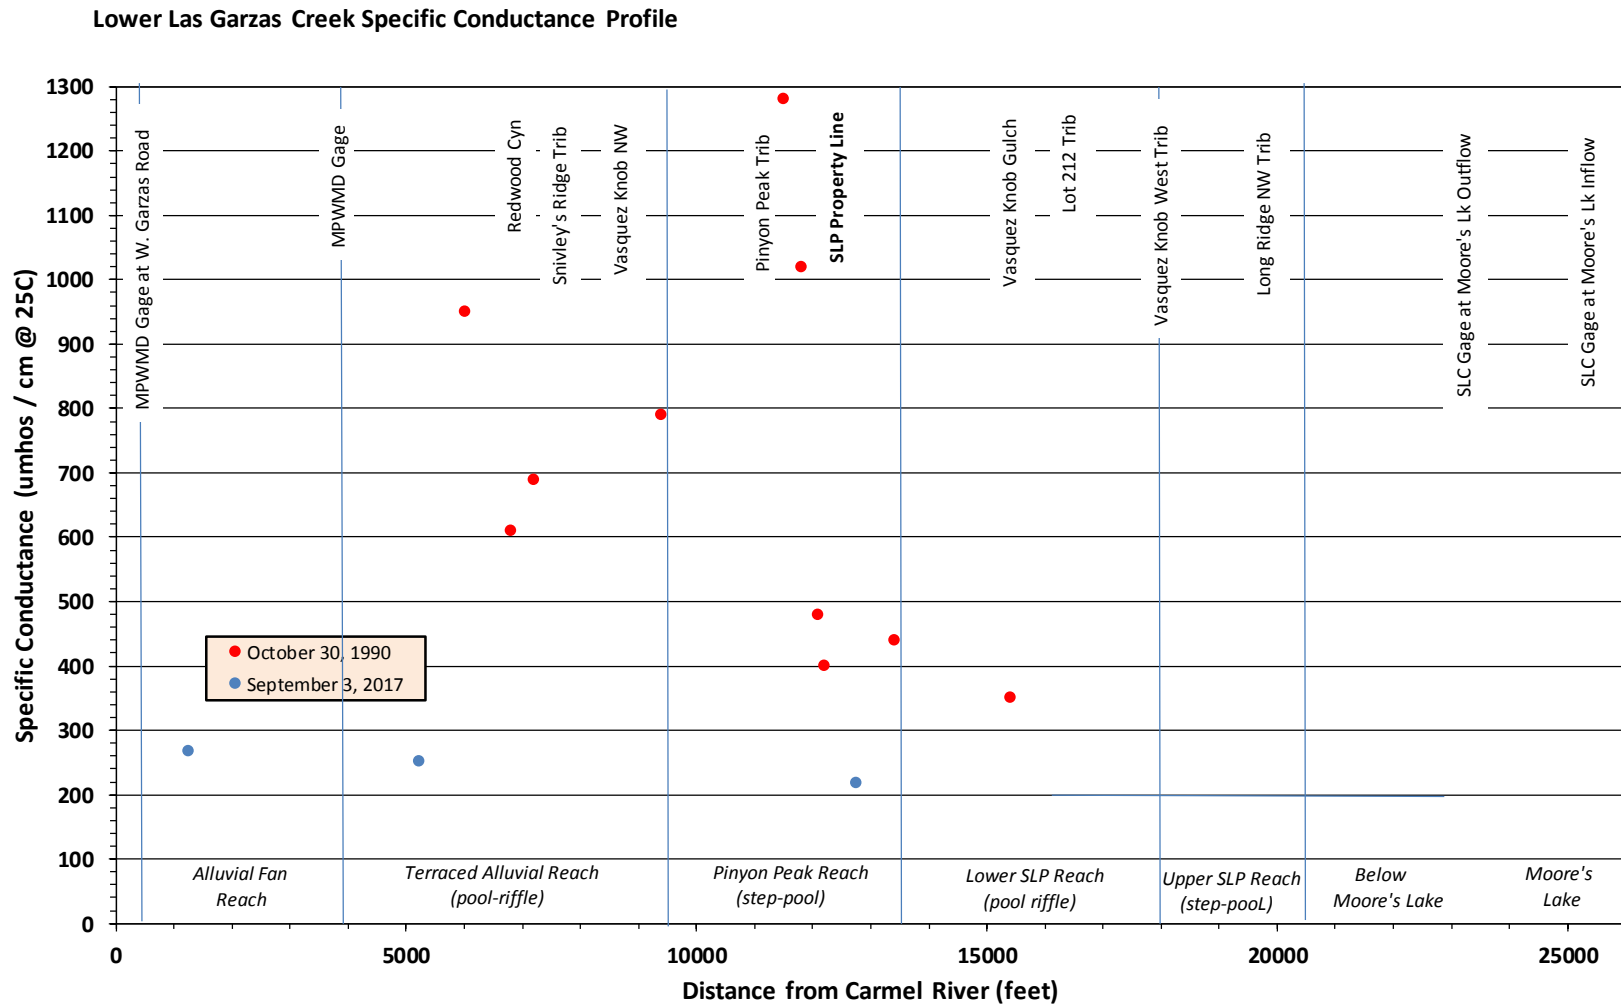
Figure 4. The comparison of Lower Las Garzas Creek specific conductance measurements from October 1990 and September 2017 illustrated the 2017 specific conductivity was lower than 1990 conditions. The specific conductivity data for 1990 was extremely variable, so it is very difficult to "characterize" the data for 1990 with a meaningful average.

Specific conductivity was extremely variable in 1990. The specific conductance from 2017 is lower than 1990 but generally follows the same spatial trend of decreasing conductivity as distance increases from the Carmel River (Figure 4).

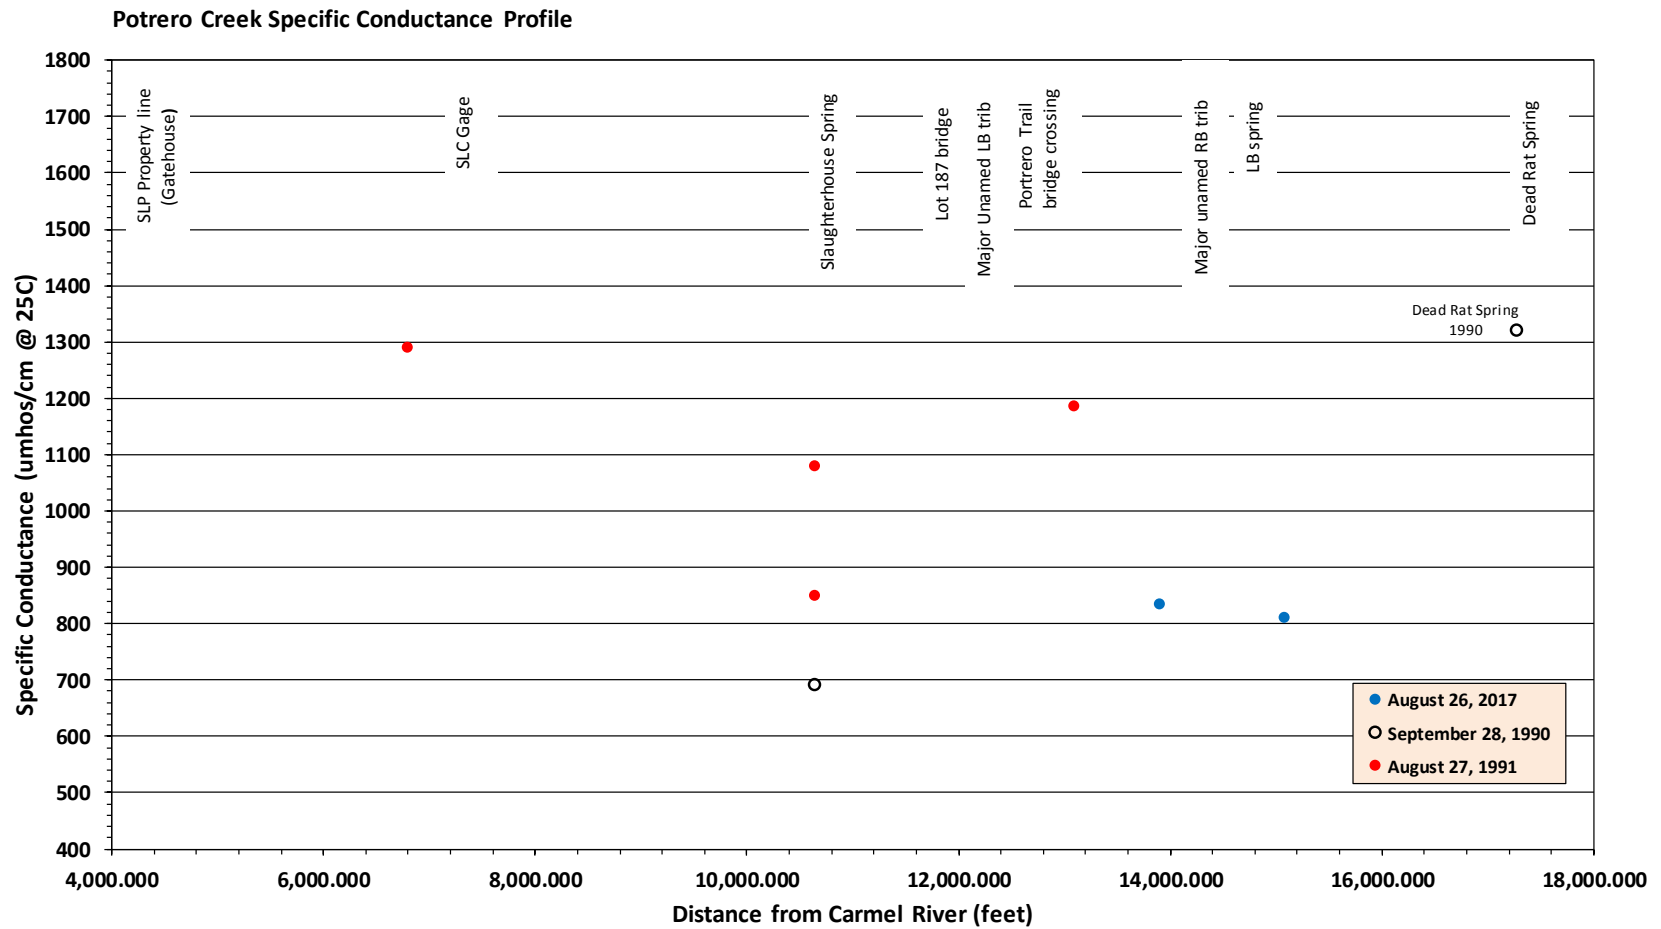
Figure 7. The comparison of Potrero Creek specific conductance measurements from September 1990, August 1991 and August 2017 illustrated the 2017 specific conductivity is lower than 1990 and 1991 conditions.

but still well below average. The Potrero Creek specific conductance measurements taken in 2017 were generally lower than the 1991 measurements (Figure 7). Historically, Potrero Creek conductivity measurements have consistently been high relative to other creeks on the Santa Lucia Preserve.

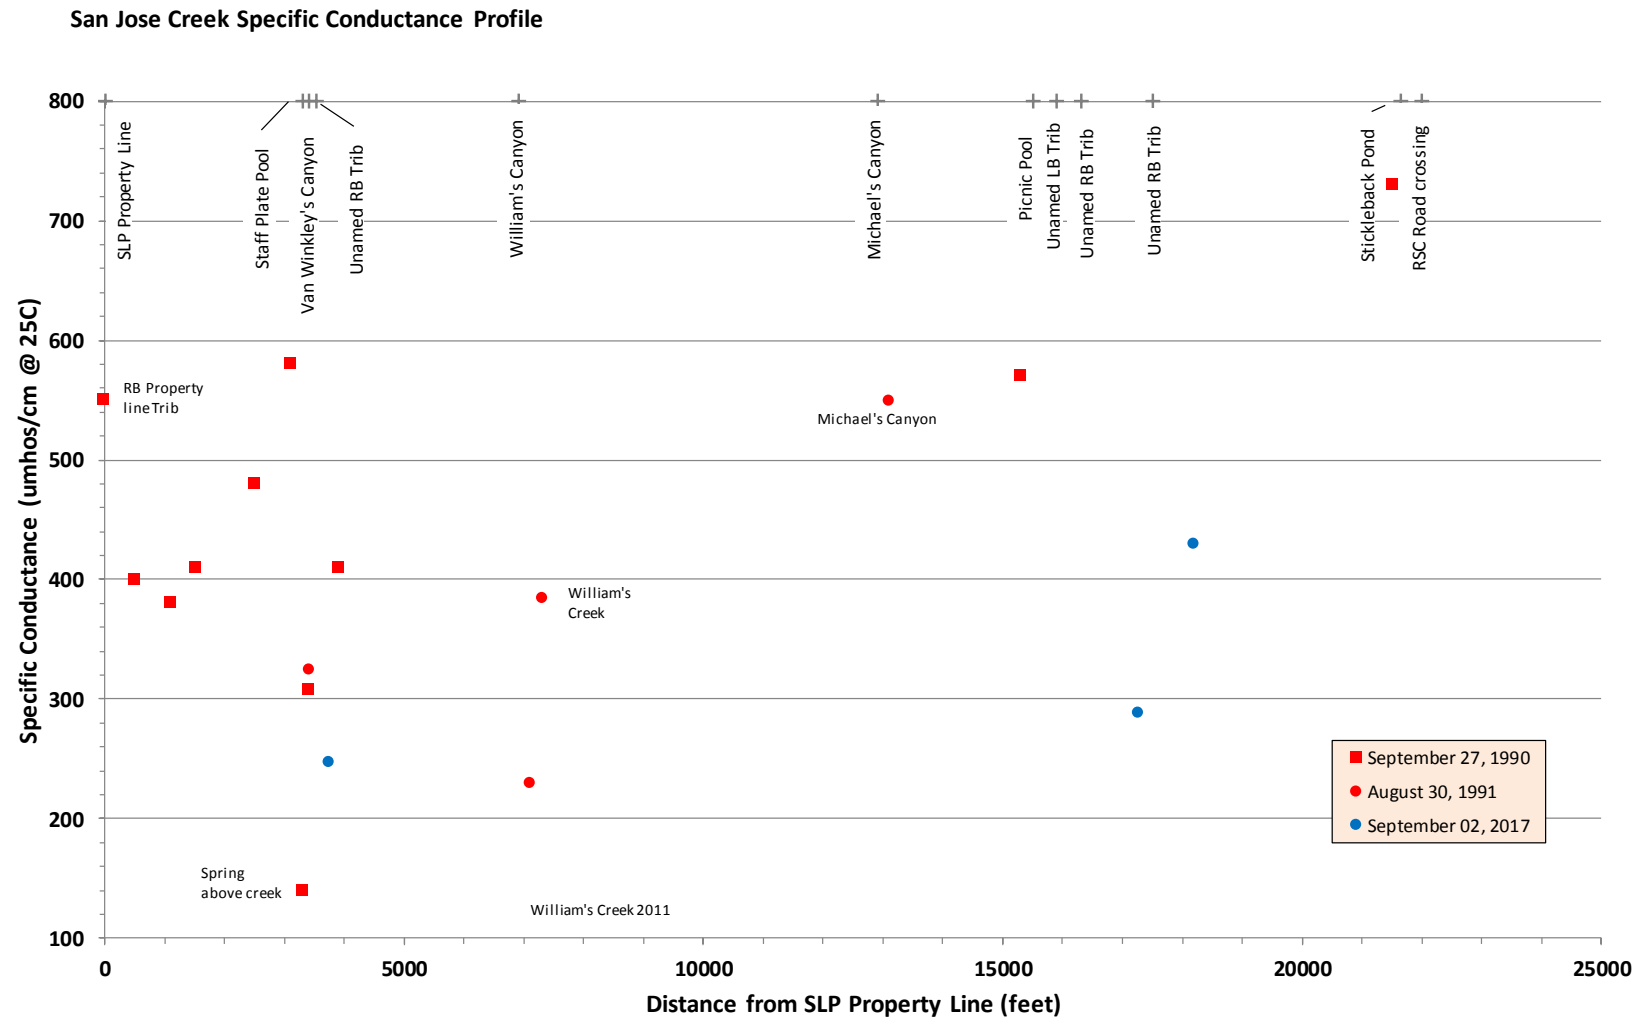
Figure 10. The comparison of San Jose Creek specific conductance measurements from September 1990, August 1991 and September 2017 illustrating the 2017 specific conductivity was generally equivalent or lower than 1990 and 1991 conditions.

Specific conductance measurements from San Jose Creek were generally equivalent or lower in 2017 than highly variable measurements from 1990 (Figure 10). On the San Jose Creek, the trend for specific conductivities is from lower values to higher values with distance upstream, with a significant increase at the most upstream location.

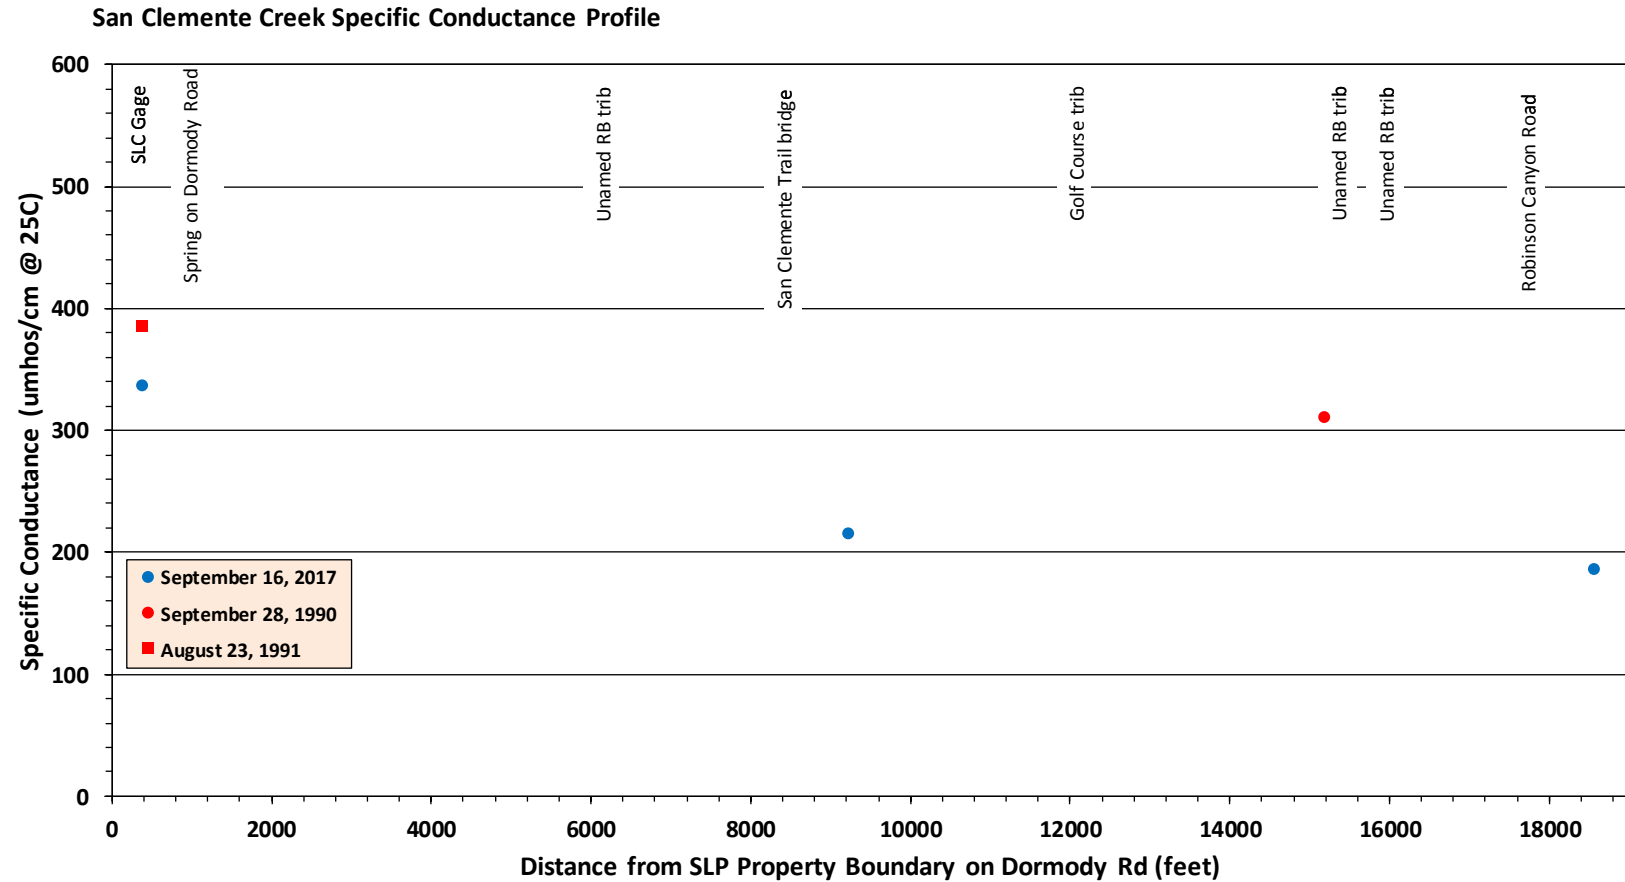
Figure 13. The comparison of San Clemente Creek specific conductance measurements from September 1990, August 1991 and September 2017 illustrates the 2017 specific conductivity was slightly lower than 1991 conditions and substantially lower than 1990 conditions.
