Central Coast Watershed Studies

Publication No. WI-2008-7

100 Campus Center, Seaside, CA, 93955-8001 831 582 4696 / 4431 Post-Fire Baseline Monitoring of Big Sur River Lagoon: November/December 2008

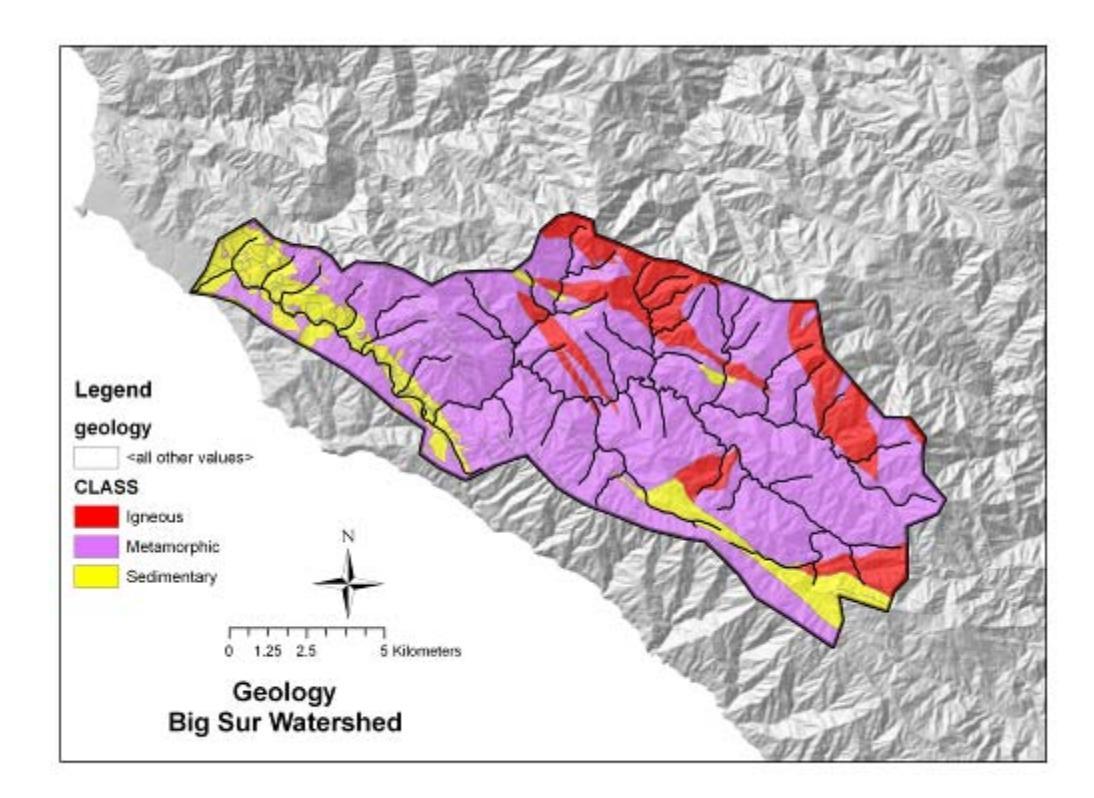
The watershed is underlain by 85% metamorphic rock, 19% igneous rock, and 15% sedimentary rock and recent deposits (Fig. 2). Five percent of the watershed is covered by existing historic landslides (Fig. 3), and there are slopes with high potential for landslides throughout the watershed (Fig. 4). The region has steep hill slopes and the bedrock is both deeply weathered and pervasively fractured and faulted, resulting in ubiquitous high erosion potential (Fig. 5).

Figure 2: Basic Geology of the Big Sur Watershed (GIS data from Rosenberg (2001)).

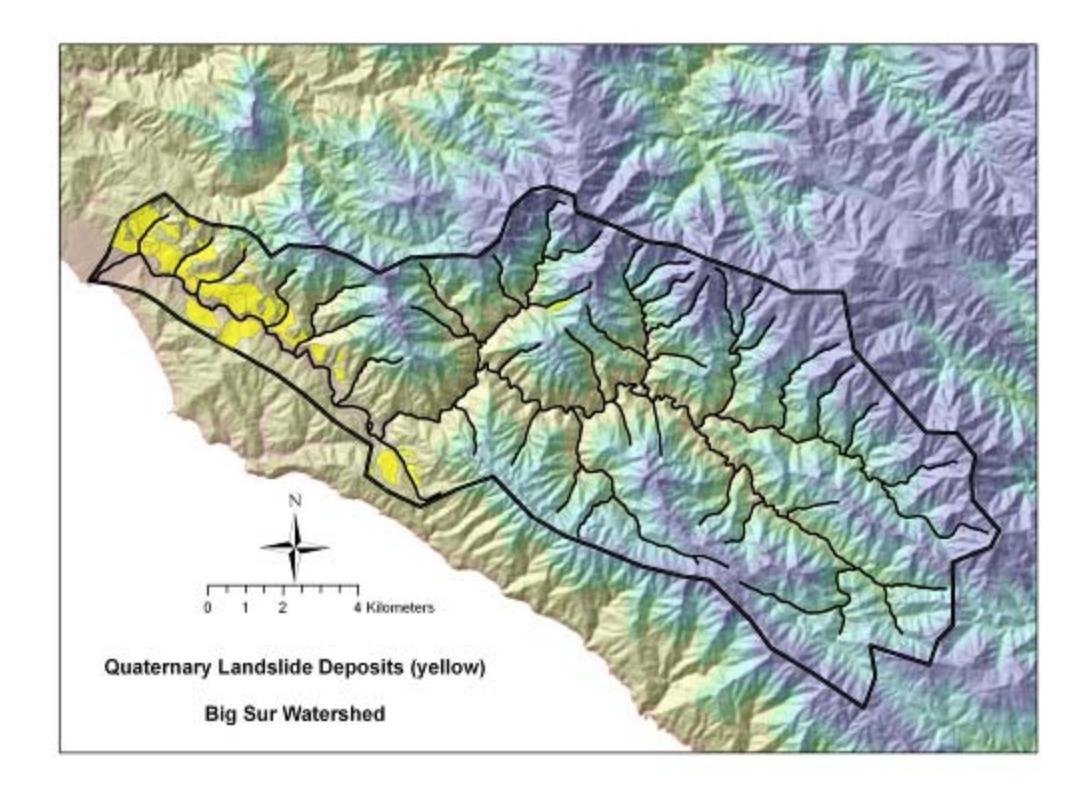
Figure 3: Historic landslide deposits in the Big Sur Watershed (GIS data from Rosenberg (2001)).

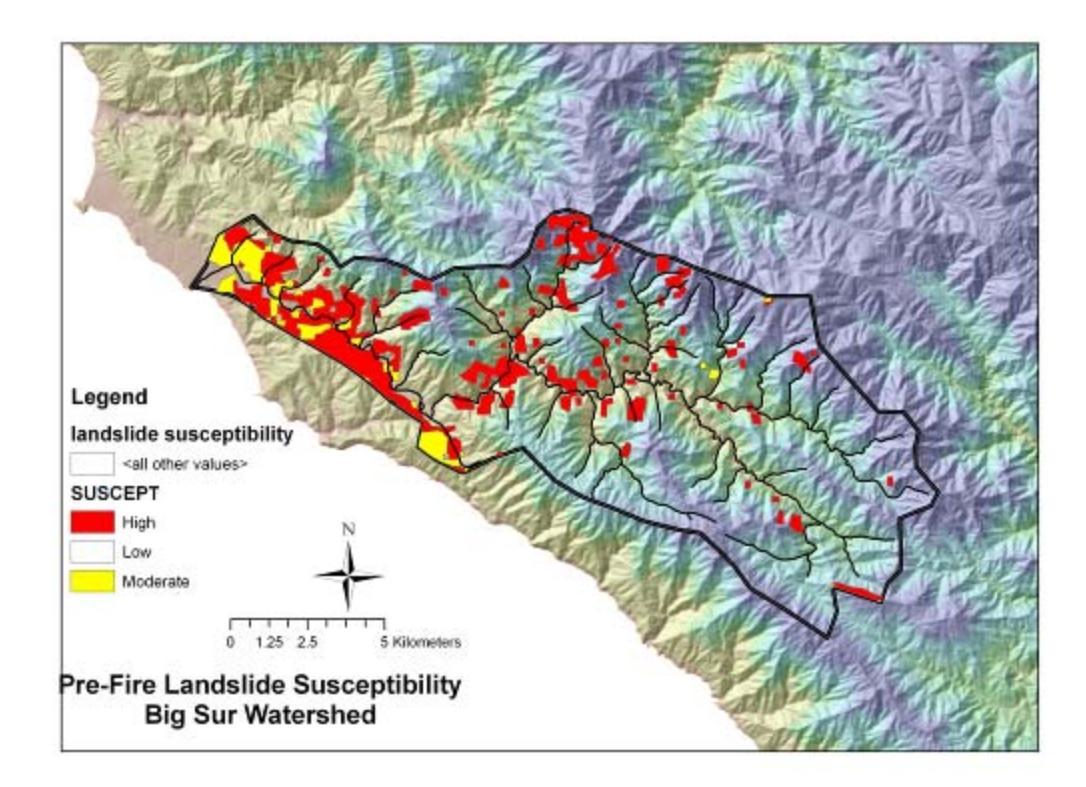
Figure 4: Landslide susceptibility in the Big Sur Watershed (GIS data from Rosenberg (2001))

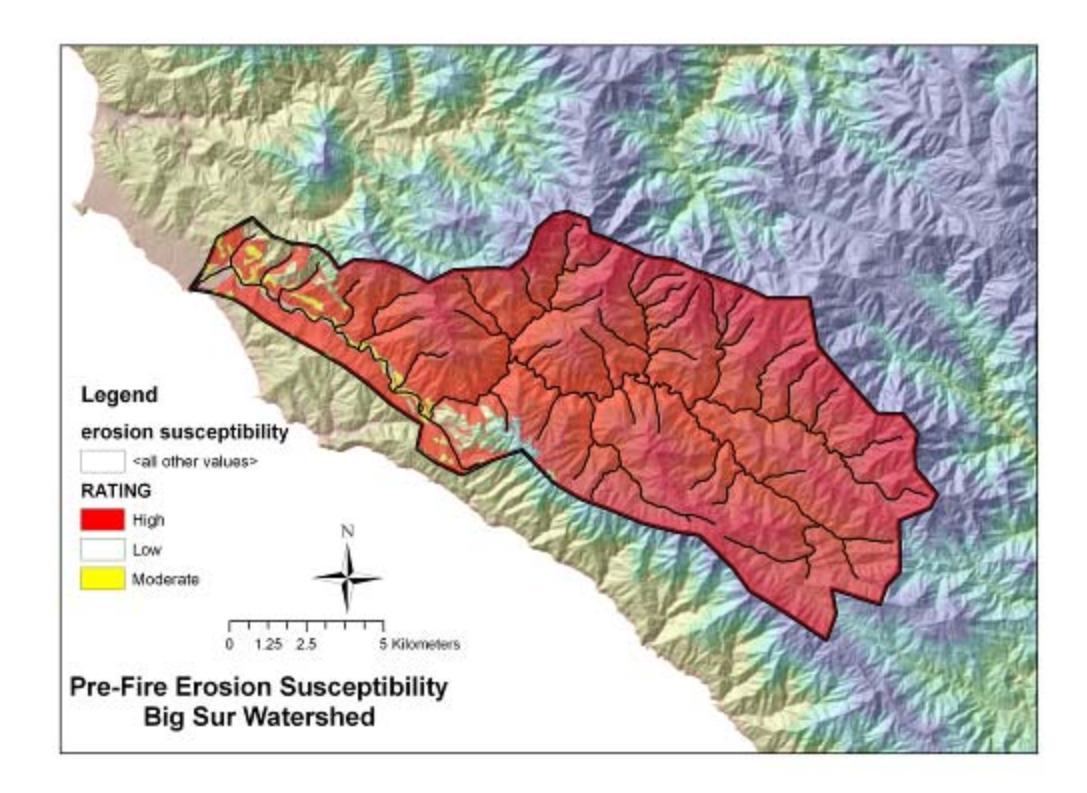
Figure 5: Erosion Potential (GIS data from Rosenberg (2001))

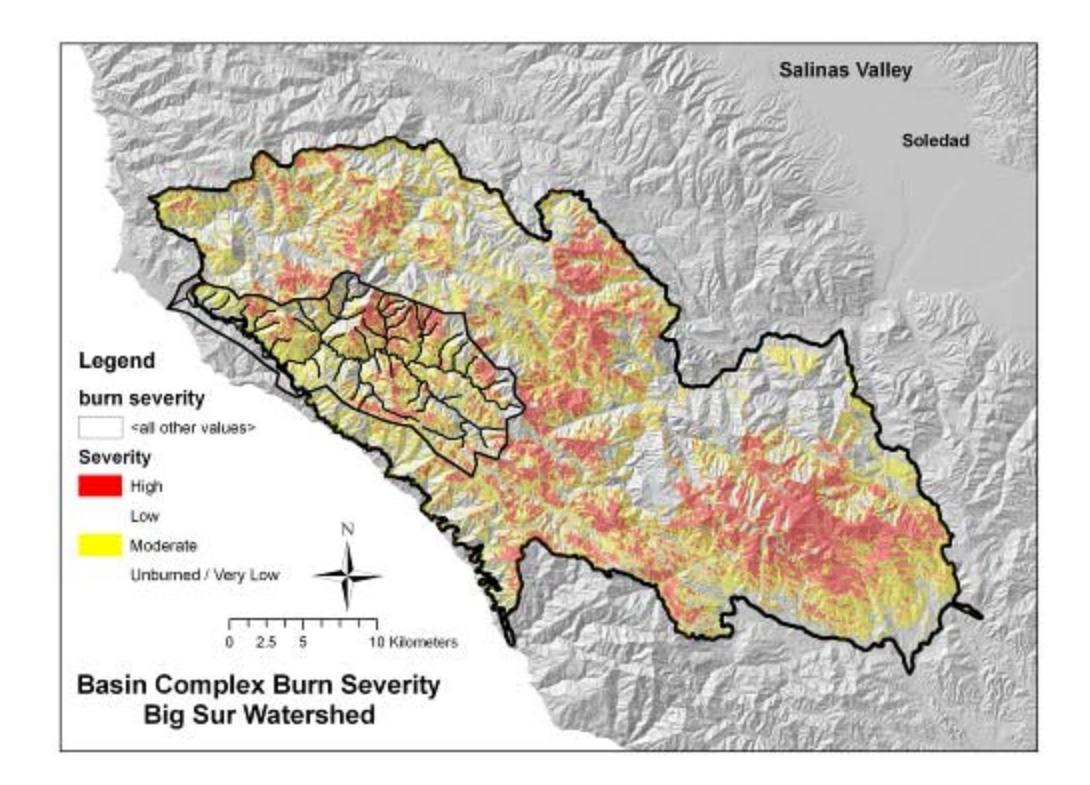
Figure 6 and Table 2 show the burn severity distribution in the Basin Complex Fire. Cannon et al., (in press) have found that the moderate-to-high burn severity areas generate the majority of debris flows during post-fire rains events; 65% of the Big Sur watershed falls in that category.

Figure 6: Burn severity of the Basin Complex fire. See Table 2 for more details. (GIS data from USDA (2008)).

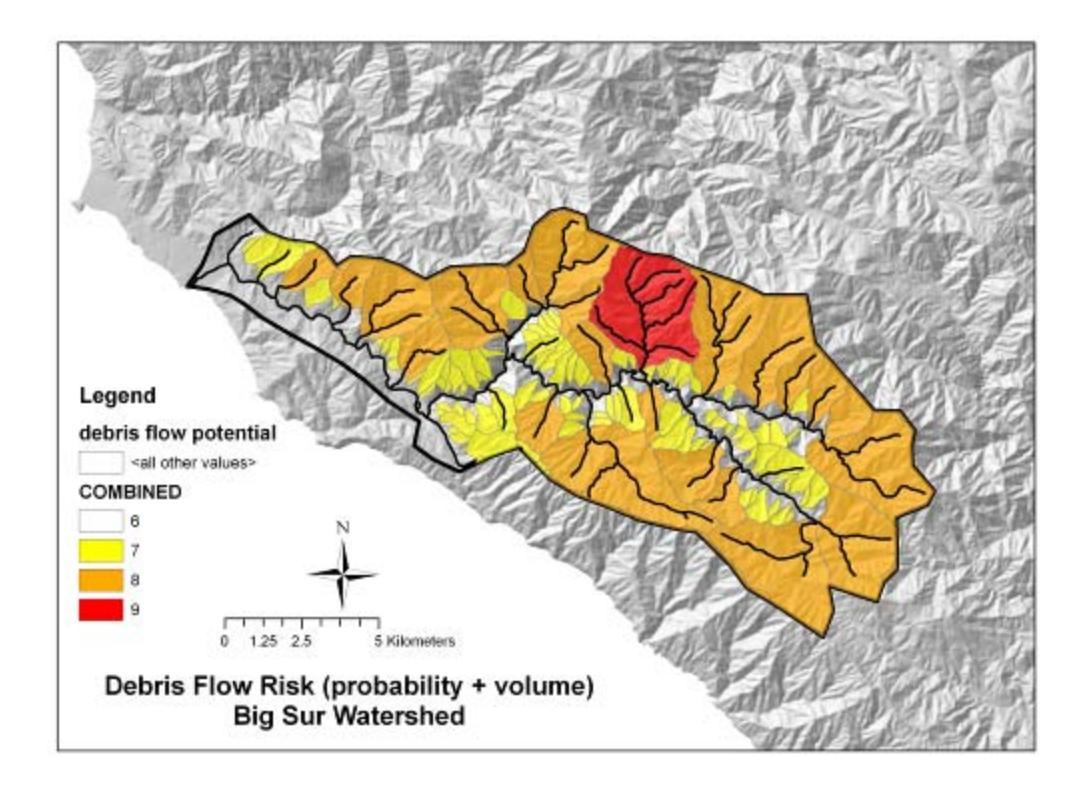
Slope failure and debris-flow generation are the primary risk in the first few years following a fire in the Big Sur basin. Debris flow risk has been modeled in other parts of the country with reasonable success (Cannon et al. in press). The Cannon et al. (in press) model was used on over 850 sub-watersheds of the Basin Complex fire (Cannon 2008). Cannon (personal communication, 2008) supplied model data in GIS format so that we could estimate risks within sub-regions of the Bain Complex Fire perimeter. Analysis of 141 sub-watersheds composing the Big Sur watershed indicates that approximately 80% of the Big Sur watershed is at high risk of developing debris flows through increased erosion or slope failures (Fig. 7 and Table 3). The model figures might underestimate the true risk owing to the naturally weak substrate of the northern Santa Lucia Range (Figs. 5 and 6). Lions Creek draining Ventana Cone has the highest risk of a very high volume debris flow (red watershed in Fig. 7)

Figure 7: Debris flow risk of the Big Sur watershed See Table 3 for legend details (GIS data from Cannon (2008)).

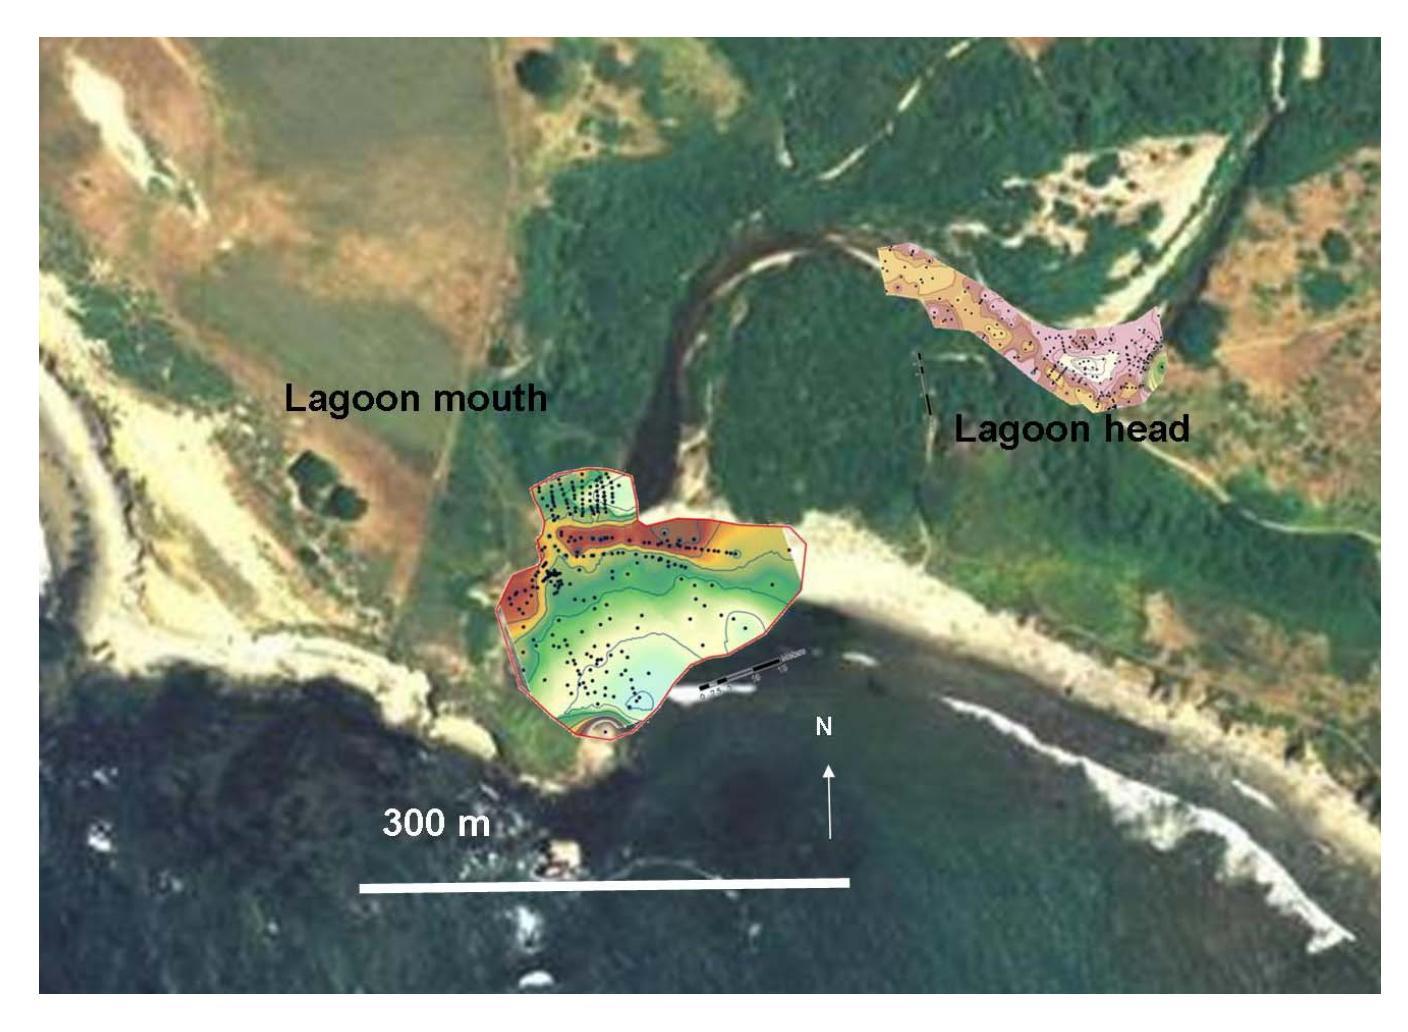
We focused our attention on two parts of the lagoon. On November 13 and December 4 we worked at the mouth of the lagoon (Fig. 2). On November 20, we worked at the head of the lagoon, the most upstream reach of river that is typically influenced by tides (Fig. 8).

Figure 8: Survey data covering study sites at mouth and head of the Big Sur Lagoon.

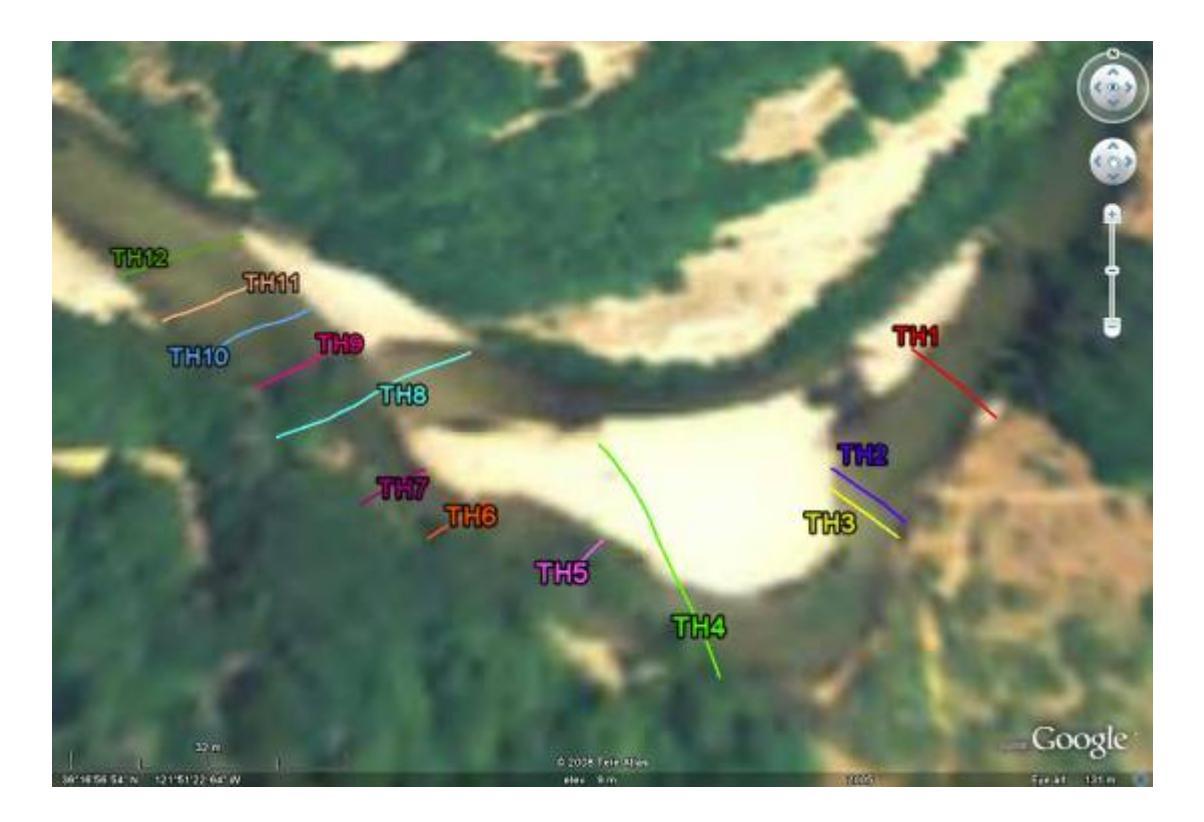
Multiple pebble count transects were performed at both the lagoon head (Fig 9) and mouth (Fig. 10). Sediment transect counts were performed in the river bed and adjacent bars and banks. Randomly chosen individual particles were measured at their intermediate axis with a metric ruler. Fine particles <2mm were counted, but sand and mud particle sizes were estimated based on field observations and not measured. Percent fines, arithmetic mean and standard deviation were calculated for each transect, lagoon head, mouth, and all locations to help determine baseline lagoon conditions. Pebble counts were tallied into particle size classes. Percent pebble counts were graphed into histograms.

Figure 9: Sediment transects at the Big Sur lagoon head location. TH2 is located on a riffle, and TH4 goes across a cobble bar.

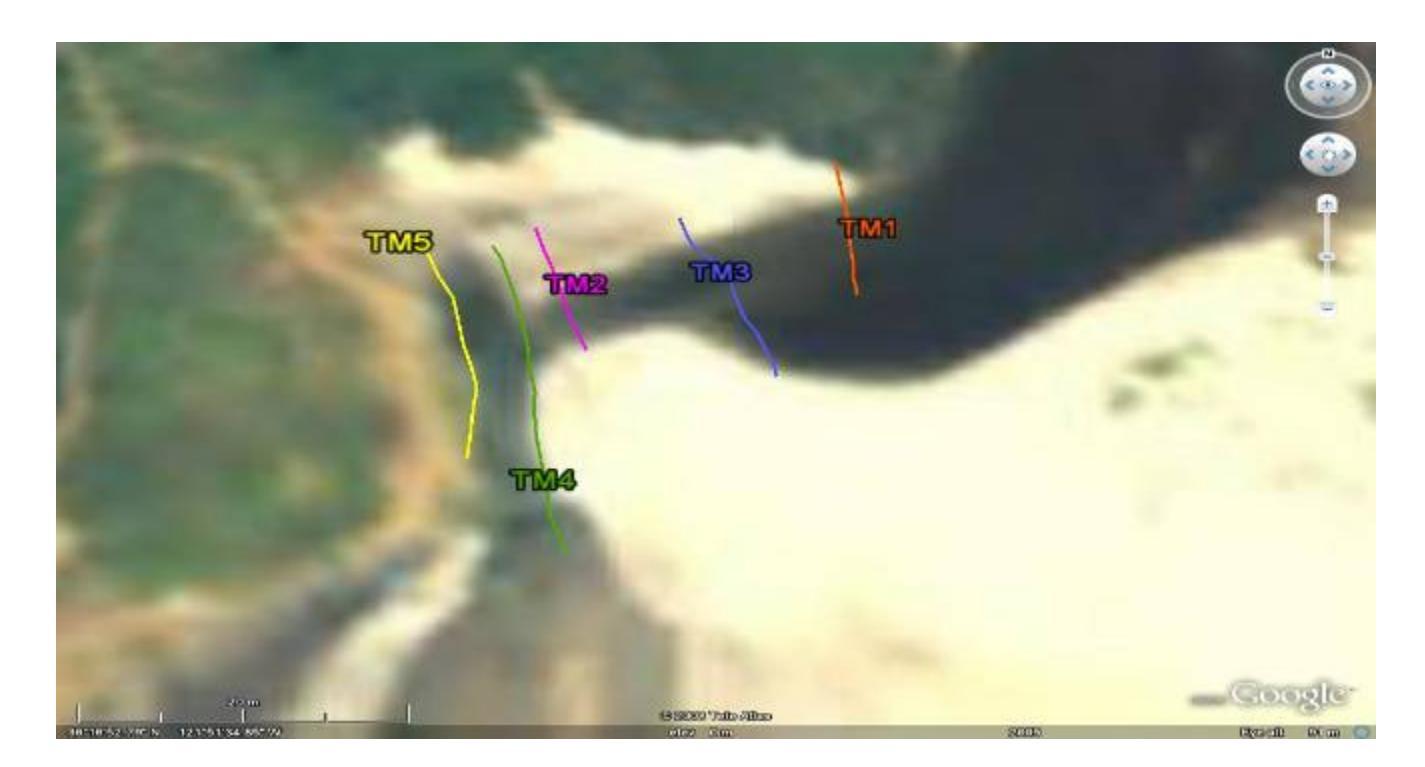
Figure 10: Sediment transects at the Big Sur lagoon mouth.

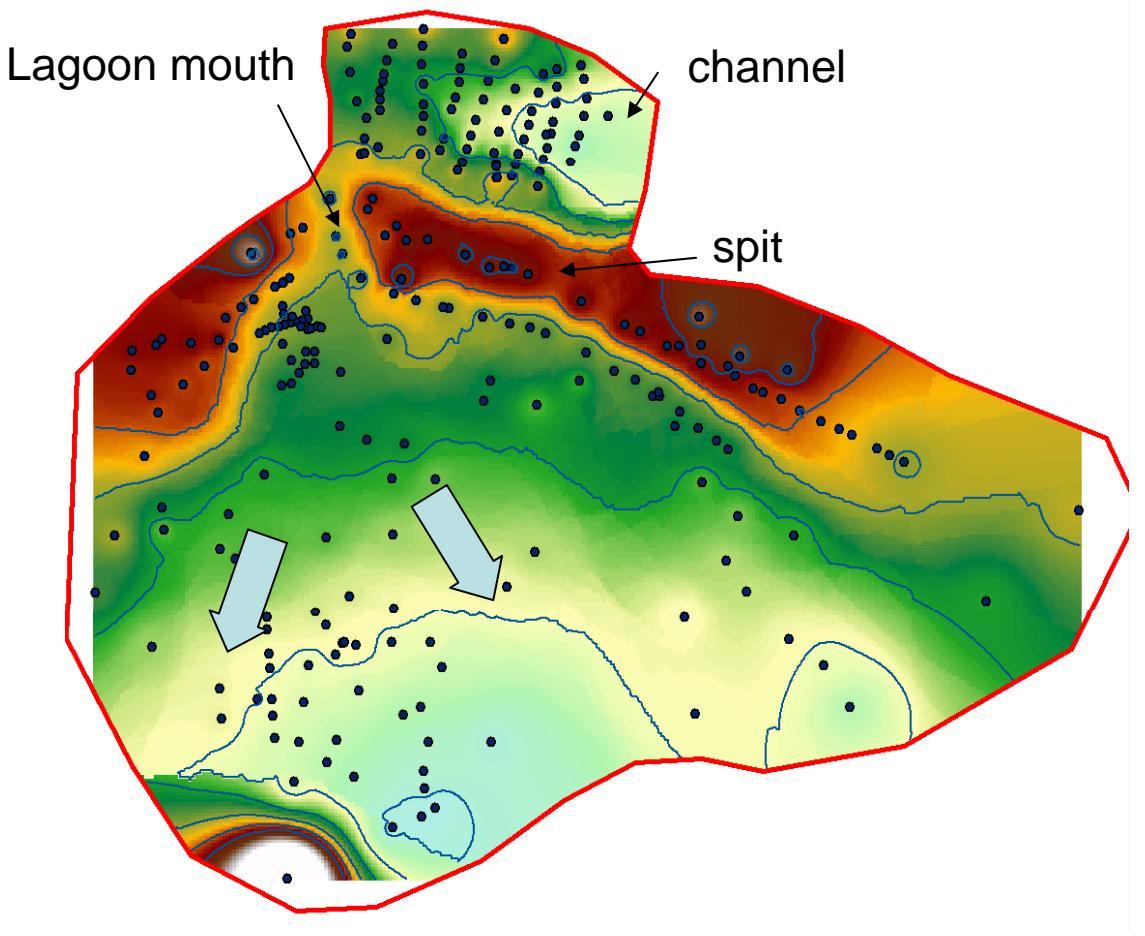
Post-processed field data were imported into GIS where a raster was created using the Inverse Weighted Distance (IDW) tool in spatial analyst. The resulting maps illustrate surveyed locations and interpolated points. Figure 11 shows topography of the lagoon mouth on 11/13/08.

Figure 11: Total station data interpolated into a raster image of the lagoon mouth using Inverse Distance Weighted averaging. Colors correspond to elevation zones where light green and light blue correspond to lowest elevations and red areas represent higher elevations. Red boundary is a user-created line to clip the raster to fit the data points. Points are in a local arbitrary reference frame. Red and white areas have greatest elevations and light green and light blue have the lowest elevations. Rocky cliff extends upward in upper left and bottom of the image. A horizontal sand spit runs parallel to the shore and constricts the lagoon mouth

Higher areas (red) are located across the mouth in the form of a partial lagoon barrier or river mouth spit, along with the bluff backed beach and cliff where total stations were setup. The deepest areas (light green to light blue) appear at the base of the bluff nearest the ocean, where highest wave energy occurs, and the upper part of the lagoon system behind the gravel bar. A plug of sediment provides hydrologic control over freshwater outflow into the ocean. At the lagoon head, a riffle just before the big bend marks the approximate endpoint of saltwater influence (Fig. 12).

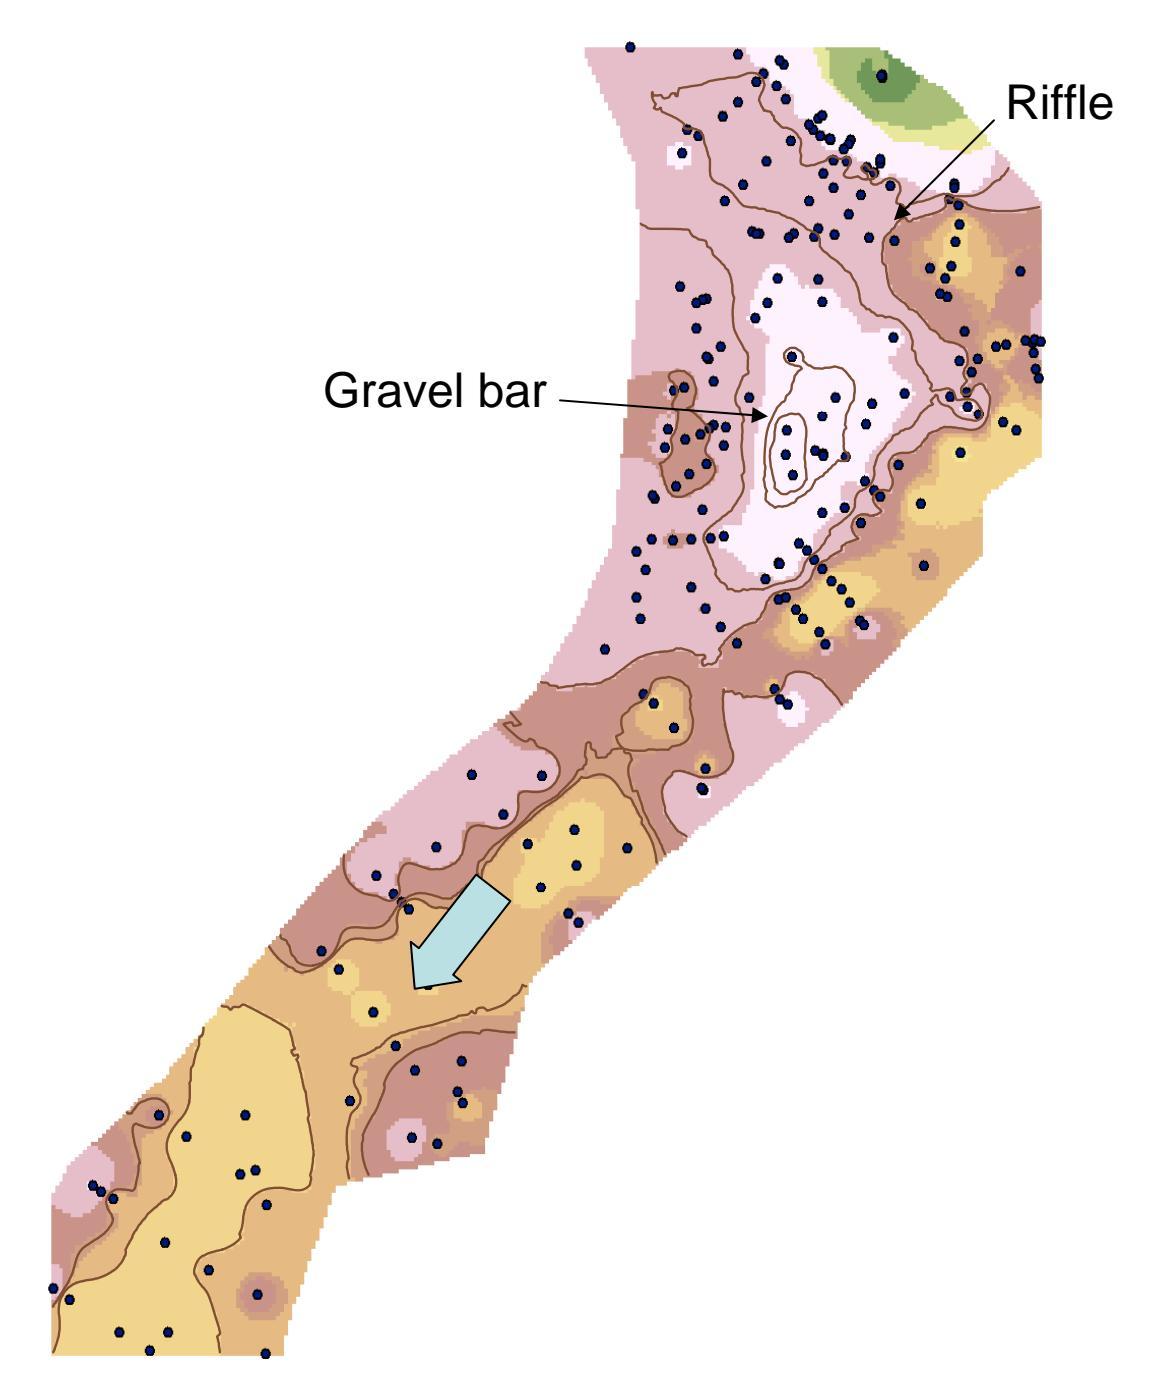
Figure 12: Lagoon head survey at a sharp right bend in the river channel. Colors correspond to elevation zones. Lght tan correspond to low elevations while purple and white areas represent higher elevations. Water elevation during survey approximately located along purple/sandy color interface. Arrow indicates flow direction. A gravel point bar was present at the white colored area, with water flowing outside in the tan areas.

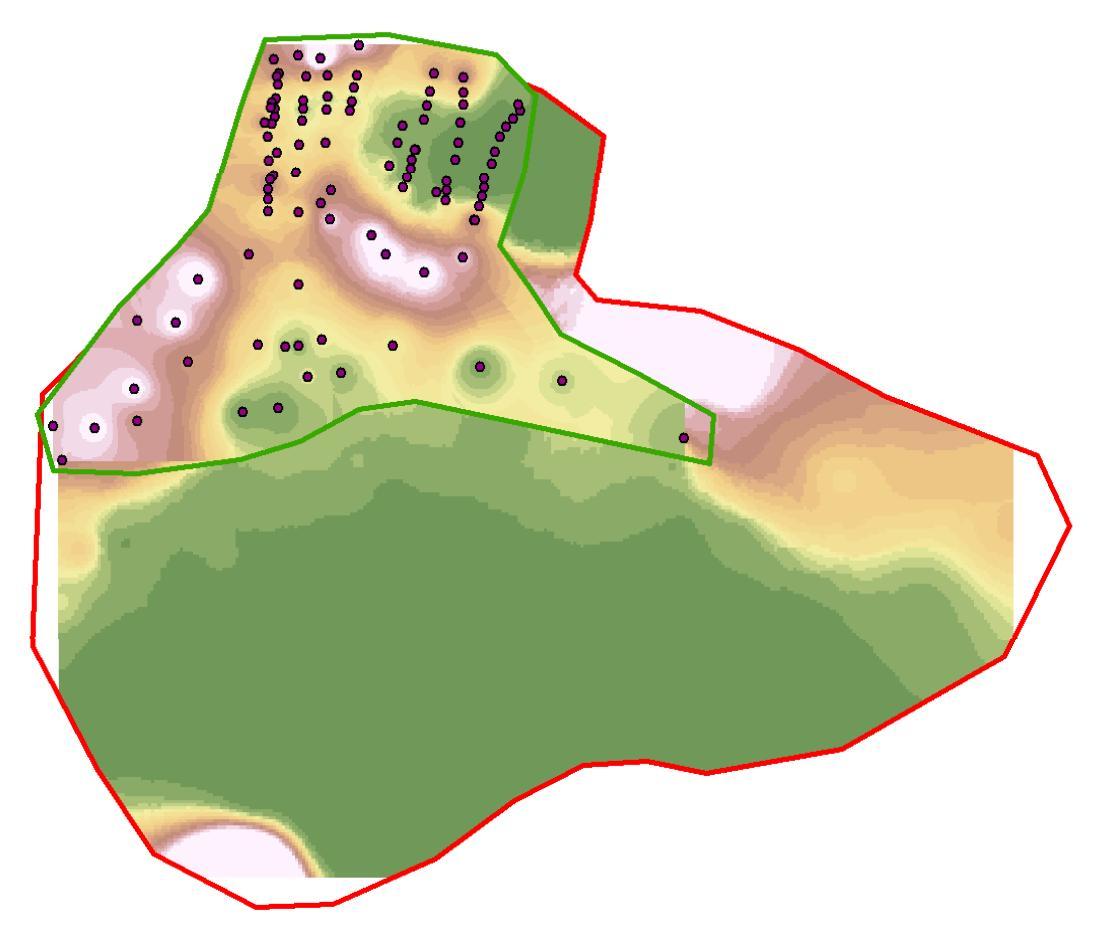
A resurvey of the lagoon mouth on 12/04/08 maps natural variability within the system Given good point density and overlapping transects between repeated surveys (Fig. 13), comparison of elevation values could quantify variability at the lagoon mouth. Raster subtraction of the survey dates 11/13/08 from 12/04/08 (Fig. 14) yielded approximate change over 3 week period that included several days of large surf

This is a highly dynamic system with observed changes over a 3 week period without fire impact.

Figure 13: December 4, 2008 total station data point cloud and interpolated raster plotted on top of November 11, 2008 clipped raster. Both rasters were clipped using appropriate user-created mask. White corresponds to the higher elevations and dark green corresponds to the lower elevations. Color ramp used for each survey dataset is identical, providing the ability to qualitatively examine variability within the system.

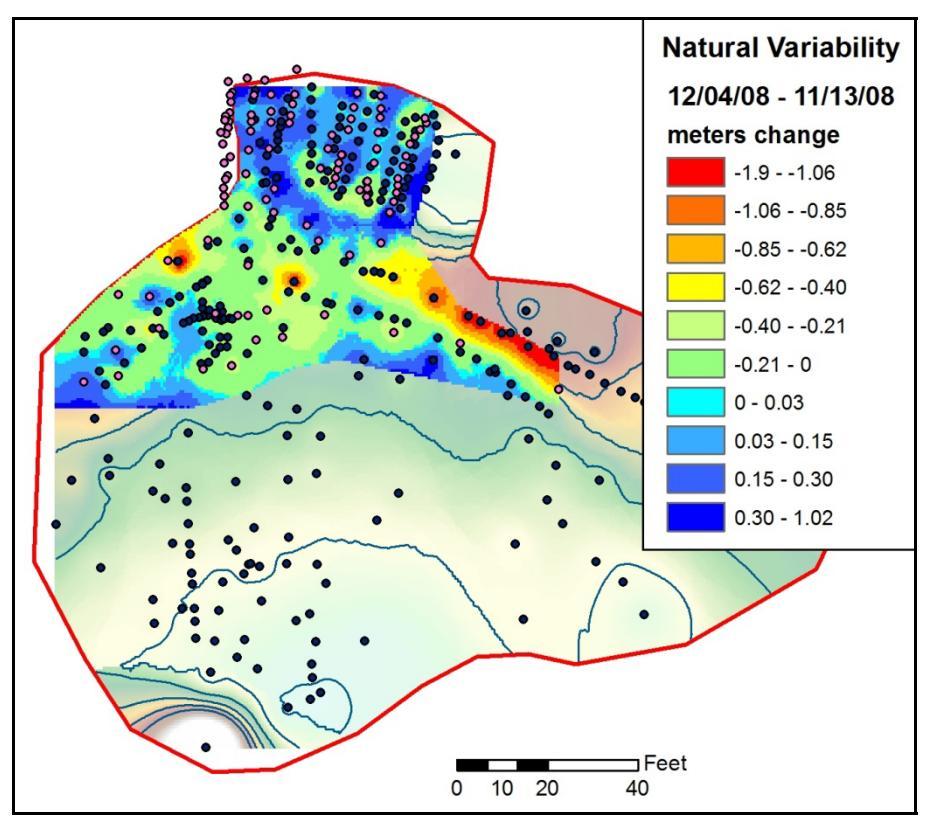
Figure 14: Raster subtraction of November 11th and December 12th clipped datasets plotted over muted November 11th interpolated raster. Point cloud from both surveys are shown. Changes in areas with low point density are less defendable than those with greater point density. Depth changes are in meters and warmer colors indicate erosion while cooler colors indicate accretion.

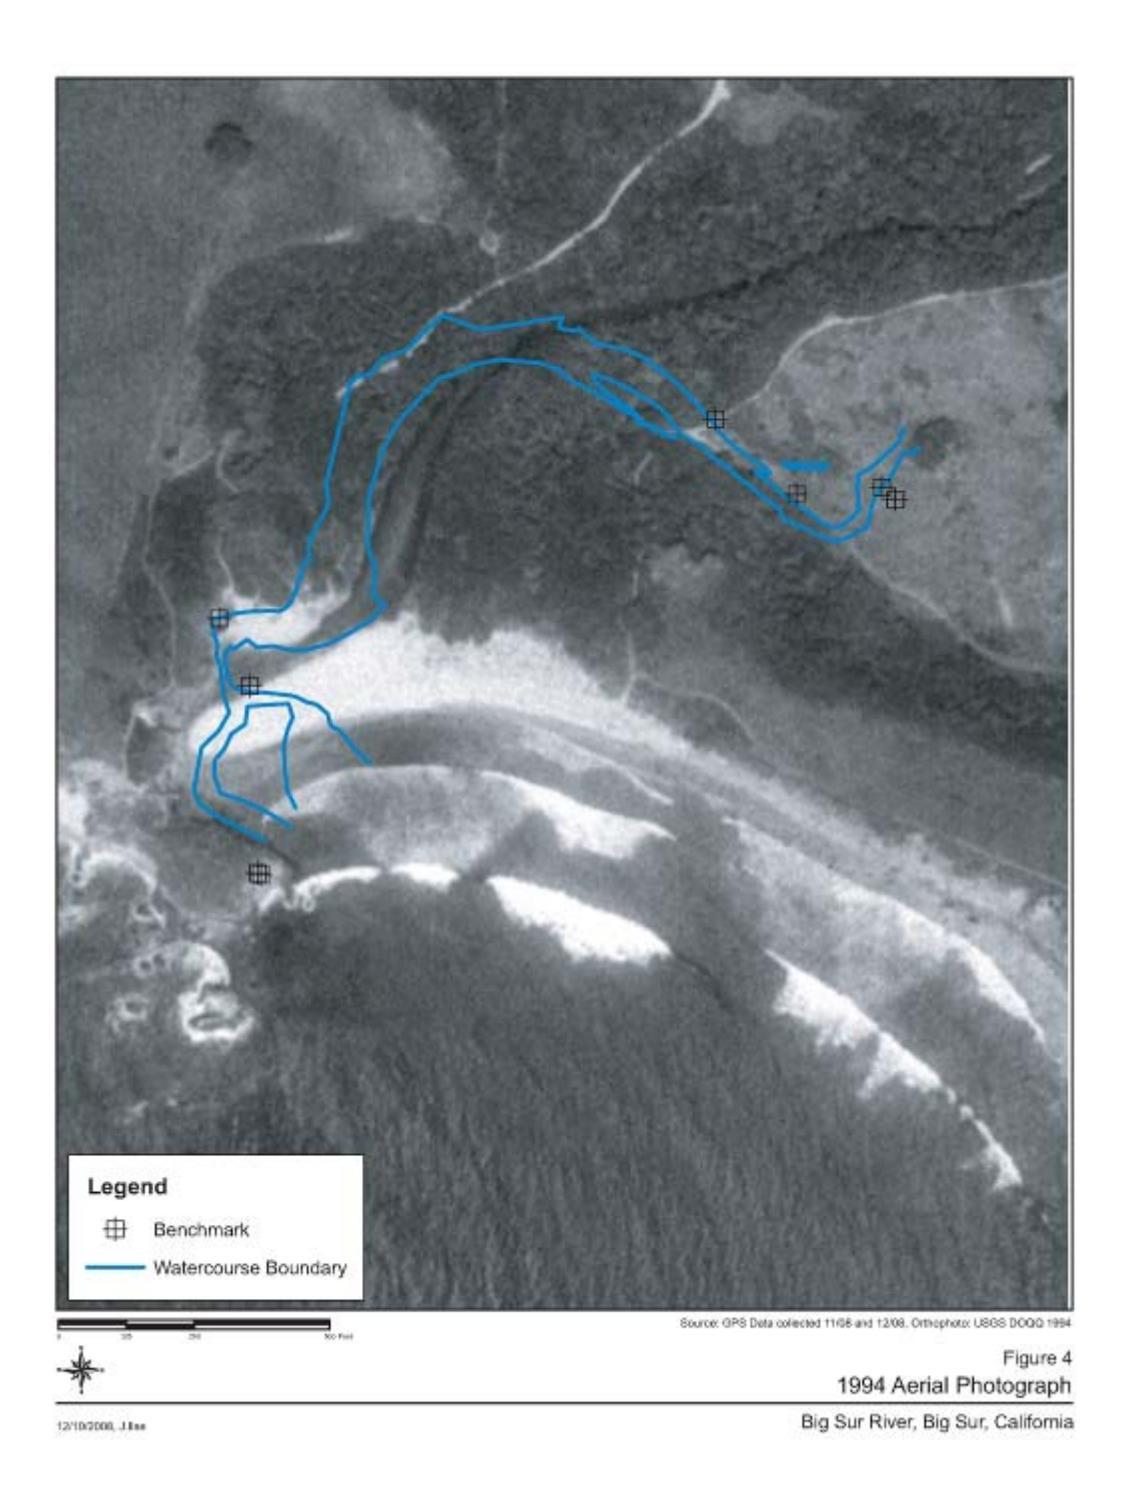
The result of the GPS points collected and the GIS mapping is a delineation of the current lagoon edge at the Big Sur River lagoon. This layer file can be used as a baseline for the location of the lagoon edge. The series of maps (Figs. 15, 16 and 17) illustrates the movement of the Big Sur River channel between 1994 and 2007. This series of maps shows that the position of the channel has rapidly changed, even in the absence of high sediment loads imposed by fire impacts. Figure 17, the Big Sur River lagoon layer file projected onto a 2007 Google image, provides a reasonably accurate representation of the current location of the Big Sur River lagoon, as the projection error is estimated at only half a meter based upon our local comparison with optical survey data. The layer file, created from GPS point data taken in November and December 2008, can be used as a baseline for comparison with future post-fire impact surveys.

Figure 15: GPS position of channel margins plotted on 1994 aerial photograph.

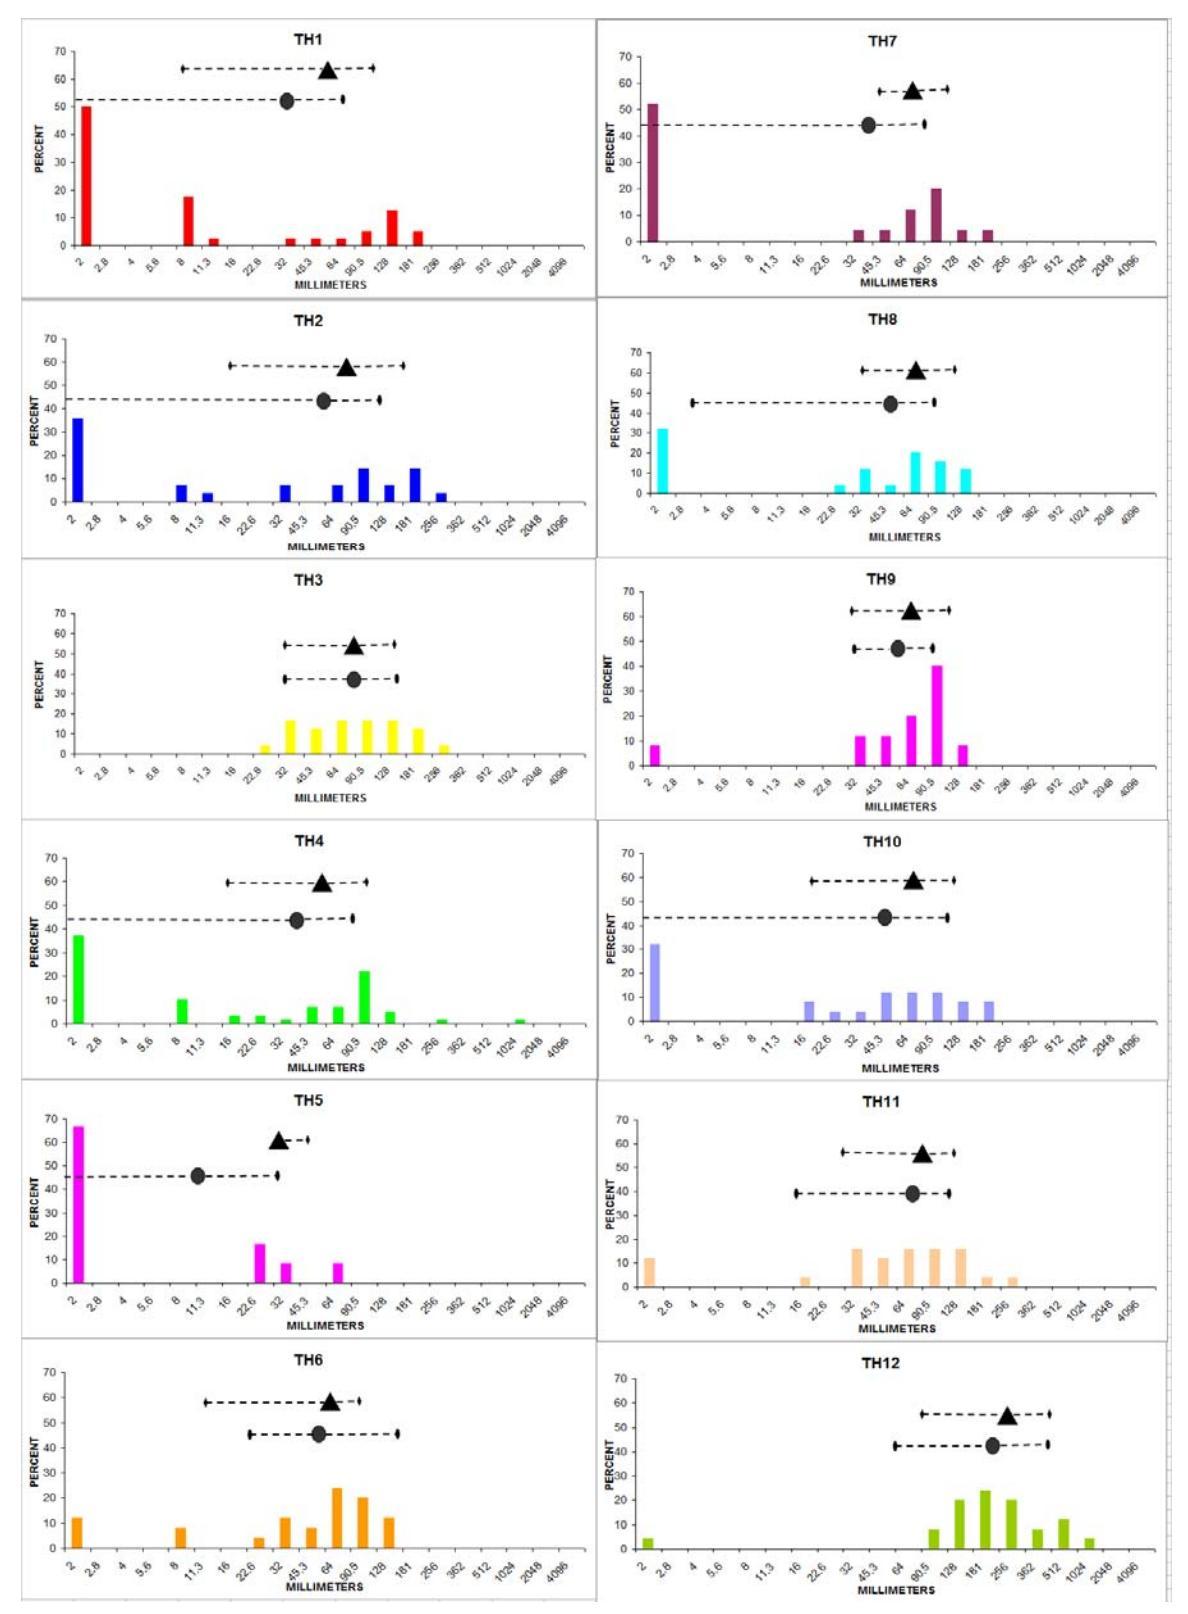
Arithmetic mean and standard deviation results are given in Table 1 for each transect and overall average. Figures 18 and 19 show histograms of percent pebble counts for each particle class size on each transect. The mean is approximately shown as a black circle hovering above the appropriate size class, with a black triangle representing the mean calculated with the fine particles removed (<2mm). With the exception of TH3, all histograms show a bi-modal distribution of particle sizes with a strong fines spike <2mm. The fines are present as a thin veneer on framework grains and as interstitial fill. The Big Sur transects range from poorly sorted to extremely poorly sorted when the fines are included.

Figure 18: Histograms for lagoon head transects showing mean with (circle) and without (triangle) fines. Dashed lines represent standard deviation.

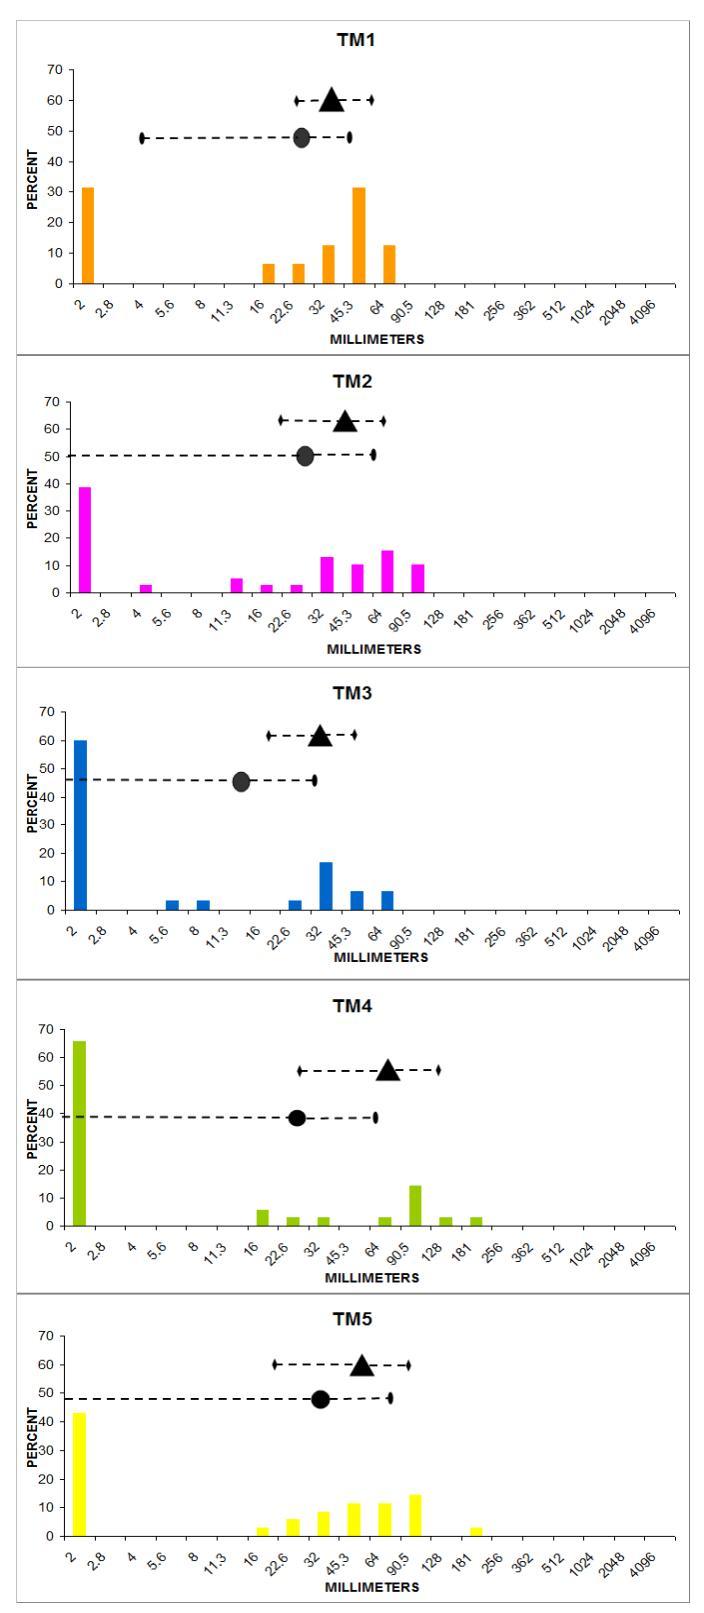
Figure 19: Histograms for lagoon mouth transects showing mean with (circle) and without (triangle) fines. Dashed lines represent standard deviation.

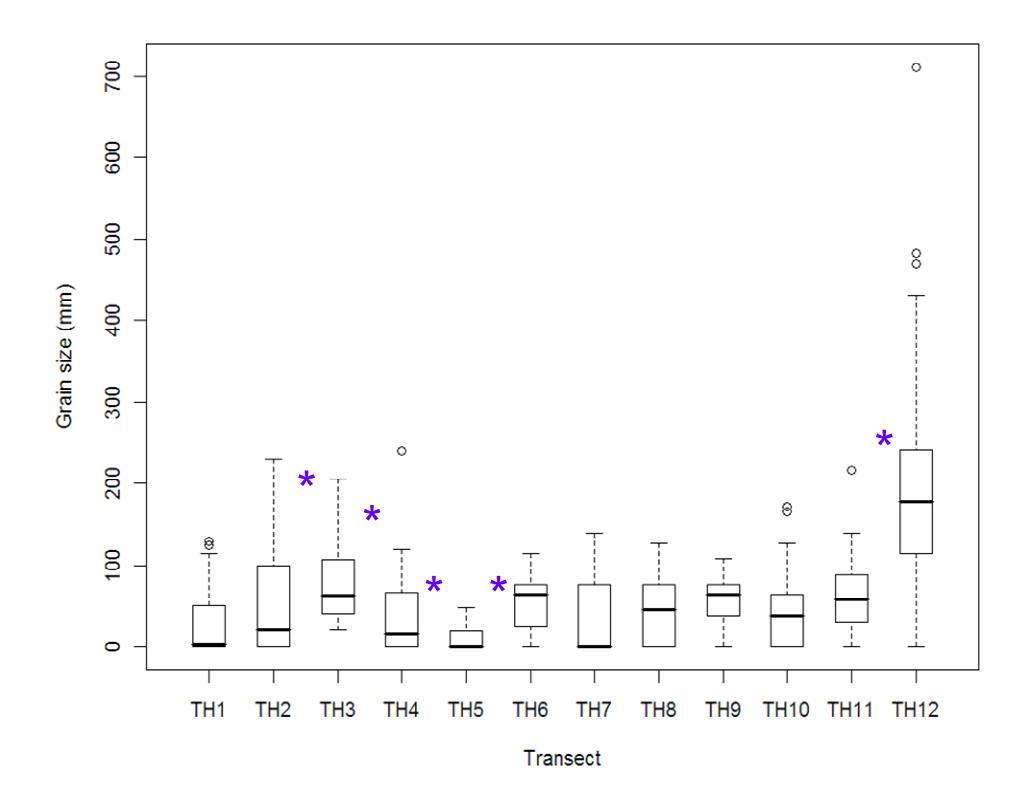
A Kruskal–Wallis test conducted on the 12 pebble count transects at the lagoon head showed significant variability between transects (α =0.05, p=4.491e-14; Fig. 20). The Wilcoxon rank sum test for differences between adjacent transects showed differences between five of the adjacent transects (α =0.05, Fig. 20). The five pebble count transects placed at the mouth of the lagoon showed no variability between transects (α =0.05, p=0.1063) following the Kruskal–Wallis test (Fig. 21).

Figure 20. Boxplot of 12 pebble count transects at the head of Big Sur River Lagoon. Asterisk (*) indicates a significant difference (α =0.05) between adjacent transects.

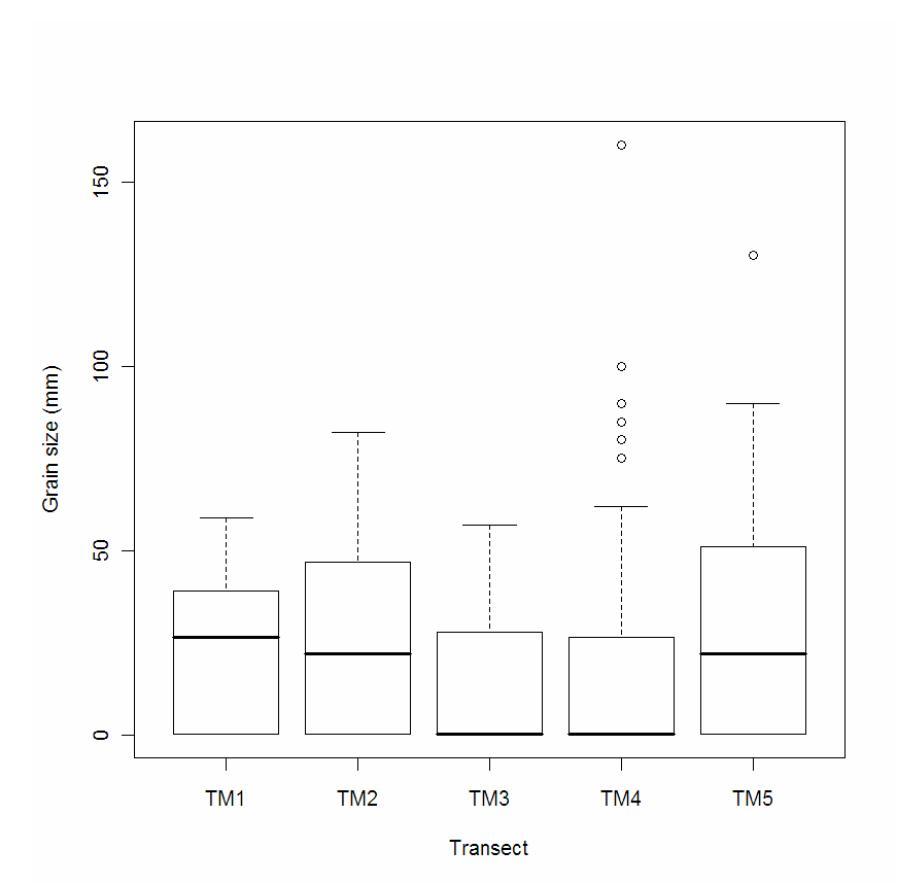
Figure 21. Boxplot of 5 pebble count transects at the mouth of Big Sur River Lagoon. No significant differences between transects were found (α =0.05, p=0.1063).
