Central Coast Watershed Studies

Publication No. WI-2008-7

100 Campus Center, Seaside, CA, 93955-8001 831 582 4696 / 4431 Post-Fire Baseline Monitoring of Big Sur River Lagoon: November/December 2008

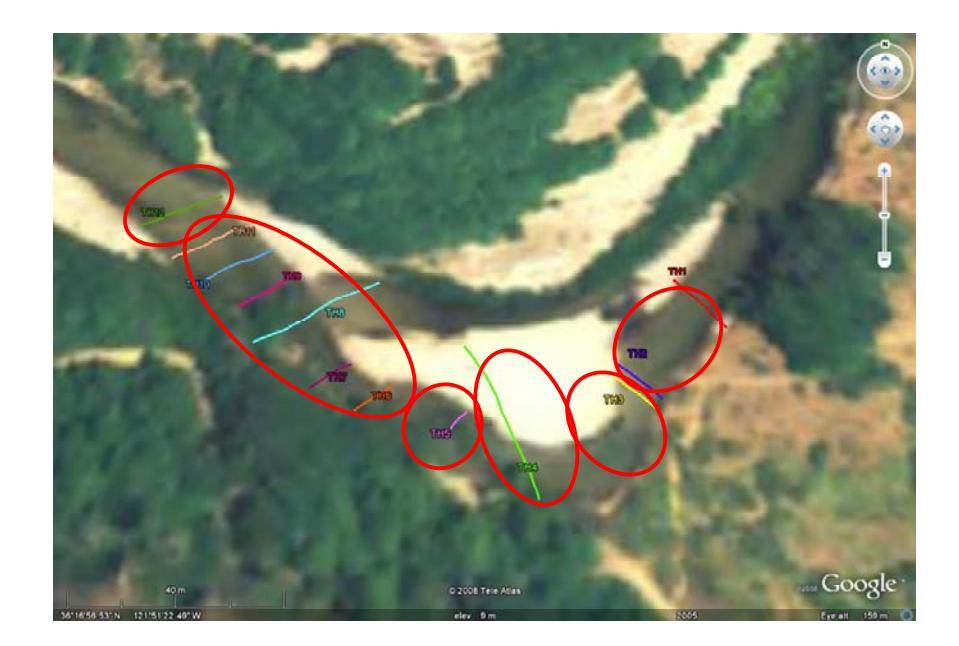
Figure 22. Pebble count transects at the Big Sur River lagoon head in 2008. Red circles indicate the six recommended transect locations for future surveys.

We conducted post hoc power analyses to determine optimal sampling for future efforts. At the lagoon head, we recommend six well-placed transects to adequately capture the variability of the area surveyed (Fig. 22). Pebble counts within each of these transects should be increased to 105 in order to detect a smallest meaningful difference (SMD) of 30 mm (α =0.05). Increasing the pebble count to lower the SMD below 30 mm would significantly increase sampling effort. At the mouth of the lagoon, pebble counts could be conducted using either three transects of 105 counts each or five transects of 65 counts each to assess the area sampled during the baseline survey (α =0.05). These recommended pebble counts would capture an SMD of 12 mm and 15 mm respectively (α =0.05).

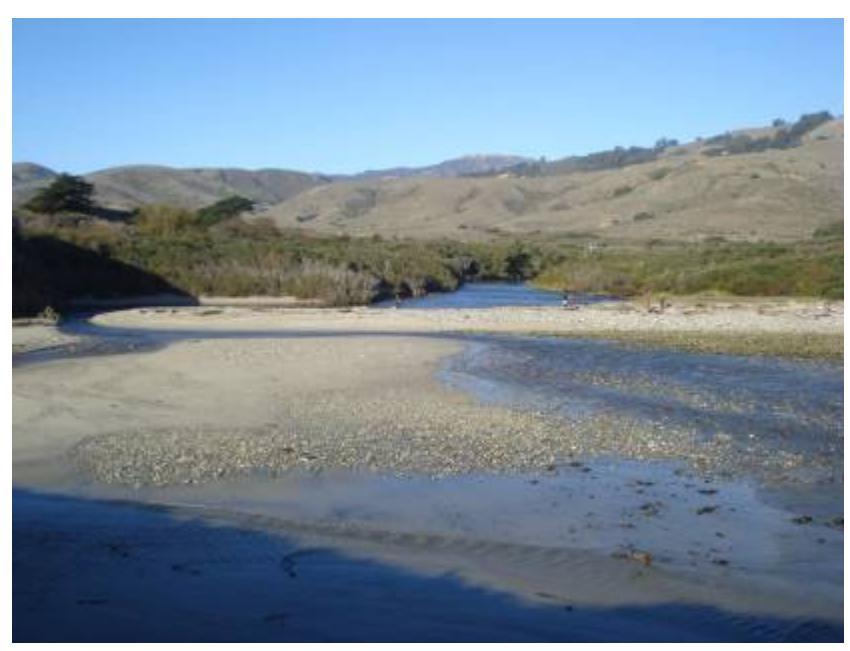
A subset of photos is provided here. Figure 23 shows an overview of the lagoon mouth. Figure 24 shows the natural variability in the lagoon mouth following a period of high waves. Changes can be seen in the amount of organic debris in the spit and the shape of the spit following the high waves in late November (Fig. 24). Figure 25 shows a close-up view of the mouth on December 4.

Figure 23: Mouth of Big Sur River Lagoon during low tide. (November 2008)

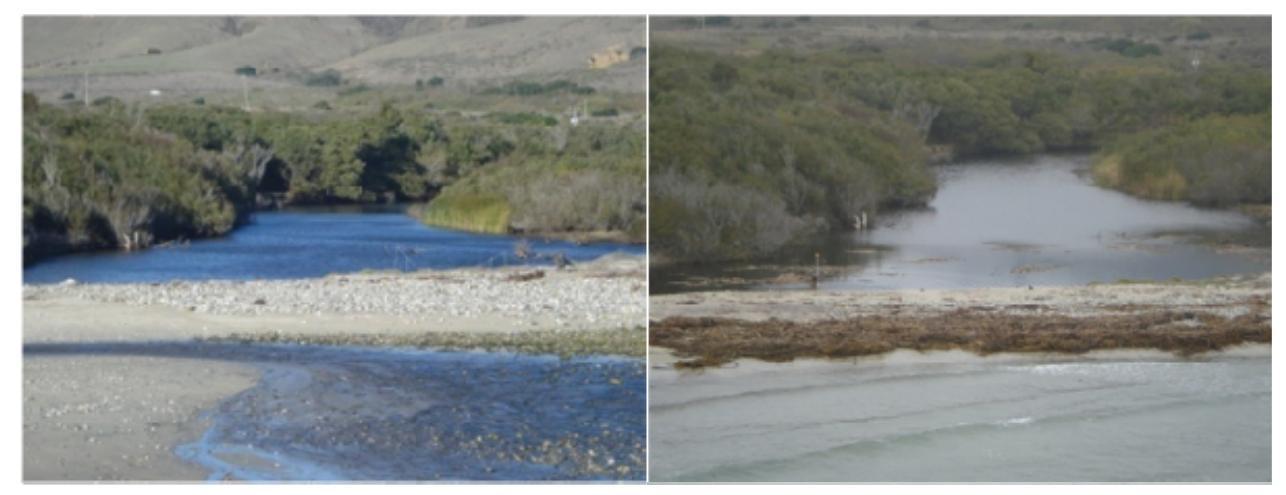
Figure 24: Lower reach, mouth of Big Sur River Lagoon. Time series comparison from November 20th 2008 (left) and December 4th 2008 (right), note kelp deposit.

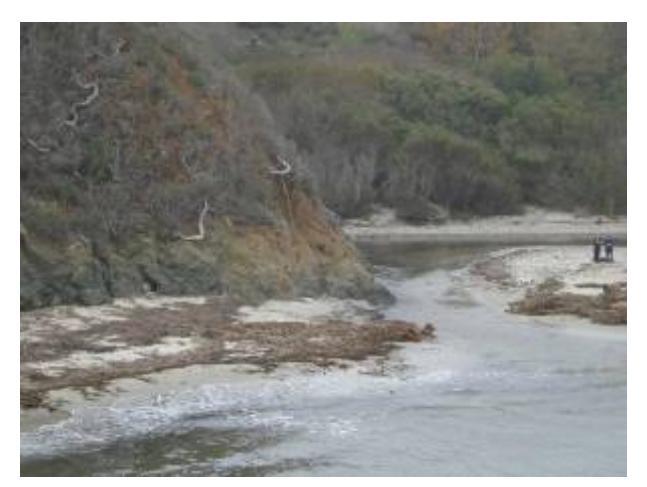
Figure 25: Lower reach, point-of-entry of Big Sur River Lagoon mouth and ocean. (December 2008)

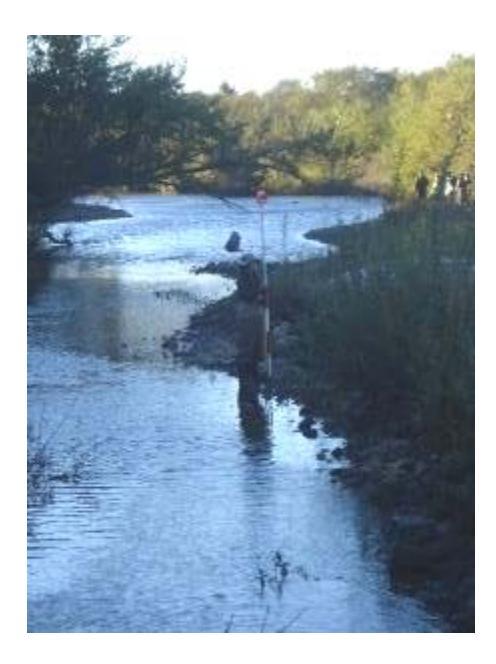
Figure 26 and 27 are views downstream from the right bend at the lagoon head. Figure 28 is the upstream from the lagoon head, immediately above the riffle defining the limit of tidal influence. An initial increase in mud is documented in the substrate along the gravel bar at the Lagoon head (Fig. 29). This mud veneer was not present during a site visit on November 16. Between November 16 and November 20, there was the first significant rain of the water year in the Big Sur watershed. The runoff produced a peak flow of 200 cfs, and apparently brought the first fine-grained sediment yield as well.

Figure 26: Lagoon head. View downstream from gravel point bar (November 2008).

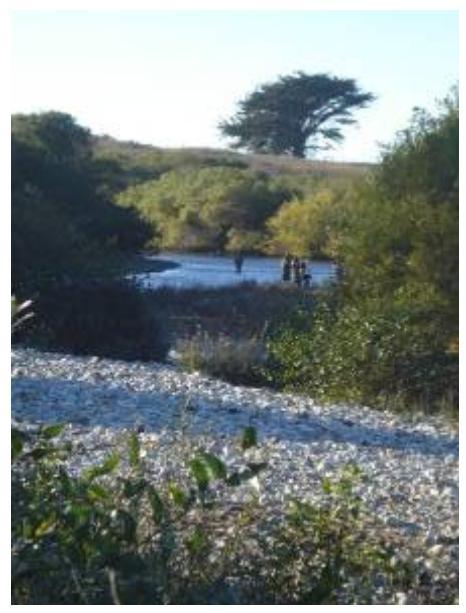
Figure 27: Lagoon head. View downstream across gravel point bar (November 2008).

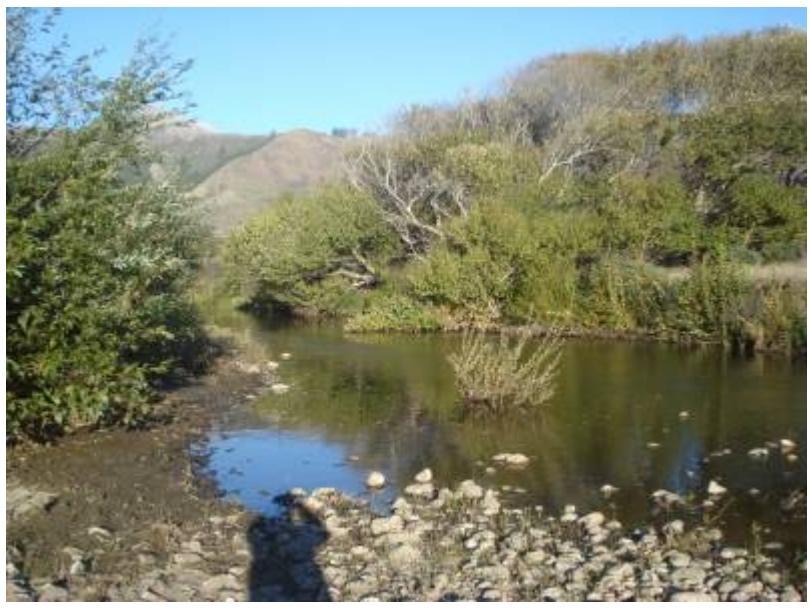
Figure 28: View upstream of Big Sur River Lagoon. Upstream edge of gravel point bar visible in bottom of photo. Note mud veneer on gravel and along bank (November 2008).

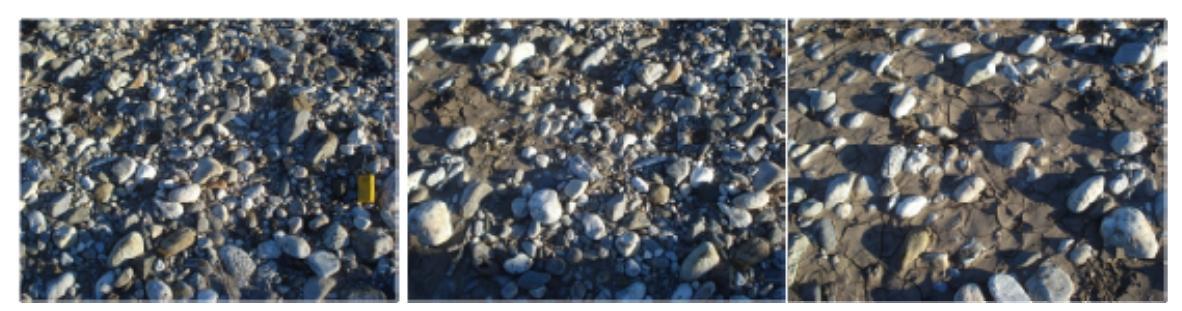
Figure 29: Lagoon head. Various levels of substrate embeddedness at the upstream edge of the gravel bar (November 2008).

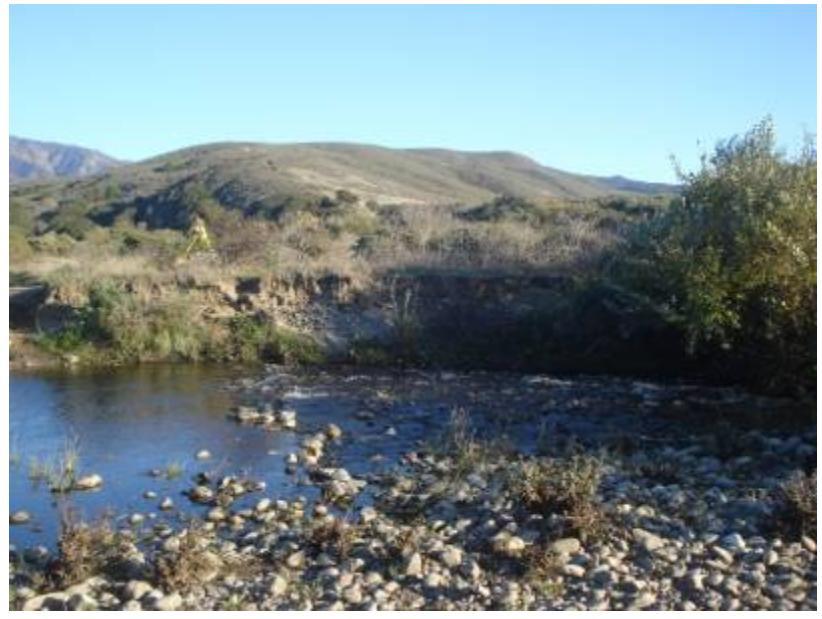
Figure 30: Lagoon head. Riffle delimiting the upper boundary of tidal influence in the river. Raw, freshly eroded bank is at apex of sharp right bend (November 2008).

Based on our analysis of historical aerial photographs, and personal observations through time, we predict continued rapid erosion along the outer bank of the bend above the lagoon head. There are few mature trees with complex root systems or young stream-bank willows along the apex of the bend for stabilization (Figs. 30 and 32). The presence of a high longitudinal water-surface slope, tall bank height, steep bank angle, weak floodplain deposits, and lack of root density on the outer bank of a bend with diminutive radius of curvature (Fig. 31) allow us to predict continued rapid erosion at this point in the river.

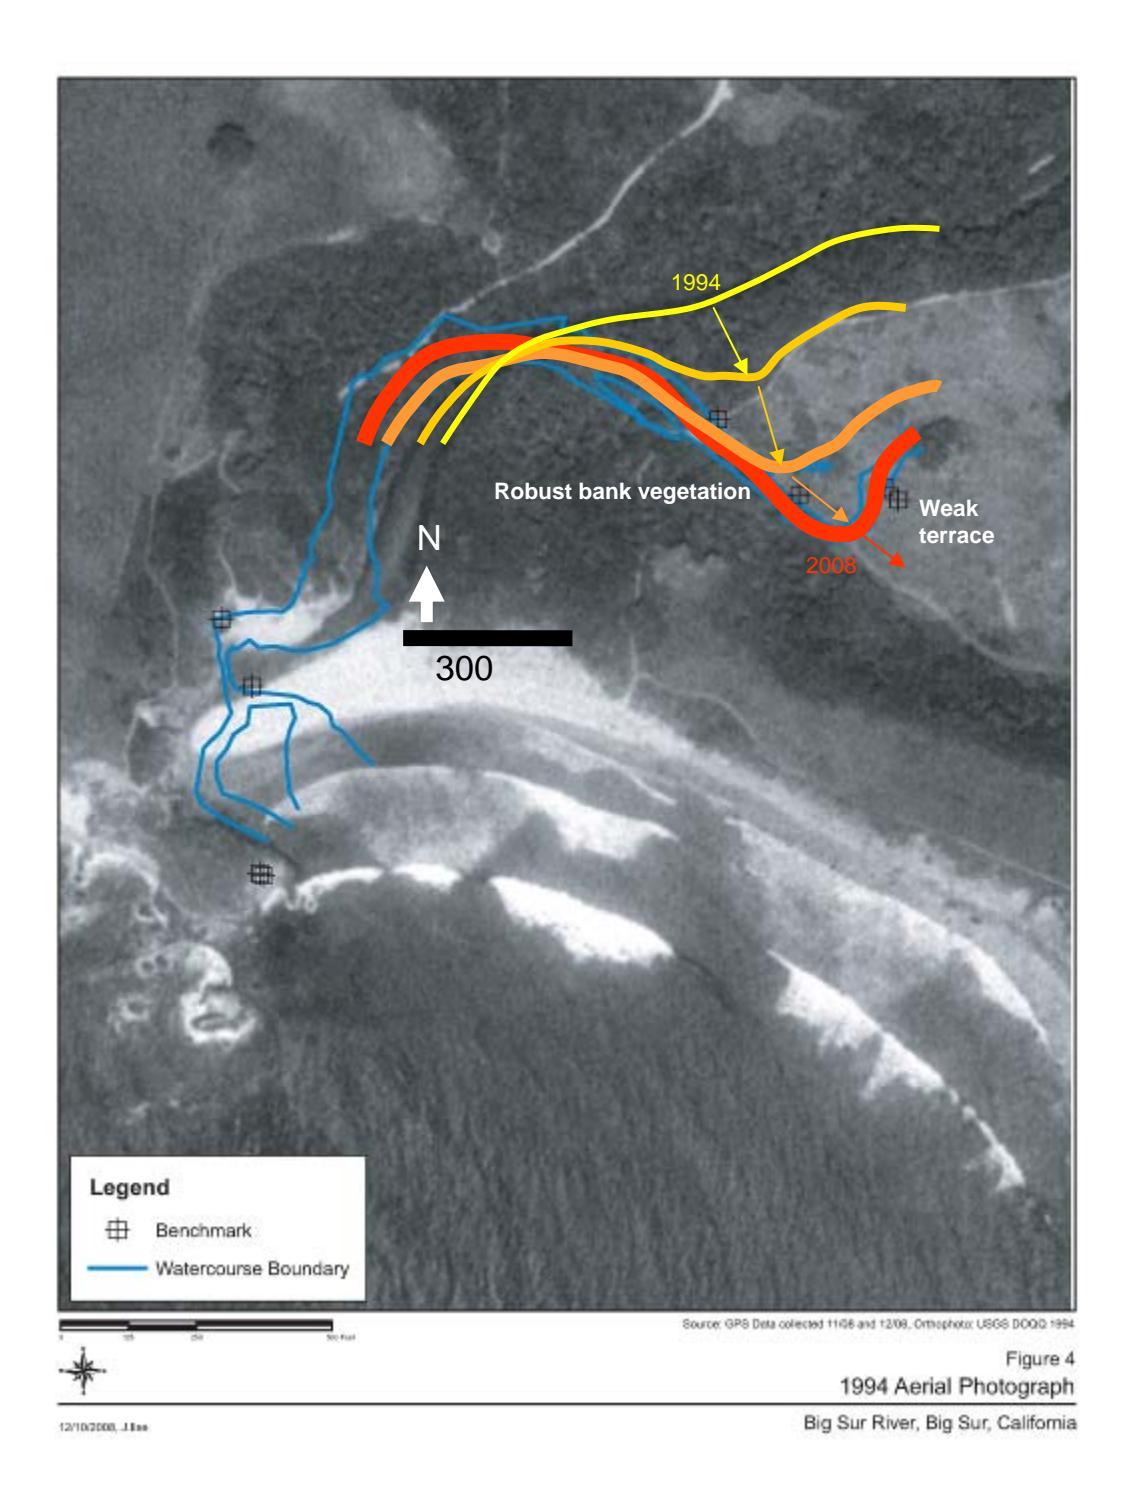
Recent historic aerial photos analyzed in this study indicate that the mouth of the Big Sur River is typically located adjacent to the rocky cliff at the northern end of the spit. This observation suggests that the mouth position is in decadal-scale steady-state equilibrium, with an "average position" that does not vary through decades.

In contrast, the position of the lagoon head, especially the sharp right bend, is not in decadal-scale steady-state equilibrium with current watershed (or local) conditions. It has monotonically shifted south, gradually increasing the river length and decreasing its average slope. The abrupt change from dense riparian forest to un-forested terrace (Fig. 31) provides the context for a positive feedback between bank erosion and greater shear stress. As the outer bank erodes into the weak terrace materials, the stout riparian bank vegetation downstream from the bend resists any change. The result of this uneven erosion is a gradually decreasing radius of curvature in the bend (Fig. 31). The tighter bend, resulting from this erosion, increases the stream attack angle on the bank and the attendant shear stress on the weak bank (Fig 30). The bend currently has a radius of curvature that is approximately one half the value typically found in unmodified streams of the same size.

Figure 31: Approximate recent positions of the lagoon channel based upon remnant topography of aerial photographs and recent GPS (Figs 15,, 16, and 17).

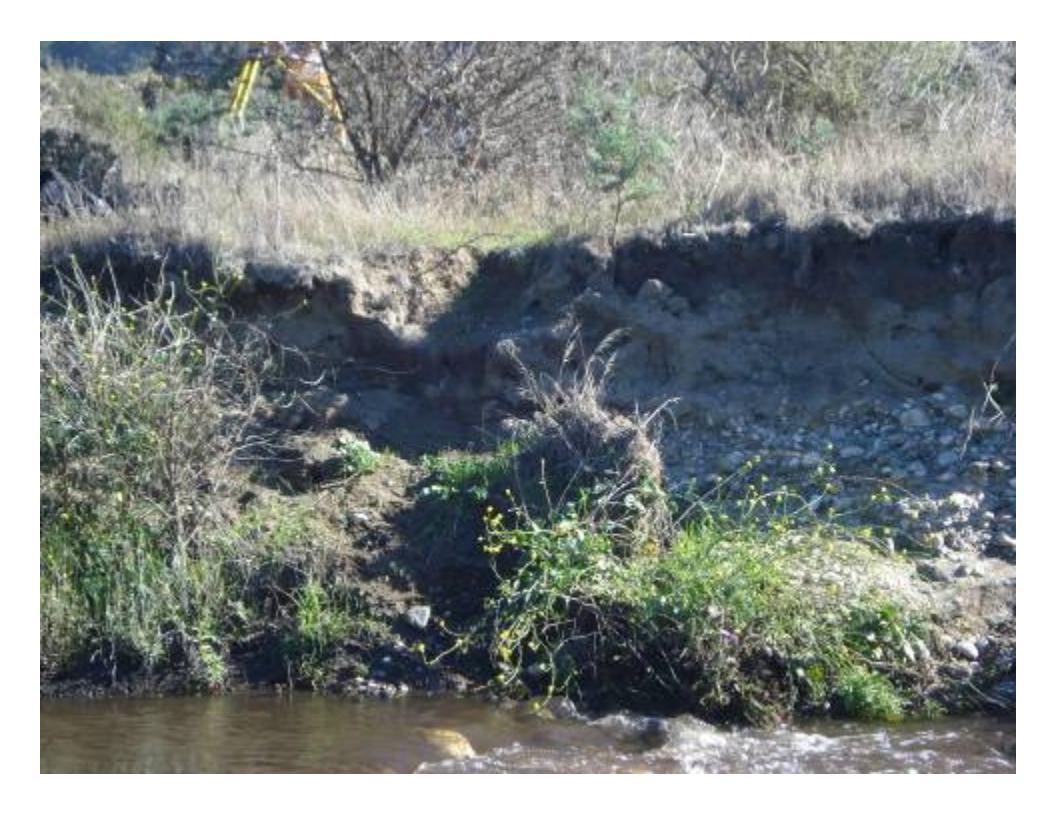
Figure 32: Detail of weak floodplain deposits underlying eroding terrace (November 2008).

We also expect increased erosion on the outer bank from increased shear stress ($\tau = \gamma RS$) during large storm events in the post-fire rainy season. Shear stress (τ) is defined as stress which is applied parallel or tangential to a face of a material; in this case the hydraulic stress applied to the riverbank. The components of shear stress are the specific density of water (γ), which is equal to 9800 kg/m³; the hydraulic radius (R) of the channel, and the slope (S) of the water surface. Large storm events will likely transport large amounts of sediment downstream. Sediment deposition on the inner bend of the channel will cause the hydraulic radius (R) of the channel to sporadically increase which will cause an increase in shear stress (τ) on the outer bank of the curve.
